## CAIRO

### FUNERARY COMPLEX OF AMIR KEBIR QURQUMAS

**Jerzy J. Kania**

The present report covers the period from 1 January to 31 December 1996.<sup>1</sup> The work included conservation and re-building of some parts of the complex, as well as point excavations.<sup>2</sup>

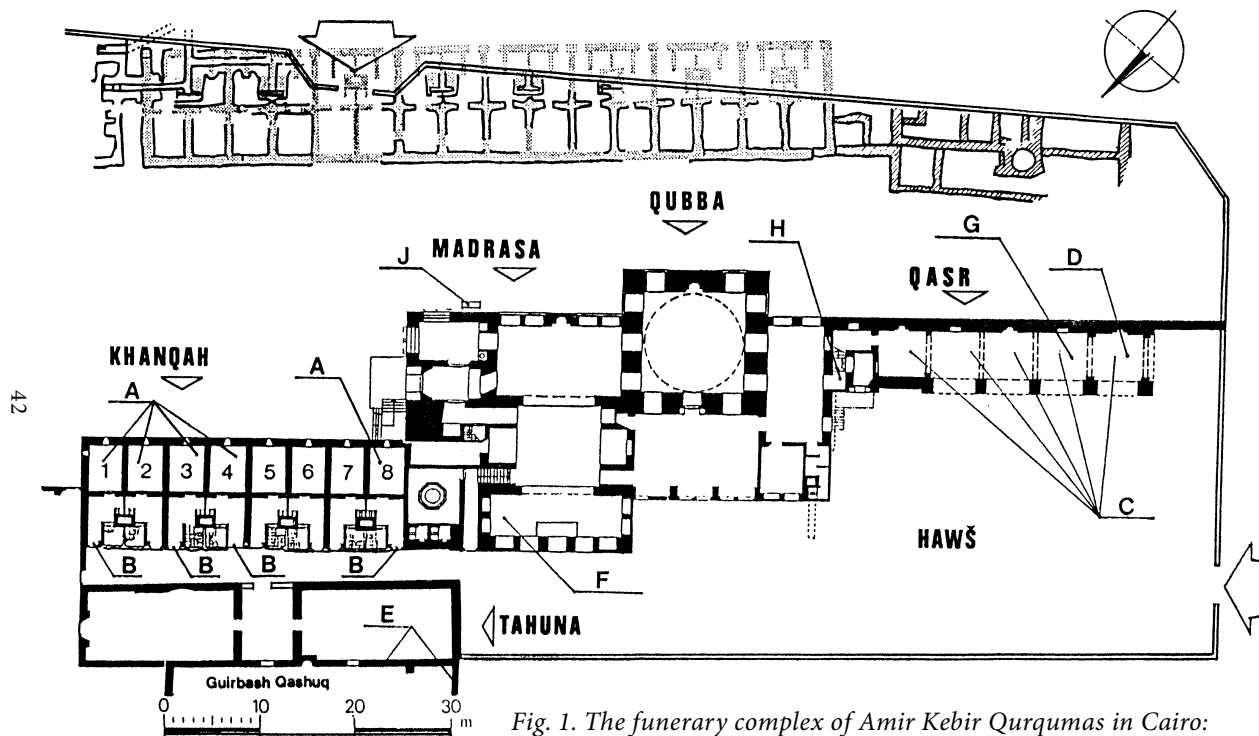
Changes for the worse were observed in the structure of the westernmost spheroid dome (Fig. 1.D). Weakened joints between the ashlar close to the keystone caused considerable danger to the stability of this part of the Qasr. Required technical and safety measures were taken. The spheroid dome is now supported by square-sawn timbers based on steel-pipe scaffolding.

Fig. 1. The funerary complex of Amir Kebir Qurqumas in Cairo: key plan with topography of the restoration works (consult the text for descriptions).

The missing outer doorsills in units nos 1, 3, 4, 8 were reconstructed in a hard limestone and set in their original positions (Fig. 1.B). The paving of units nos. 1, 2, 3, 4, 8 (vestibules, storerooms, lavatories) was brought to an end (Fig. 1.A), followed by the replacement of ashlar in the walls and barrel vaults. The reconstruction of the staircases according to a prepared technical design is a task intended for the summer of 1997.

After exploration of grave G-20 under the arcades, surplus earth and debris were removed, leaving the area free for leveling and final paving, which started in mid March 1996 and lasted until October 1996 (Fig. 1.C). The *qiblah*-wall composed of three mihrabs has thus regained its distinguished and expressive character.

The stone pavement in the *mabit* of the residential part was dismantled and filling materials were removed. The upper part of the spheroid is still uncovered after reinforcing. A special mortar was used to fill the voids between ashlar and the joints between of walls and dome in order to be more resistant against seismic movements.

In the ruins of the mill (*tahuna*) emergency repairs, such as the replacement of eroded stone blocks in the upper parts of endangered walls bordering with the Guirbash-Qashuq funerary yard, were carried out in November - December 1996 (Fig. 1.E).

The conservation work on the original wooden ceiling, altogether 36.63 sq.m of surface in the Northwest *liwan*, took place from 1 February until 31 March 1996 (Fig. 1.F). The choice of method for protecting the original painted ceiling was based on conclusions contained in the conservation expertise commissioned in 1984, and was as follows:
