MARINA EL-ALAMEIN

CONSERVATION WORK, 2001

Stanisław Medeksza

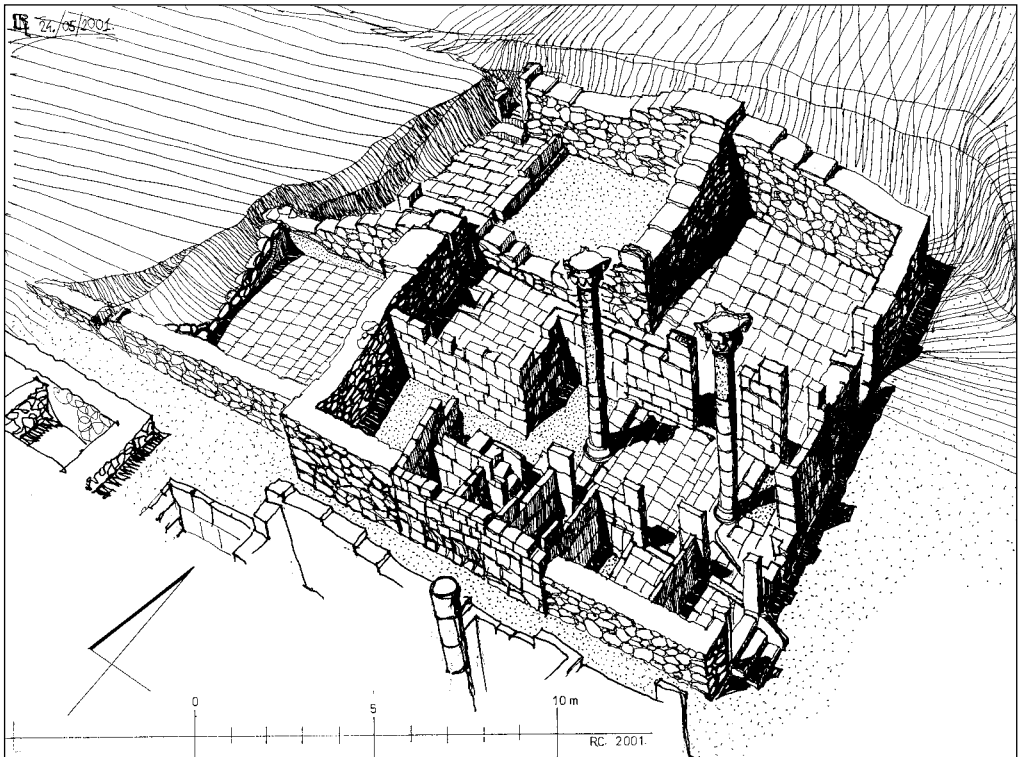
Fig. 3. House H 19. Axonometry after the 2001 season (Drawing R. Czerner)

1. **House H 19.** While the western end of the building still escapes study, its northward extent has been traced (*Fig. 3*). Room 2 turned out to be a corner space, adjoined on the west by room 11 (6.65 by 4.15 m). The northern wall of these rooms was at the same time the outer wall of the structure, and running westward along it was another alley, parallel to the one separating the house from neighboring house H 10a to the south. A doorway with stone jambs interrupted this wall just beyond room 11; through it one enters room 13. Only a thin partition wall (built of stone slabs measuring 0.50 x 0.35 x 0.16 m)

3. **House H 19.** The main thrust of building conservation activities this season, beside H 21c, was focused on this house (*Fig. 4*). Two columns with Nabatean-style capitals⁴ were raised in the courtyard. All the walls around rooms 1, 2, 3, 4, 5, 6, 6a, 7, 8, 9 and 10 were either re-laid or raised. In room 11, all the walls except for the west one were raised, while in room 12 only the east wall and part of the north wall could be raised. In room 13, the northern outer wall of the house was extended to reach the eastern jamb of the street entrance.

The wall between rooms 3 and 4 and the west wall of room 12 were originally made of mud brick in a mud mortar bonding. Without expensive chemicals there is no way to preserve such construction. Thus, for the sake of momentary preservation – until the necessary funds will have been raised – these walls have been encased in a stone facing and capped with closely fitting slabs, using lime mortar for bonding and introducing appropriate draining facilities.

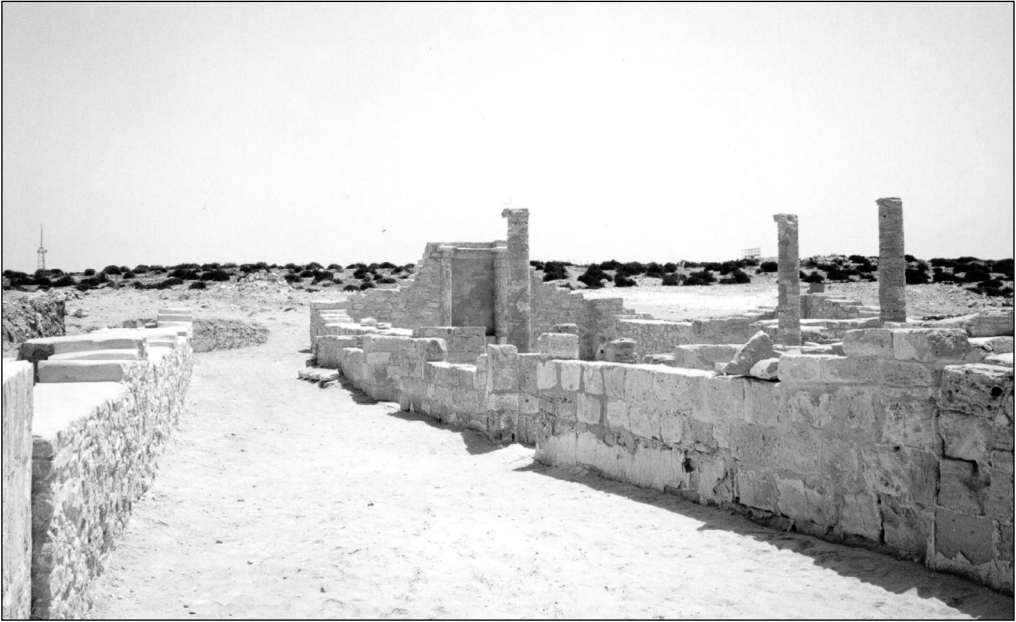
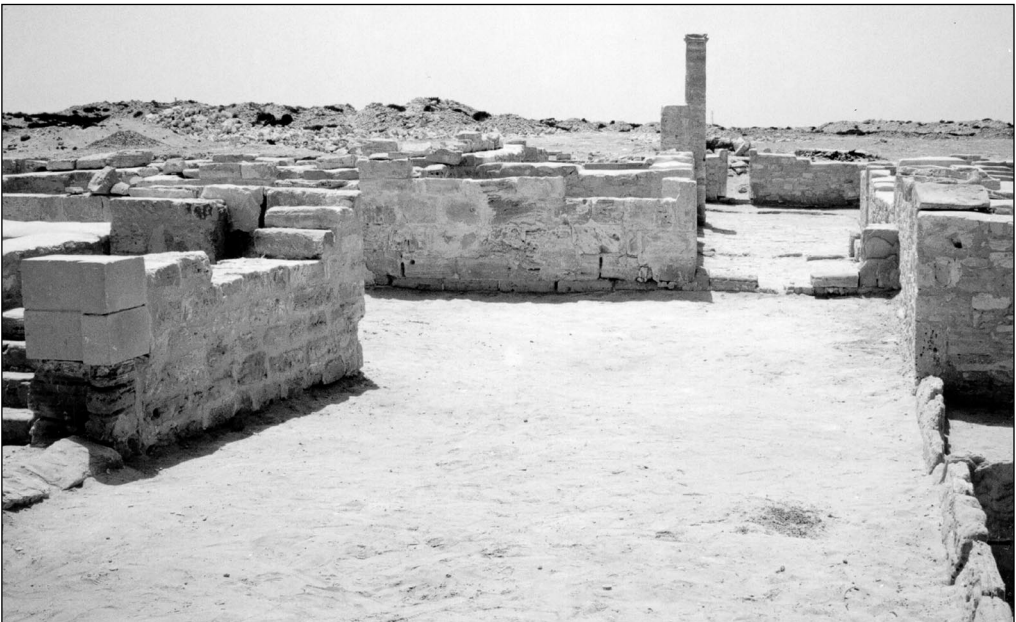
Fig. 5. Street running N-S between houses H 10 and H 10"E", view from the north, from the corner of the E-W street in Fig. 6 (Photo S. Medeksza)

Fig. 6. Street running E-W between houses H 10a and H 10"E", view from the east toward the corner of the N-S street in Fig. 5 (Photo S. Medeksza)

2. **House H 10“E”.** Some building conservation work was carried out on the outer northern and western walls, and the entrance to room 11 on the north, as well as the partition walls in order to clarify their course and raise them in height to an average 1.20 m. The partial restoration of

the western outer wall of house H 10“E”, which helped to set off the street running in front of the entrance to house H 10, enriched the display of the ancient residential quarter in Marina (*Figs. 5, 6*).

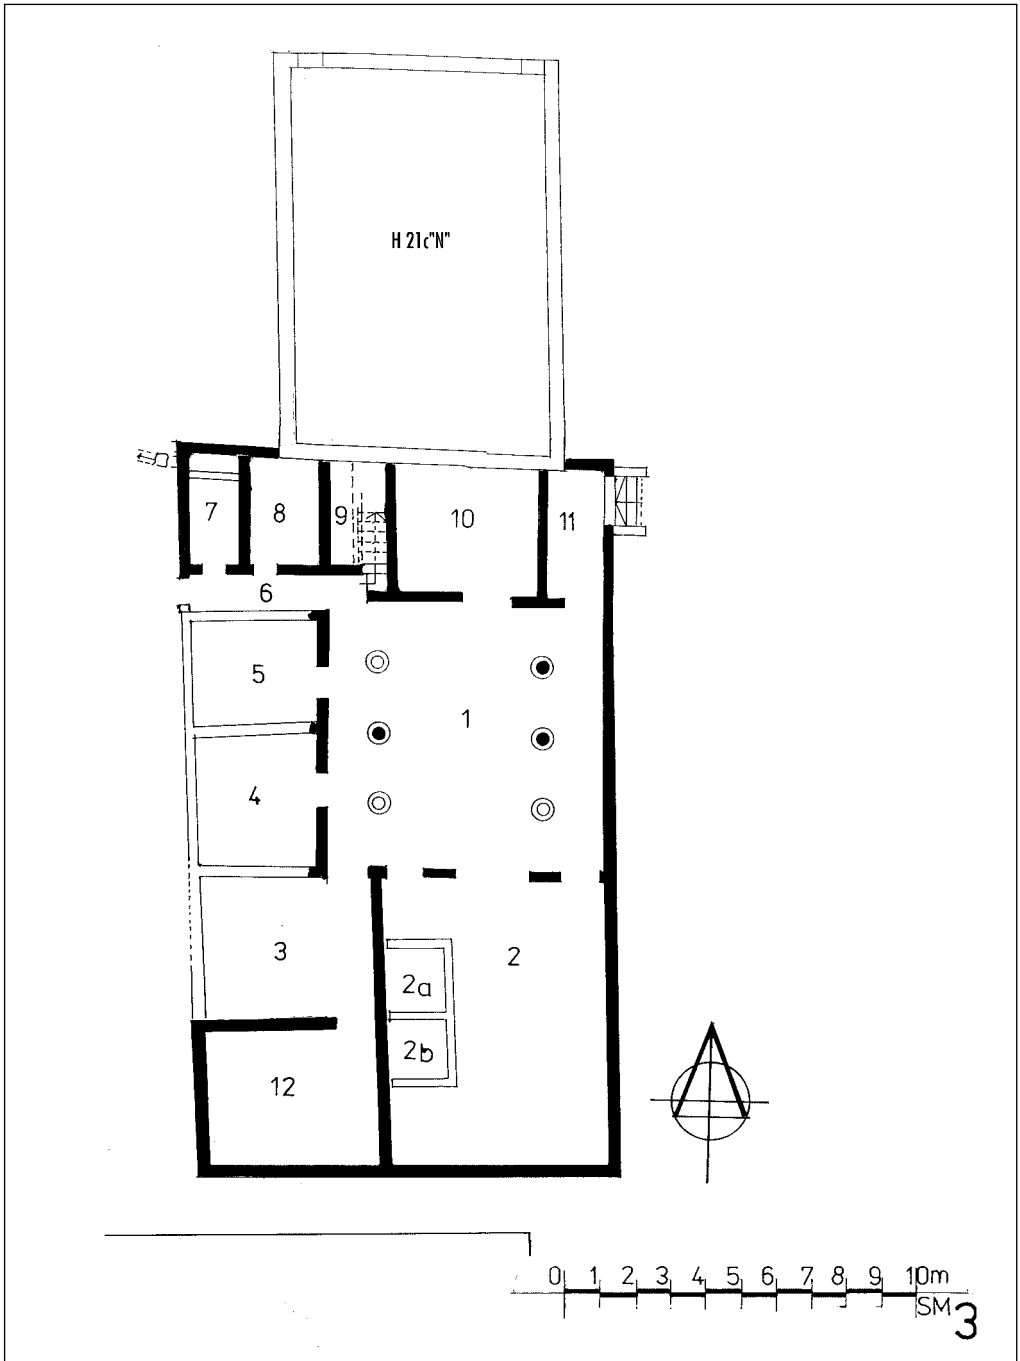
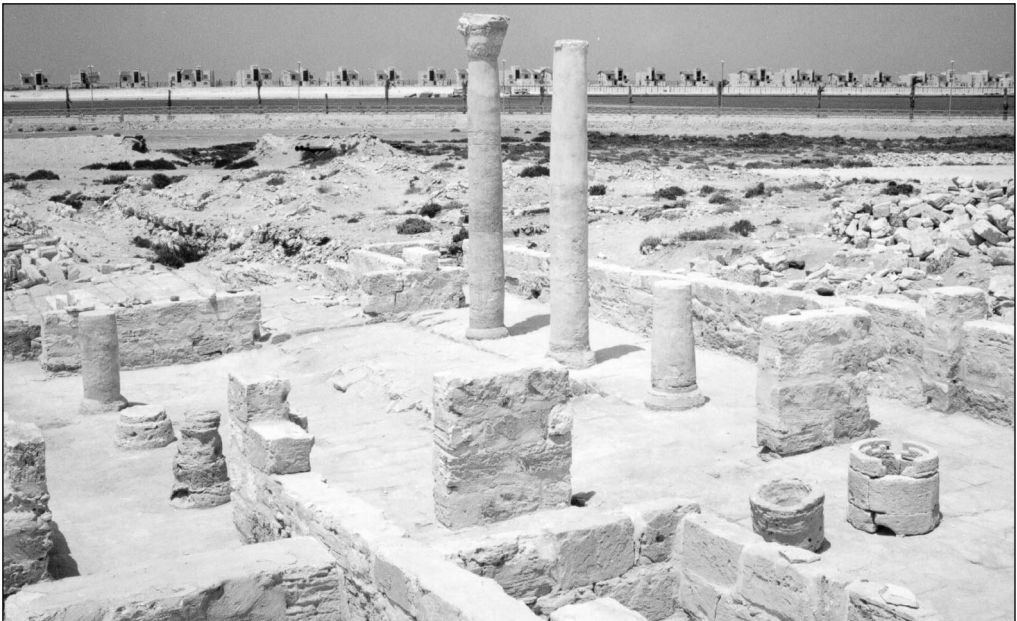
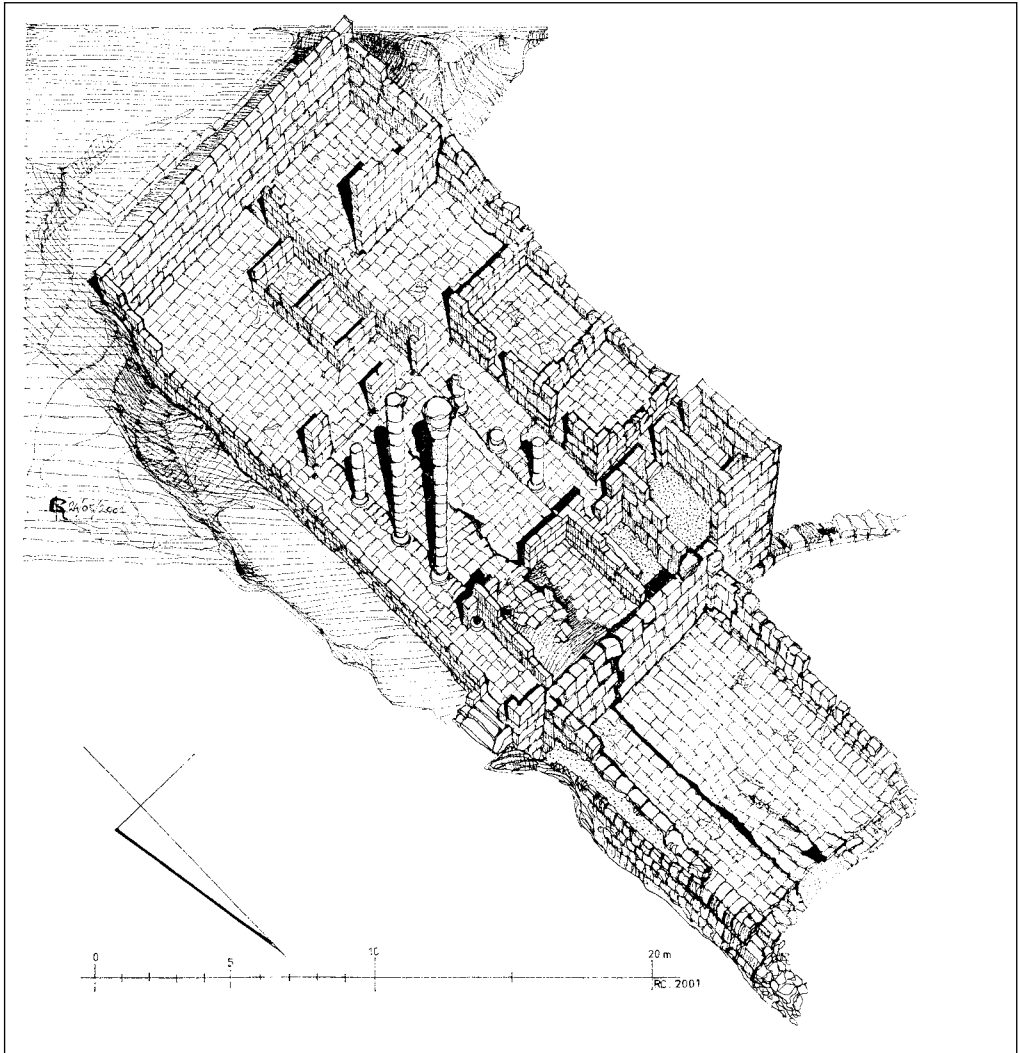
Fig. 8. House H 21c. State after the 2001 season, view from the southwest (Photo S. Medeksza)

4. **House H 21c.** A complete anastylosis of two columns in the eastern portico of the courtyard was carried out (*Figs. 7, 8, 9*). The remaining columns were raised as much as the preserved stone elements permitted it. Furthermore, the outer and partition walls were both easily

reconstructed from fallen blocks, lying obviously undisturbed from the time of the cataclysmic earthquake that had toppled the building. The lime mortar used in the restoration had a small proportion of white cement mixed in for the sake of durability.

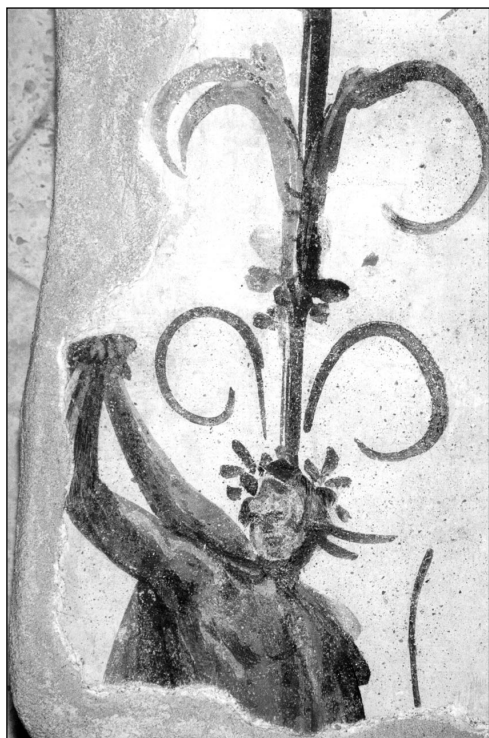
Fig. 12. Fragment of a grotesque painting from H 10a, after conservation (Photo S. Medeksza)

Work proceeded as planned on a fragment of grotesque mural discovered last year.⁵⁾ It will be displayed on the original stone ground, hence the need to fill in the structurally weak parts of the stone block around the broken plaster edges (*Fig. 12*). Conservation of a piece of mural depicting a female head crowned with the prow of a ship⁶⁾ was completed. The eight fragments were joined together with epoxy resin and the surface treated comprehensively to prepare the piece for museum display (*Fig. 13*).

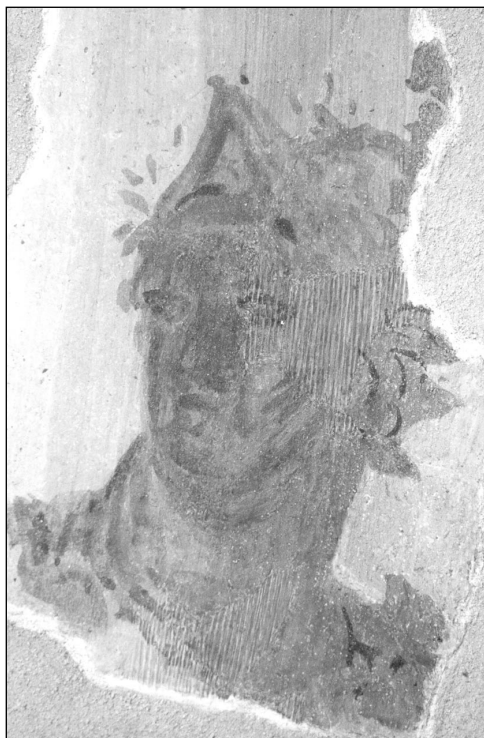
Fig. 13. Female head crowned with the prow of a ship from H 10"E", after conservation (Photo S. Medeksza)

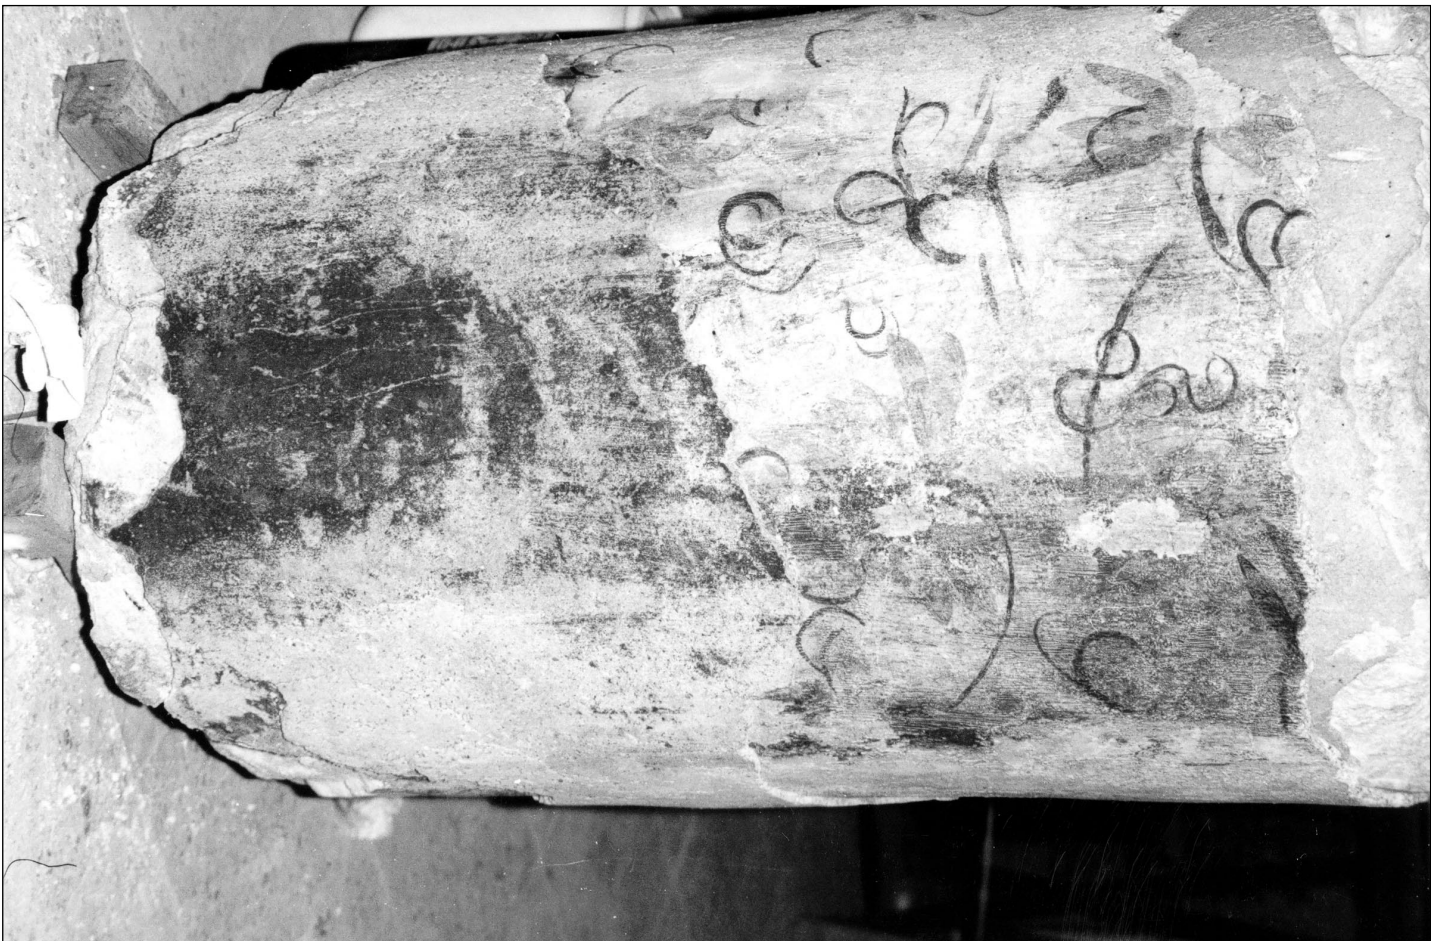
A piece of decoration of importance for understanding the phasing of painted decoration in house H 21c was uncovered in the center of the newly cleared room 12. It is a plastered and painted column shaft, 0.343 m in diameter, 0.55 m high. Of the two layers of plaster, the initial one survives over a greater expanse of the shaft (*Fig. 14*). Originally, the decoration consisted of a scrolling vegetal ornament. The second layer seems to have been a monochromatic red. The stone shaft is in good condition; the conservator's chief goal in this case was to halt deterioration processes.

*Fig. 14. House H 21c, room 12: Column shaft with two layers of painted plaster, under conservation
(Photo S. Medeksza)*
