MARINA EL-ALAMEIN PRESERVATION AND CONSERVATION IN 2005

The Polish-Egyptian Preservation Mission carried out the eleventh season of work at the site of Marina el-Alamein from April 13 to May 30, 2005.¹

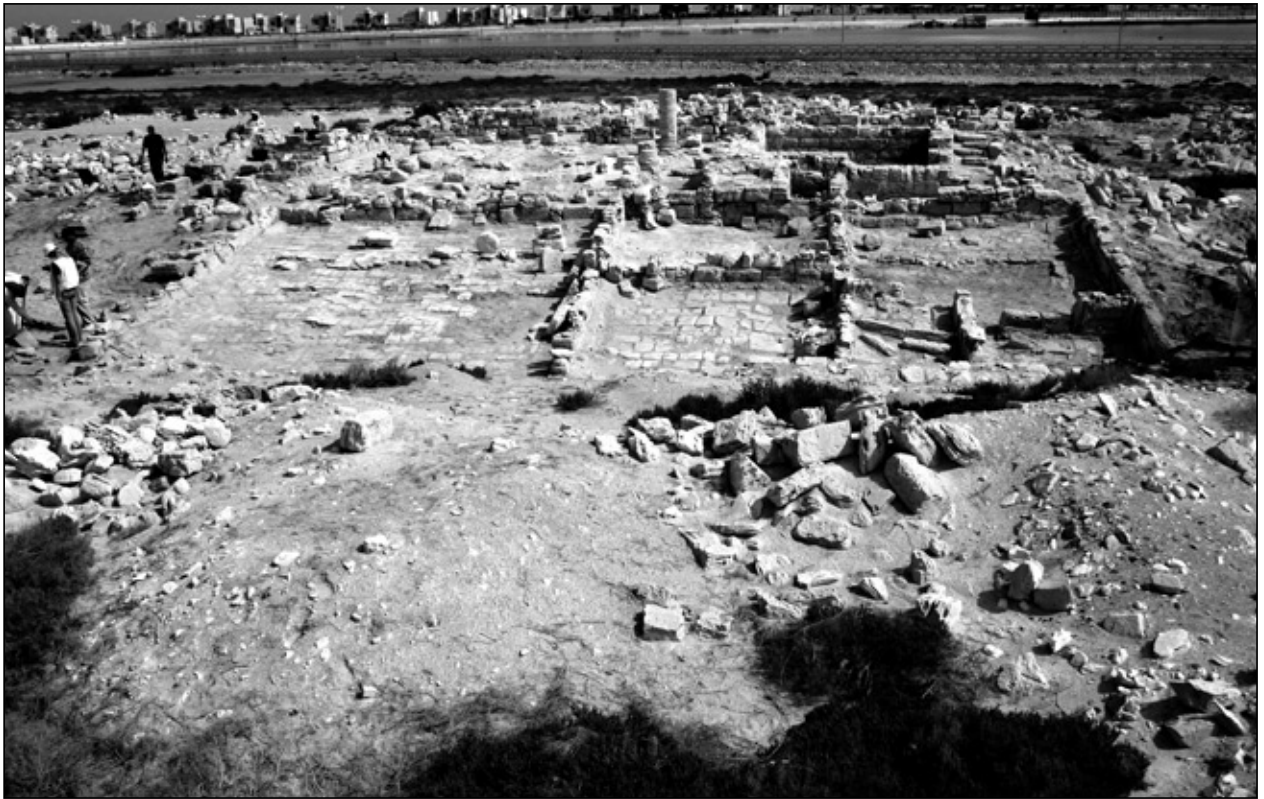
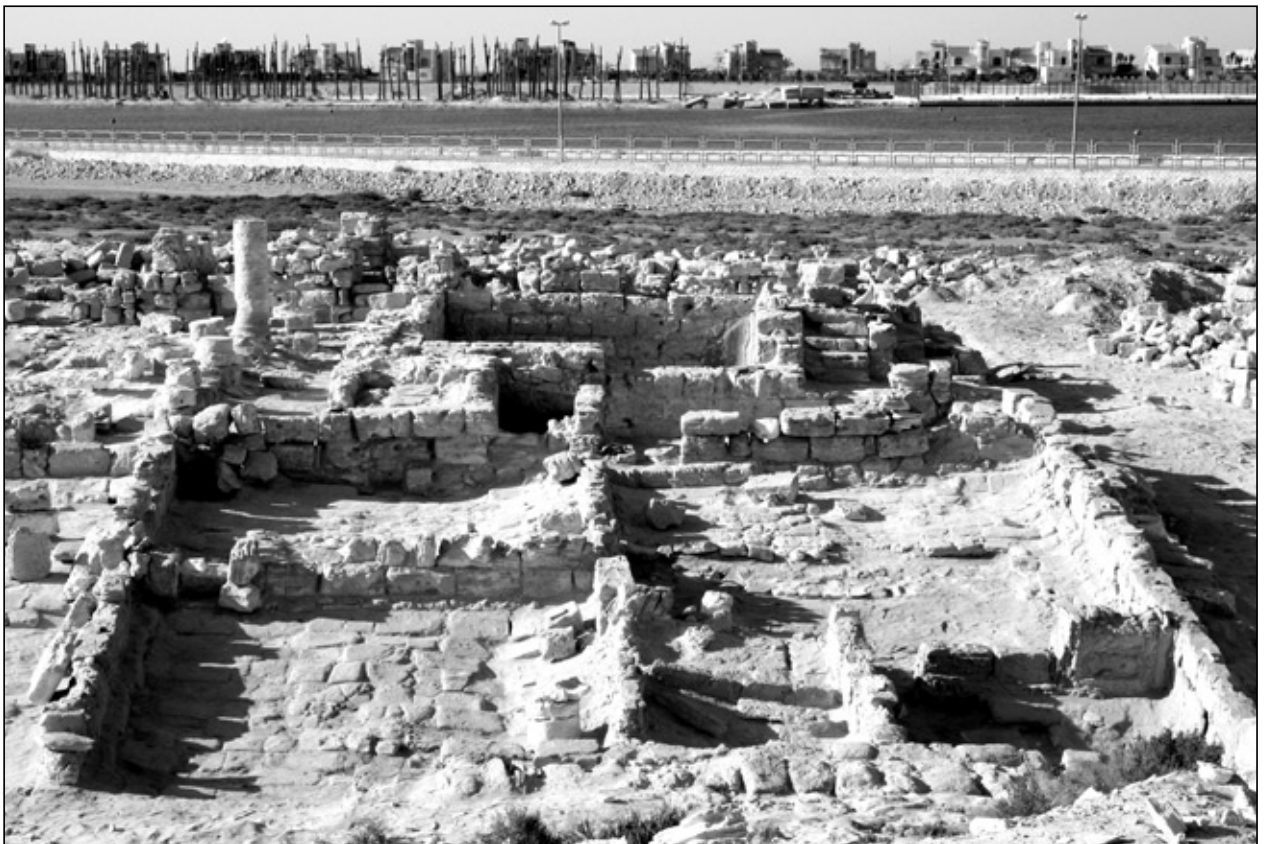
The building has suffered evidently from earthquakes and ground movement caused by other geological factors, resulting in a considerable distortion of the architectural appearance. Much subsidence of the original stone pavements is in evidence, especially in the courtyard (north portico of the peristyle) and in the area of rooms 4, 5, and 10 [*Fig. 3*]. Only the vaulting of the cistern under the floor in room 3 seems to be at the original level, but it has a deep E-W fissure that is pushing apart room 13 and basin 9. The perimeter wall also proved to be very poorly preserved, even missing entirely in places (especially in the eastern part of the house, in the vicinity of rooms 15, 14, 22, 13, 24). Room 6 appears to have been a projection, extending west, beyond the rectangular body of the house.

Fig. 3. House H1. View from the south, before (top) and after the season (Photo S. Medeksza)

The ruins of House H1 have been prepared for conservation and partial reconstruction

for the past two seasons. Rubble and secondary deposits, including vegetation, have been removed, and the vaulting of the cisterns under the courtyard protected. Architectural documentation work, in preparation for the building works to start next year, was completed this season, including fundamental revisions of the earlier documentation [*Fig. 2*]³ (indeed, more research needs to be done in order to understand the internal chronological stratification of the building).

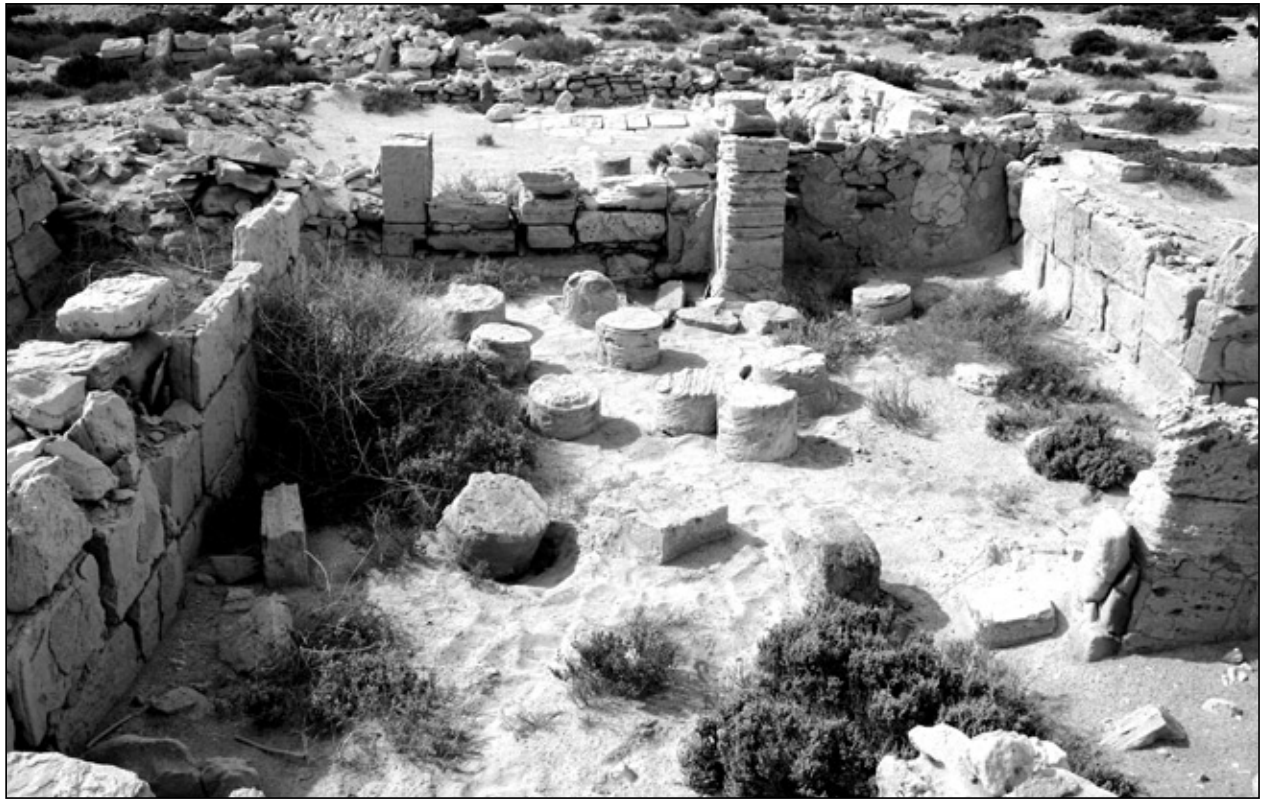
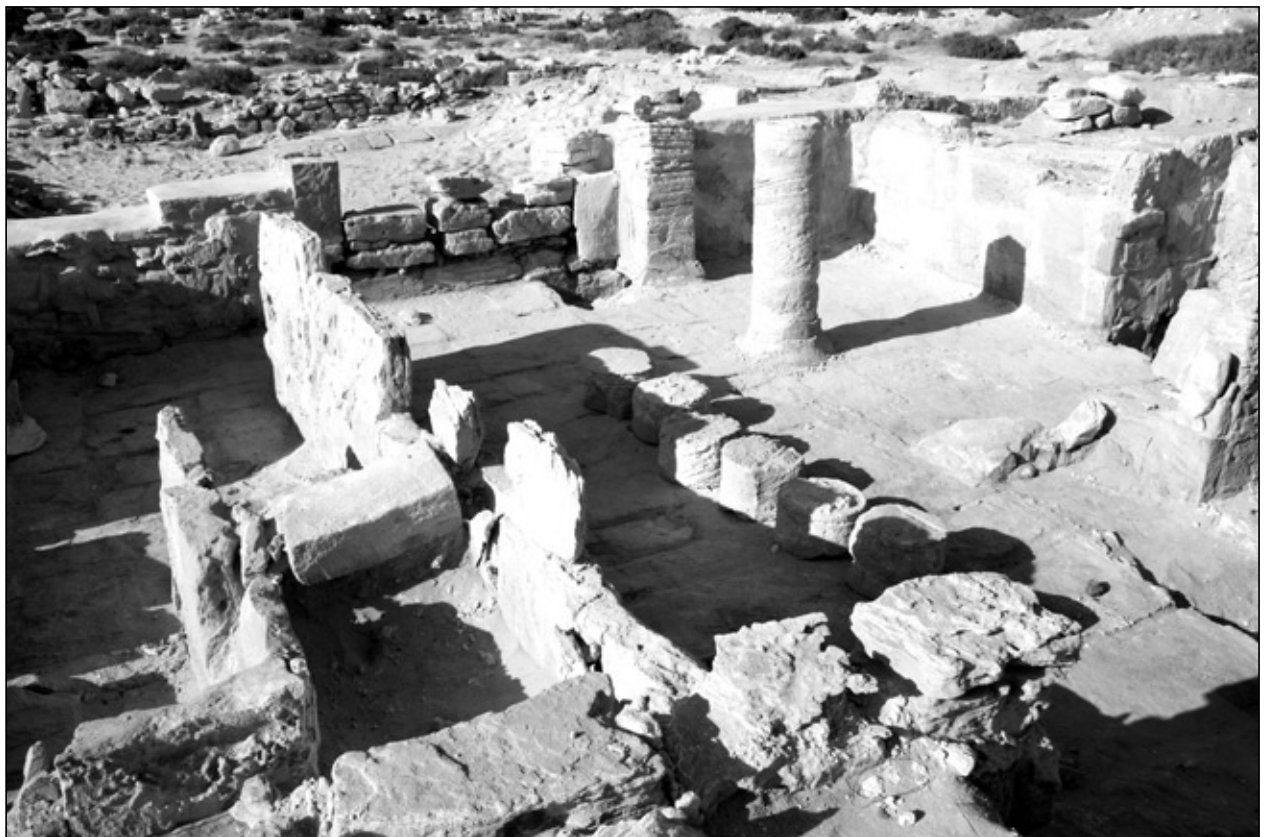
Fig. 5. House H2. View from the south, before (top) and after the season (Photo S. Medeksza)

In 2005, all the walls surrounding the courtyard were consolidated [Fig. 5]. New jointing was carried out and the missing plaster completed. The broken-stone walls had the tops protected with the regular lime-cement mortar used by the mission.

The column was raised to a height of 1.20 m and will be completed next year.

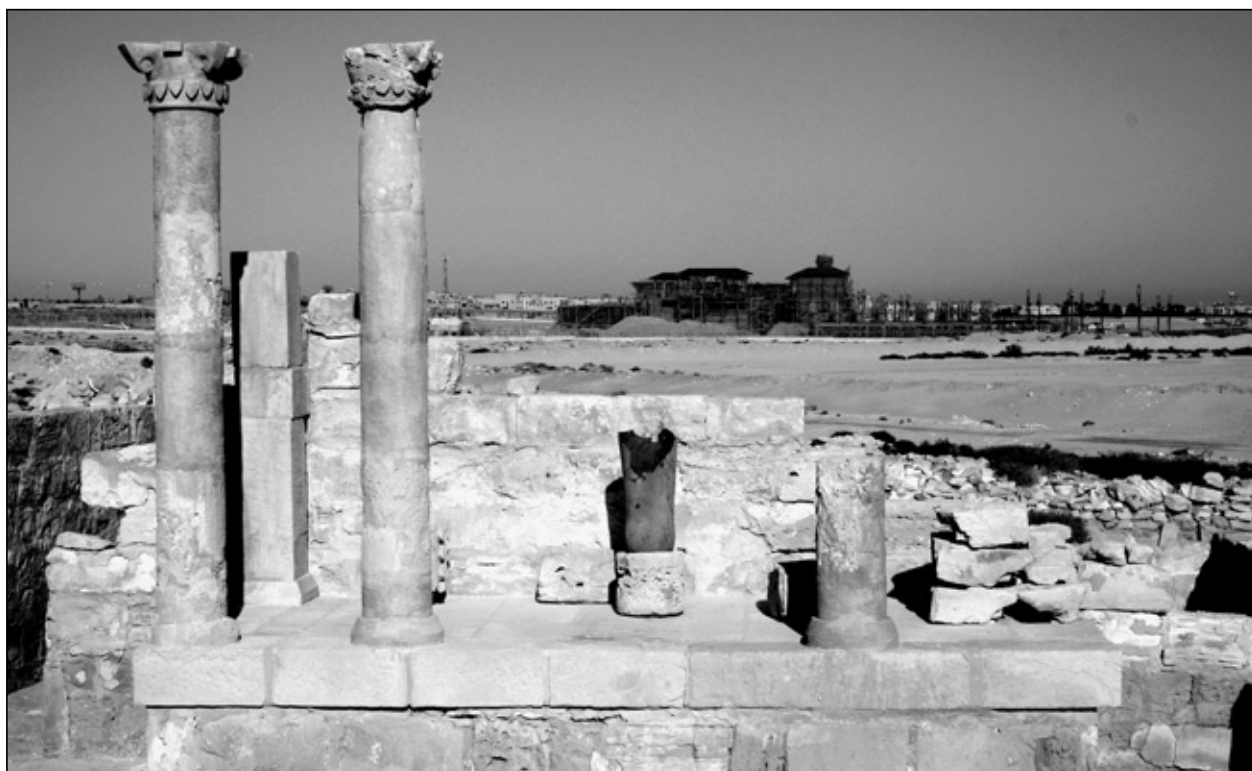
Fig. 6. Commemorative monument from House 21, after restoration work in 2005 (Photo S. Medeksza)

The commemorative monument in room 2, which had been restored to the top of the parapet walls in previous seasons, now underwent an anastylosis of the upper, decorative parts. Three of the four small columns, which together with the engaged pilasters had formed the portico, were re-erected on the platform measuring 4.00 by 2.20 m. Originally, each of the columns had consisted of four drums, the three bottom ones being 0.53 m high, the last one on top 0.45 m high; the diameter of these drums ran from 0.31 m at the bottom to 0.29 m at the top. One of the drums with preserved polychromy composed of a floral ornament, which underwent conservation in the 2000 and 2001 seasons, is intended for display in the local site museum. The other surviving

elements – five drums, a base and a capital, both 0.28 m – high were strengthened and completed with limestone of similar properties as the original.⁵ The small columns were raised using some new stone elements (four drums, three blocks from the pilaster, three bases and column capital⁶), the two columns on the south were raised to their full height, the third to the height of one drum above the base. A sizable section of the back wall of this commemorative portico and one of the engaged pilasters, 0.30 m to the side, was also reconstructed, but the surviving capital still waits to be put into place [*Fig. 6*]. The full height of the restored columns is 2.56 m. Further work on the back wall and pilasters, using surviving elements of the cornice, is planned for the coming season.

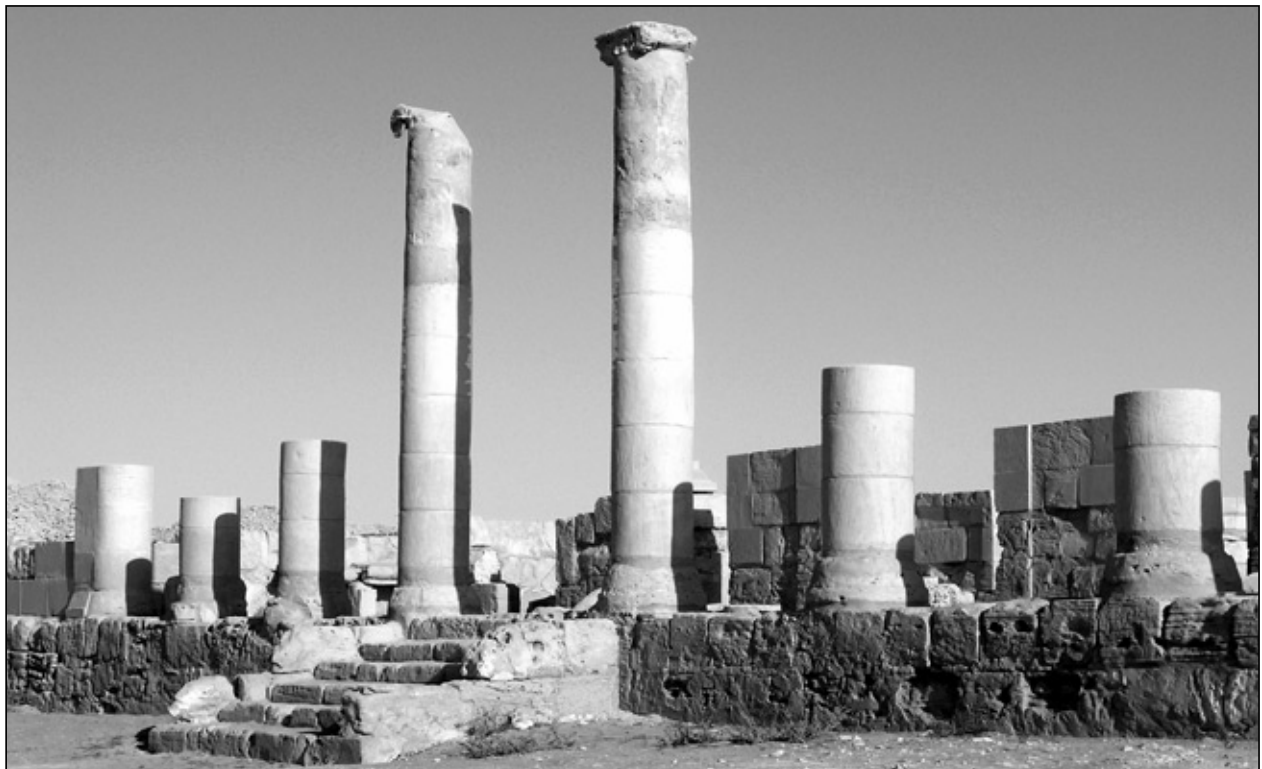
Fig. 7. Hypogeum-Mausoleum T6, façade of the mausoleum after restoration work in 2005 (Photo S. Medeksza)

Restoration work on the mausoleum of Hypogeum Tomb T6, discovered by the Polish Archaeological Mission in 1988-1998, continued with a further reconstruction of the columns of the front portico. In previous seasons these columns had been raised and restored to no more than 135 cm in height. Having some shaft drums from the upper parts of these columns (as suggested by the smaller diameter) and remains of a capital, it was possible this year to reconstruct the two columns framing the entrance to their full height of 3.25 m [*Fig. 7*].⁷ The lateral pillars with engaged columns were also raised by two blocks in the case of the eastern one and a single block in the case of the western one. Both the height and span of the portico are now clearly visible.

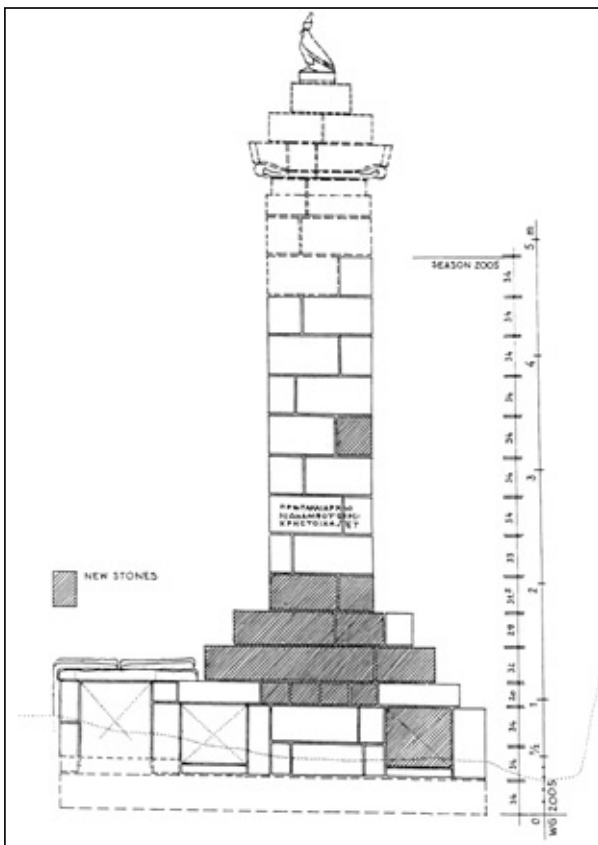
Fig. 8. Building-conservation work on tomb T12 in 2005 (Design W. Grzegorek, original drawing J. Dobrowolski)

stone. A trial mounting of particular layers based on a project design prepared originally by J. Dobrowolski and updated by W. Grzegorek, permitted missing elements to be replaced with new ones made in old and new stone. The pillar was verified as measuring 0.91 by 0.91 m, with each course being 0.34 m high [Fig. 8].

The tomb, which was discovered in 1994 by the Polish Archaeological Mission,⁹ was cleared again in 2004 in preparation for the restoration project. This season, the eroded stone blocks in the three upper courses of the base on the west and south were replaced with new blocks. The original fill consisting of small rocks mixed with clay and sand was removed from the core of the substructure and in its place larger stone blocks in lime-cement mortar were introduced. Four of the limestone slabs (52x26x20 cm each) covering the loculi comprised within the base were replaced. Also, the lowermost course of the pillar was reconstructed in new

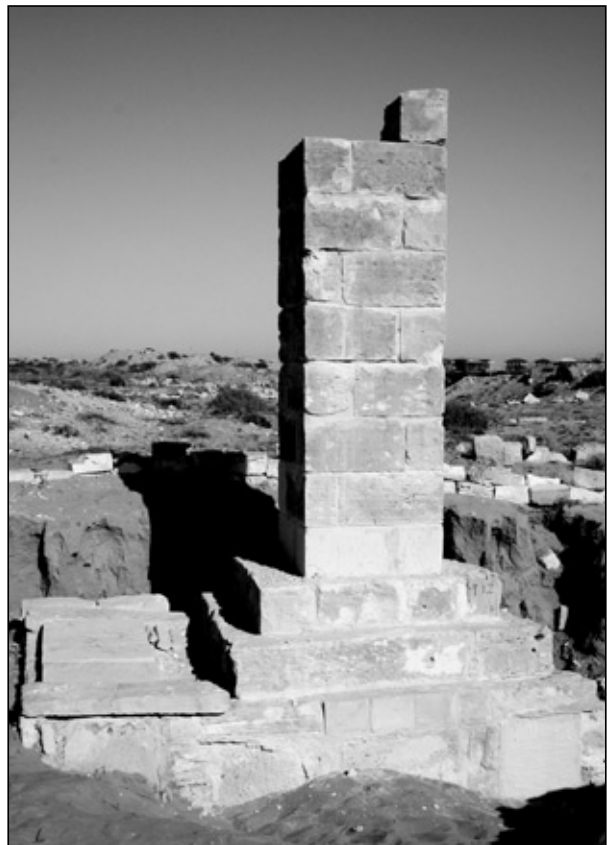
Fig. 9. Pillar tomb T12, state after reconstruction in the 2005 season (Photo S. Medeksza)

Eight courses of the pillar shaft were raised [Fig. 9]. Next year, the remaining three courses will be erected, plus the two-course capital and the course on top of the capital, which is the base under a limestone sculpture of Horus in falcon form, discovered during the earlier excavations, restored and kept in storage at the site.

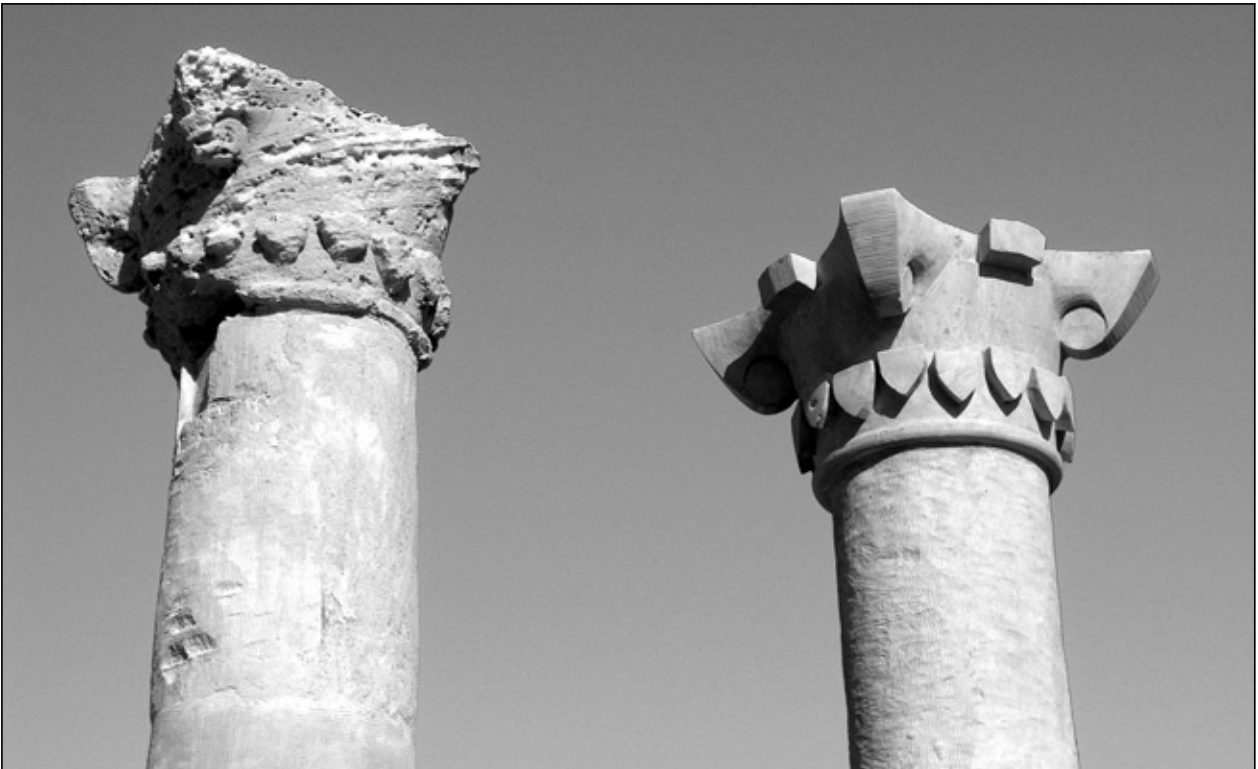
Fig. 10. Capitals from the commemorative monument in H21, after treatment (left) and reconstruction (right) in 2005 (Photo S. Medeksza)

The program calls for protection of the ancient substance, reconstruction of the original form of selected elements (determined by the needs of future display) and testing of specialist materials for use in the future. Objects for treatment were chosen from structures both in the town and the necropolis, including some which were a continuation of earlier activities, e.g. the base of a pilaster and capital in pseudo-Corinthian style typical of Marina, from the commemorative monument in H21, which were replicated in Heluan limestone, based on comparative analysis of surviving fragments and executed using traditional techniques [*Fig. 10*].

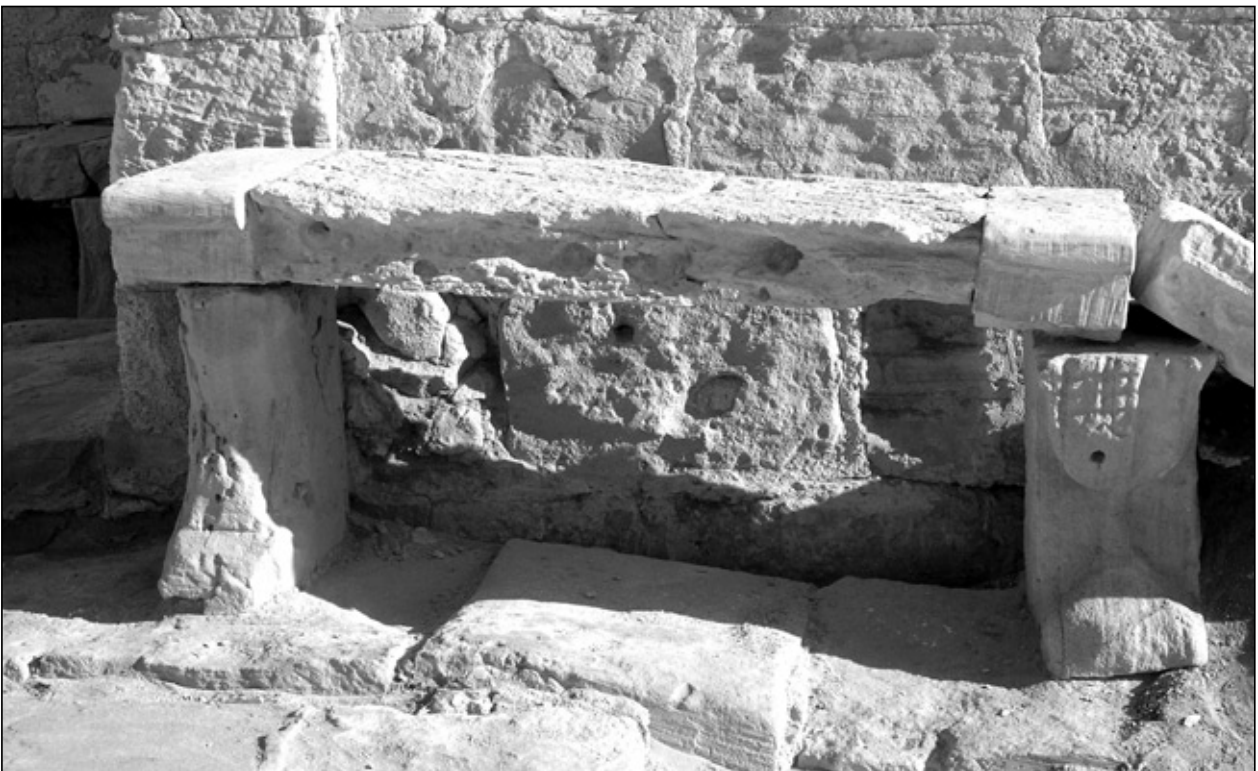
Fig. 11. Stone seat in the South Stoa of the main square, after conservation work in 2005 (Photo P. Zambrzycki)

Similar treatment was applied to the seats of benches in the South Portico of the Town Square. Surviving fragments were consolidated and the original appearance reconstructed in part. Stone replacements for missing elements were introduced based on a comparative analysis of surviving parts [*Fig. 11*]. The work will be continued in the coming season, once the remaining deposits under the benches are excavated.

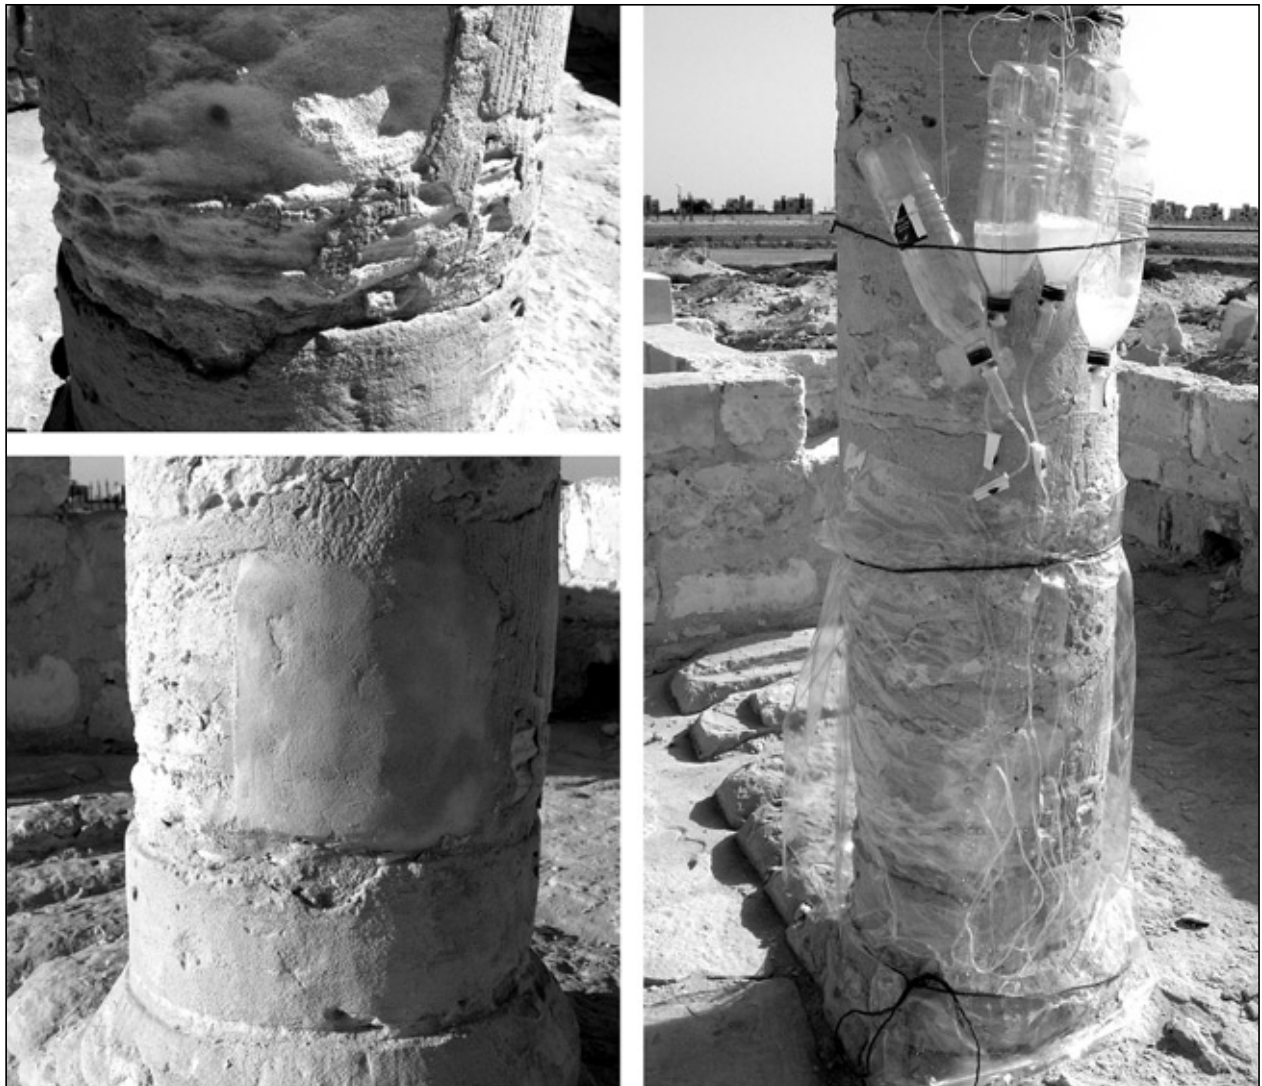
based on new materials was initiated in 2005. A major cause of on-site damage is the impact of an erosive seaside climate on faulty stone material of local origin. Substantial daily and seasonal variations in humidity and temperature levels result in granular disintegration, intensified at the absorption line. The process could have been escalated by the considerable salinity of the cement binder used so far, hence attempts to replace it with slaked lime. In chemical terms, slaked lime is also the better material because it corresponds to the stone used for the building blocks.

Fig. 12. Drum of a limestone column from H21, before (top left), during (right) and after trial conservation in 2005 (Photo P. Zambrzycki)

The object chosen for the research program was the lower drum of a column from room 1 in H21; tests included reinforcing and protecting the surface of the stone through a re-profiling with appropriate mineral mortars. The structure was reinforced with a solution of dispersive lime, which was introduced by drop injection. Upon seasoning in stable conditions, the surface was covered with lime plaster containing quartz sand filler (1 part lime to 1.5 parts sand) [Fig. 12]. The material used was dispersed lime KALKINIEKTION by Kalk-Kontor-Germany. Actual conservation
