MARINA EL-ALAMEIN

CONSERVATION WORK 1995

Stanisław Medeksza

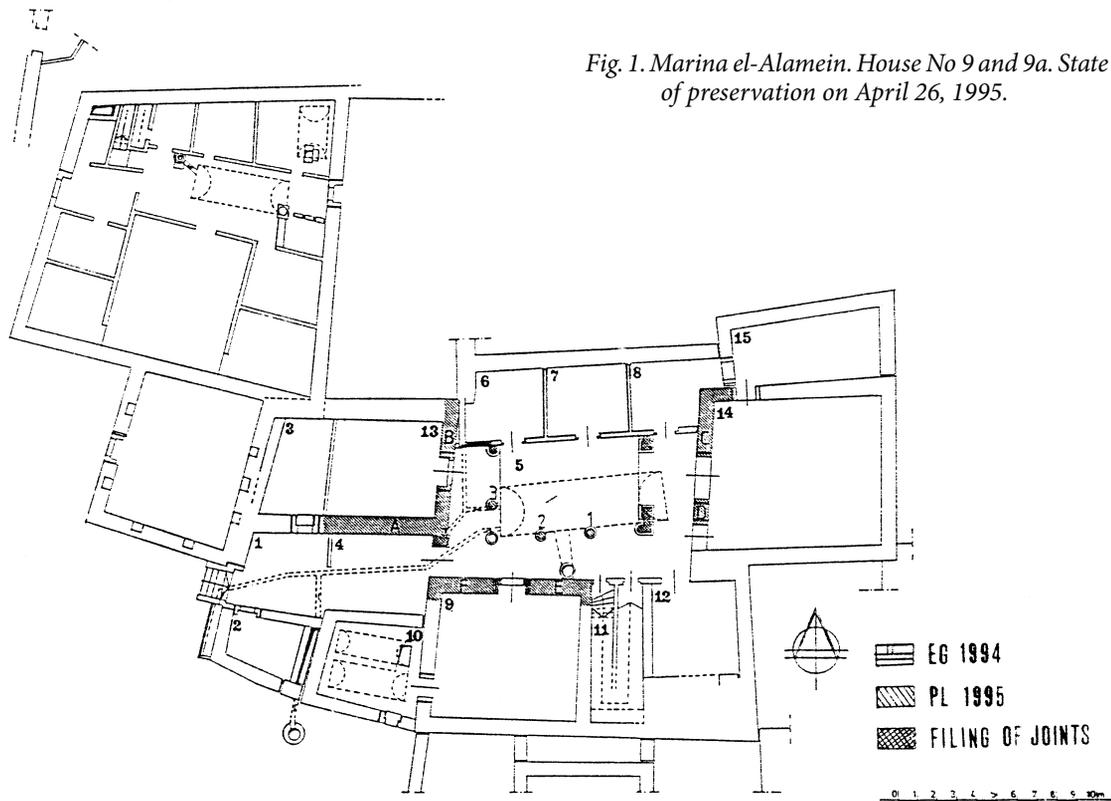
Fig. 1. Marina el-Alamein. House No 9 and 9a. State of preservation on April 26, 1995.
