MARINA EL-ALAMEIN

RESTORATION WORK 1997

Stanisław Medeksza

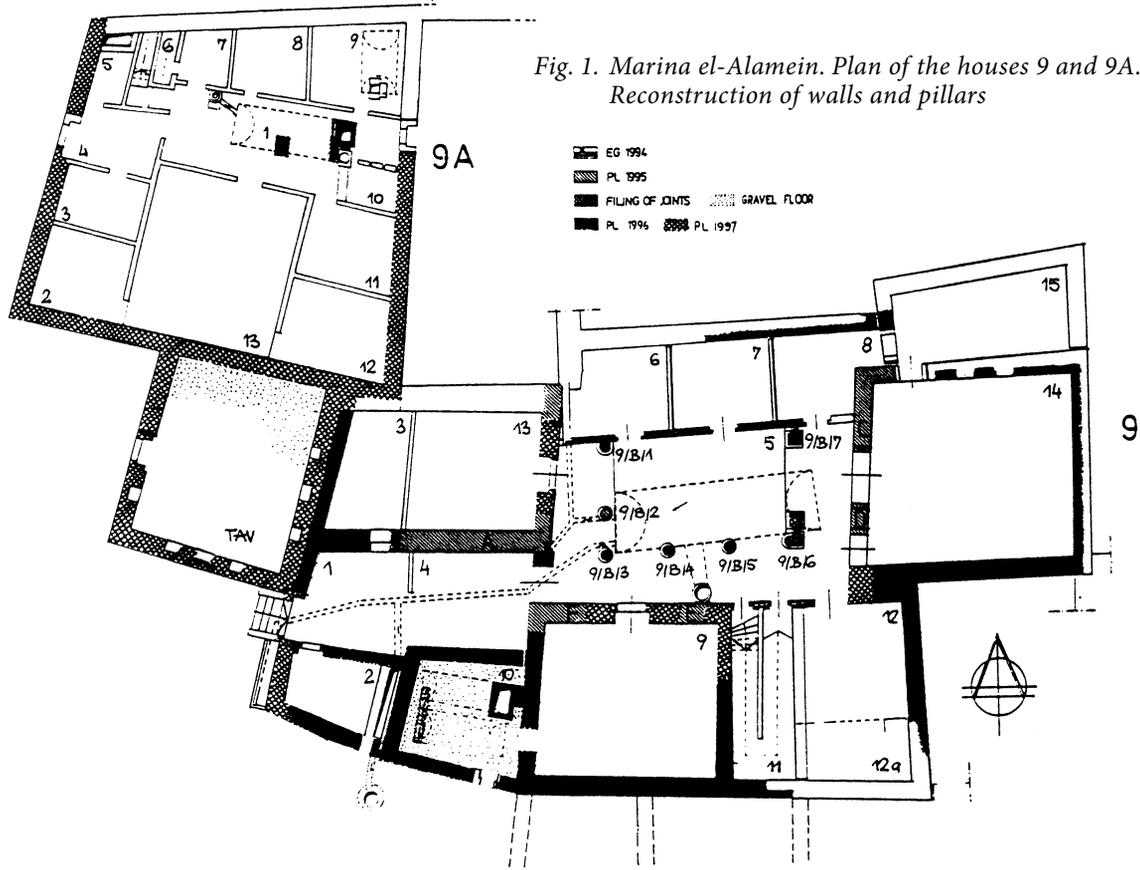
The outside walls of houses H9 and H9a (fig. 1) were treated during the season. They were made of broken stone in a clay-and-lime mortar. Also treated were the partition walls made of stone slabs set vertically in one course, using a lime mortar, especially in rooms 2, 3, 9, 10, 12, as well as the walls of the room situated between houses H9 and H9a. Many of these walls required only that the joints be restored and the wall tops laid. But the outer walls necessitated some dismantling. For example, the eastern wall of House H9a was dangerously inclined. It was impossible, however, to take it apart and restore it because of the heavily eroded stones and the big difference of levels between the room spaces that abutted it. Hence, this wall was reinforced with a new facing erected immediately in front of the original one, and joined to it taking advantage of the missing parts in the old structure. The eastern, southern and western walls originally had niches, now mostly destroyed, especially in the upper parts; these niches required restoration of their original layout.
