MARINA EL-ALAMEIN

CONSERVATION WORK IN THE 2003 SEASON

Stanisław Medeksza et al.

From March 27 to May 30, 2003, an Egyptian-Polish conservation mission completed its ninth season of conservation work at the site of the Early Graeco-Roman town of Marina el-Alamein.¹⁾

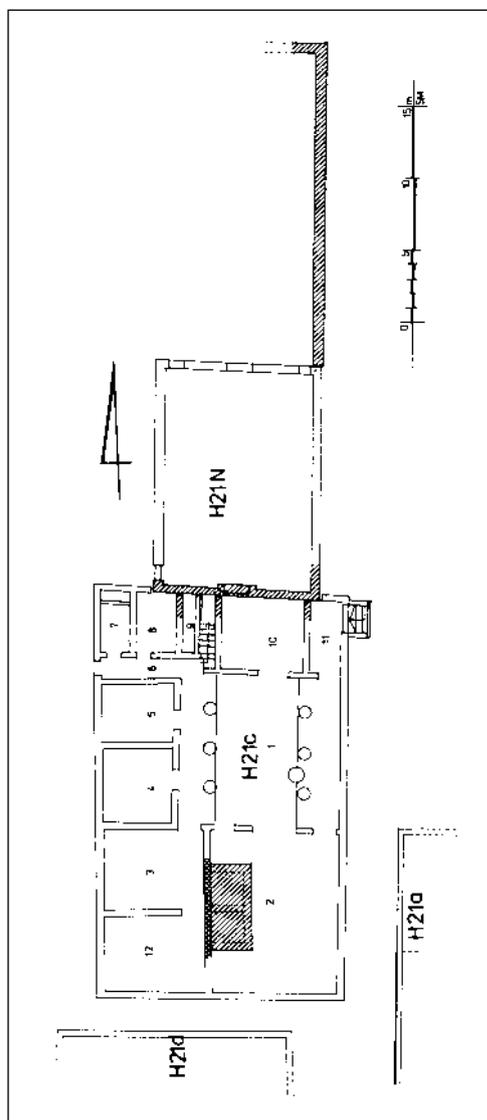
Fig. 3. House H 21c and hall H 21N.
Plan showing work completed in 2003
(hatched) Drawing S. Medeksza)

The commemorative memorial to Commodus in room 2 of House H 21c was given a limestone parapet and was covered with stone slabs (Fig. 3).⁵⁾ The bases of small columns were erected on this parapet; one whole column and a piece of another will be restored in the future. The bases are 0.30 m high; the six surviving parts of column shafts measure 0.29-0.30 m in diameter and are 0.52 m high. A single preserved column capital measures 0.30 m in height.

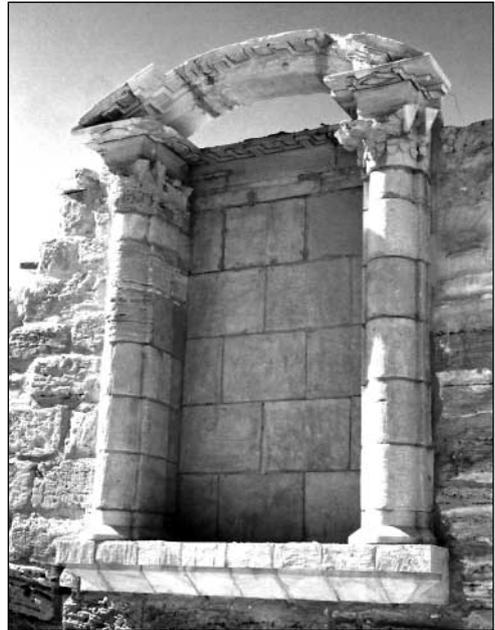
*Fig. 4b. Wall niche from hall H 21N. View
following anastylosis in 2003
(Photo S. Medeksza)*

As reported previously,⁶⁾ the niche in the south wall of Hall 21“N” had been reconstructed to the height of the impost. In 2003, the work was completed based on reconstruction drawings prepared by R. Czerner (*Fig. 4a*).⁷⁾ New fillings were inserted, glued and fixed with stainless steel dowels. Areas around the joints were strengthened with ethyl silicate stone strengthener FUNCOSIL STEINFESTIGER OH (Remmers). The adhesive used for both stone and steel was an epoxy resin ARALDITE AW 1360 (CIBA-GEIGY) with powdered limestone added. The missing sections of the ornamental cornice were carved using traditional tools. Small

fillings were made on the base of a silicon resin ADHESIL K1 with powdered limestone. The reconstructed impost blocks were then reinserted in place and fixed with mortar. The missing part of the niche tympanum was reconstructed in the same way as the impost blocks. The original elements, which had been impregnated in 2002 with FUNCOSIL STEINFESTIGER 300 (Remmers), were reassembled and the recreated piece fitted into place, thus completing the reconstruction (*Fig. 4b*).

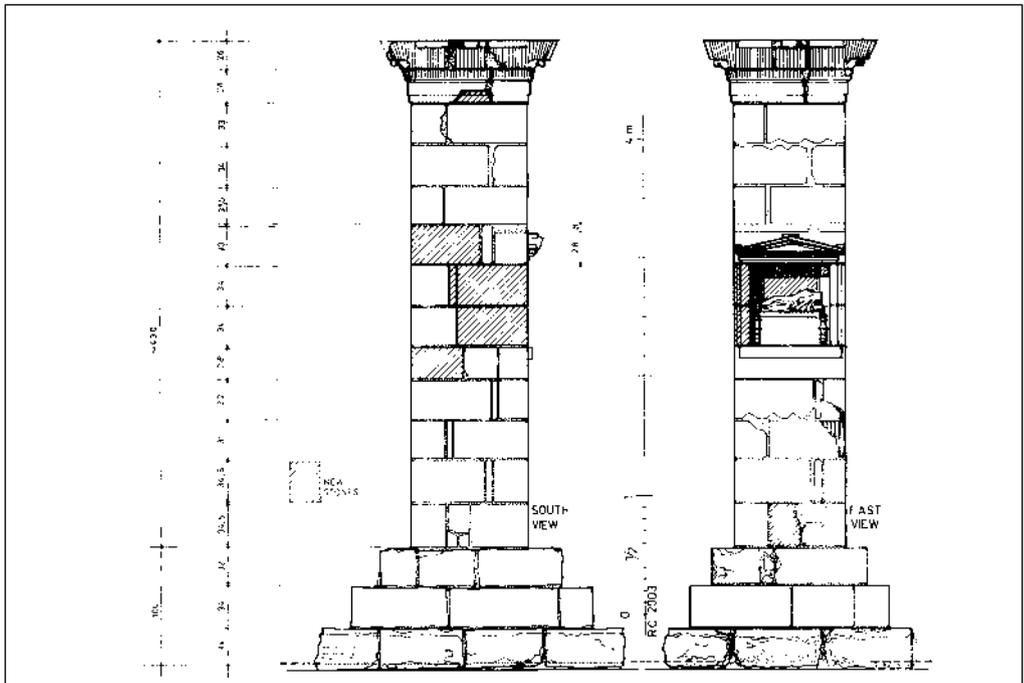
Fig. 5. *Tomb T 1K after partial anastylosis in 2003*
(Drawing R. Czerner, based in part on J. Dobrowolski, 1994)

surviving elements of this pillar-shaped monument were put back in the position in which they were found and carefully protected for future restoration.¹⁰⁾ Several blocks of similar dimensions were lying in the vicinity and it turned out in consequence that few new blocks had to be prepared for the reconstruction. Sadly enough, one of the missing pieces was the southern jamb of a small niche located in the middle height of the pillar. With some modifications resulting from the need to include the results of recent research, it was possible to raise the pillar to a height of 5.30 m, (Figs. 5, 6), leaving the remaining

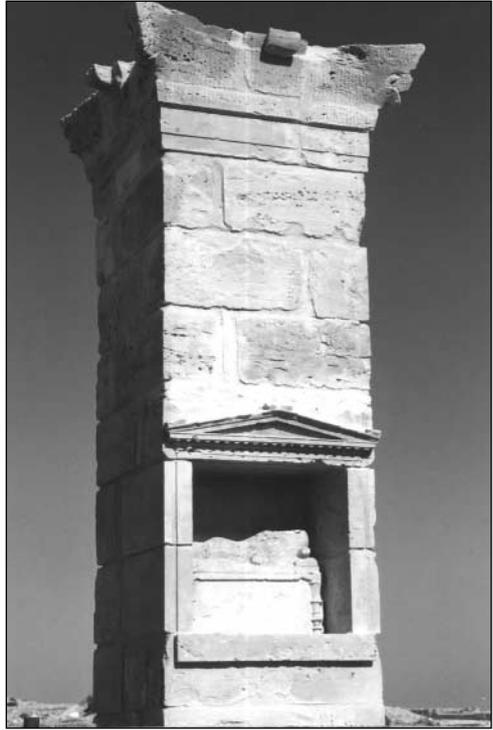
Fig. 6. View of the front of pillar tomb T 1K with reconstructed niche (Photo S. Medeksza)

parts of the cornice for the coming season. The carved representation of a man lying on a banquet couch was reintroduced into the reconstructed niche (*Fig. 6*). The stone was first desalinated and impregnated with FUNCOSIL STEINFESTIGER 300 (Remmers).
