BANGANARTI 2004: CONSERVATION REPORT

Cristobal Calaforra-Rzepka

The main task of the season was the transfer of two paintings (from Chapels 5 and 6 of the Upper Church) and uncovering of earlier paintings on the underlying plaster.

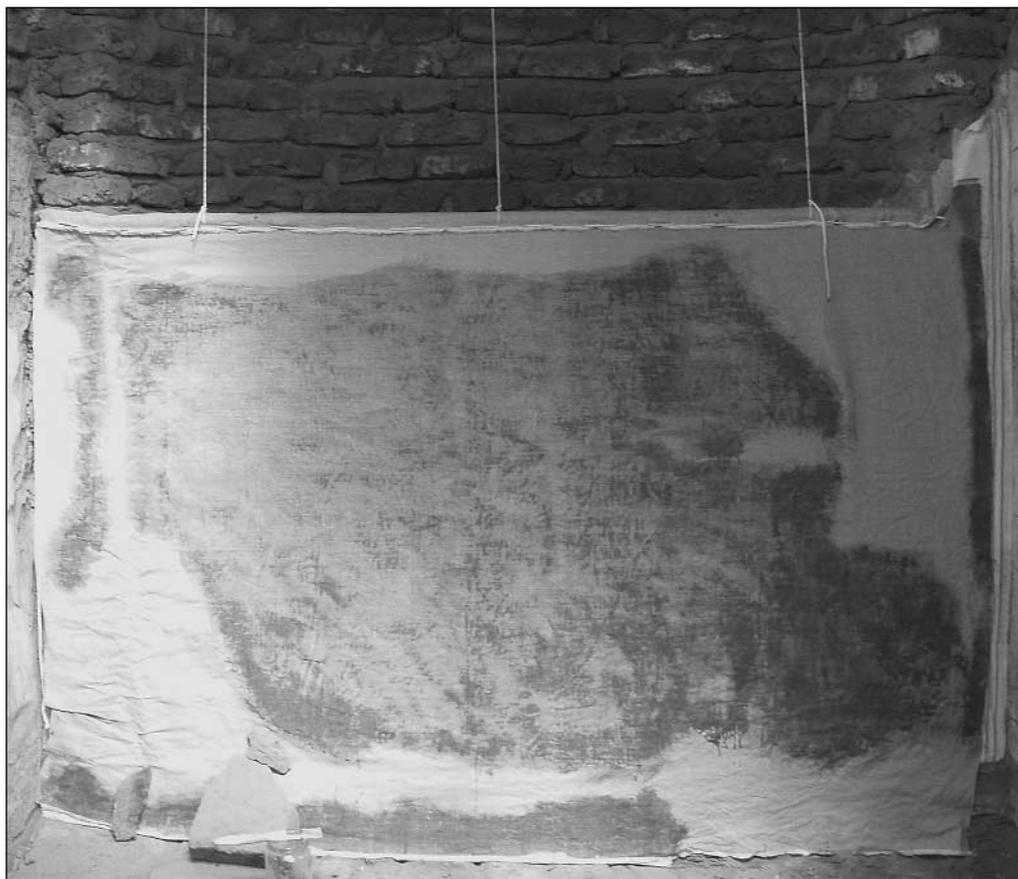
*Fig. 1. Chapel 5. Later painting with complete facing, suspended from the ceiling
(Photo C. Calaforra-Rzepka)*

The facing (two layers of Japanese tissue, two layers of cotton gauze and a layer of linen canvas) was attached with a 20% solution of MOWILITH 30/60 in ethanol. It was provided with a wooden frame support and suspended from the metal bars of the ceiling [Fig. 1]. The bricks of the supporting walls were dismantled to provide access [Fig. 6].

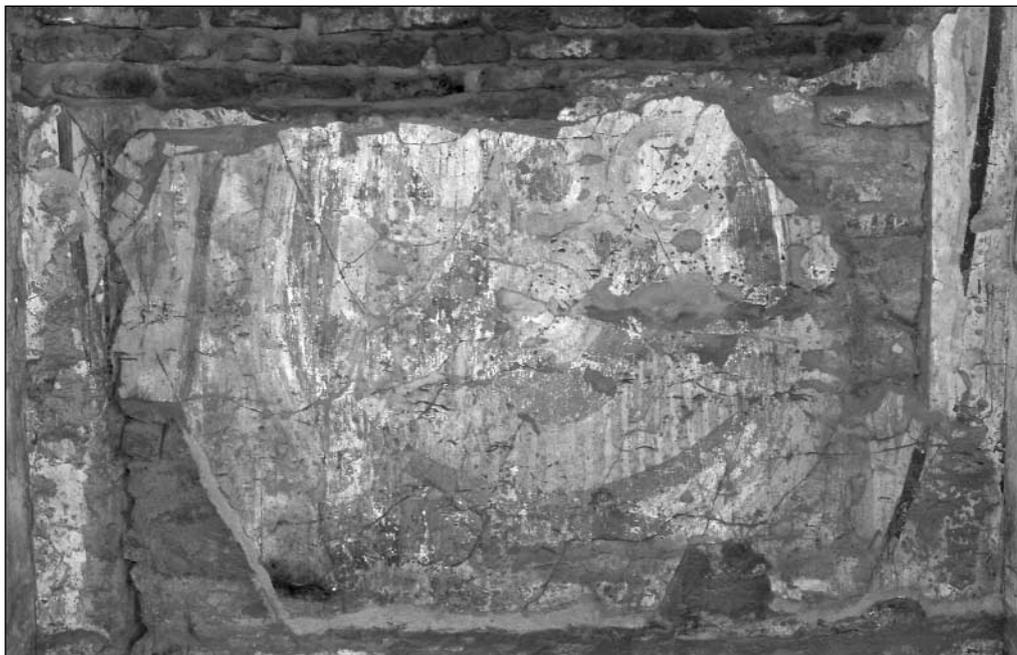
Fig. 2. Chapel 5. Later painting in situ (Photo C. Calaforra-Rzepka)

The two transferred paintings were first cleaned carefully with soft brushes, scalpels and cotton swabs with acetone. The surface was consolidated with a 2% gum arabic solution in water with a small addition of ethanol for better penetration of the consolidator. Flaking parts of the paint layer were consolidated with PRIMAL AC 33 solution (1:3 in water) [Figs. 2,7].

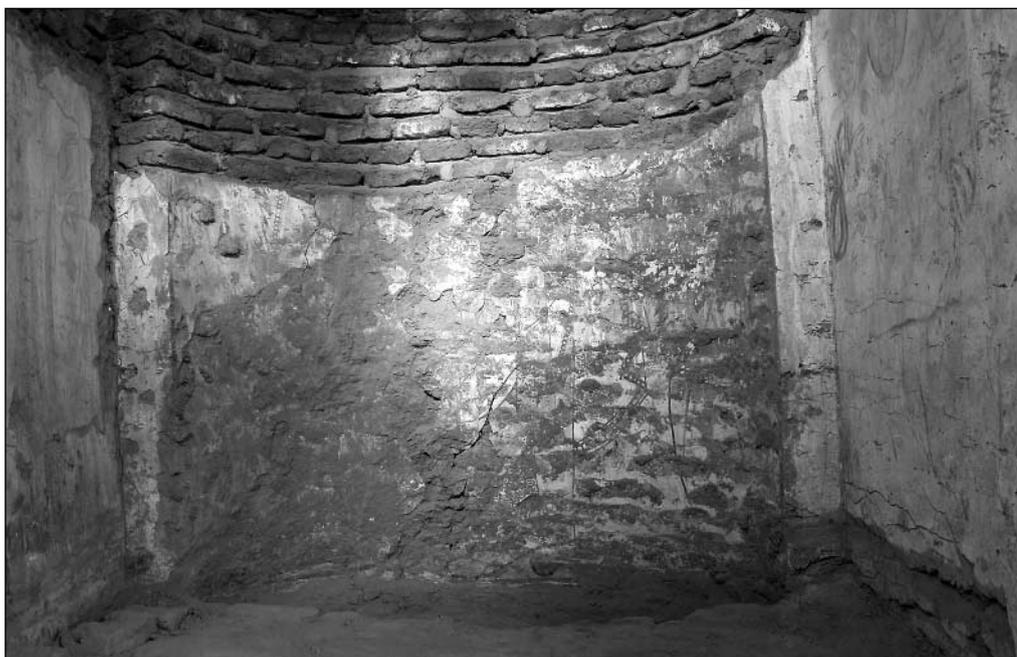
After the murals were transferred, the walls that once supported the paintings were dismantled down to the ground, exposing the earlier paintings in the niche

behind them [Fig. 3]. Unfortunately both layers of paintings were poorly preserved. The mud mortar joining the bricks was attached to the paint layer and it had even dissolved it in some parts. Its firm attachment to the original mud plaster made it impossible to rescue the original paint layer [Fig. 4].

Fig. 3. Chapel 5. Earlier painting after uncovering (Photo C. Calaforra-Rzepka)

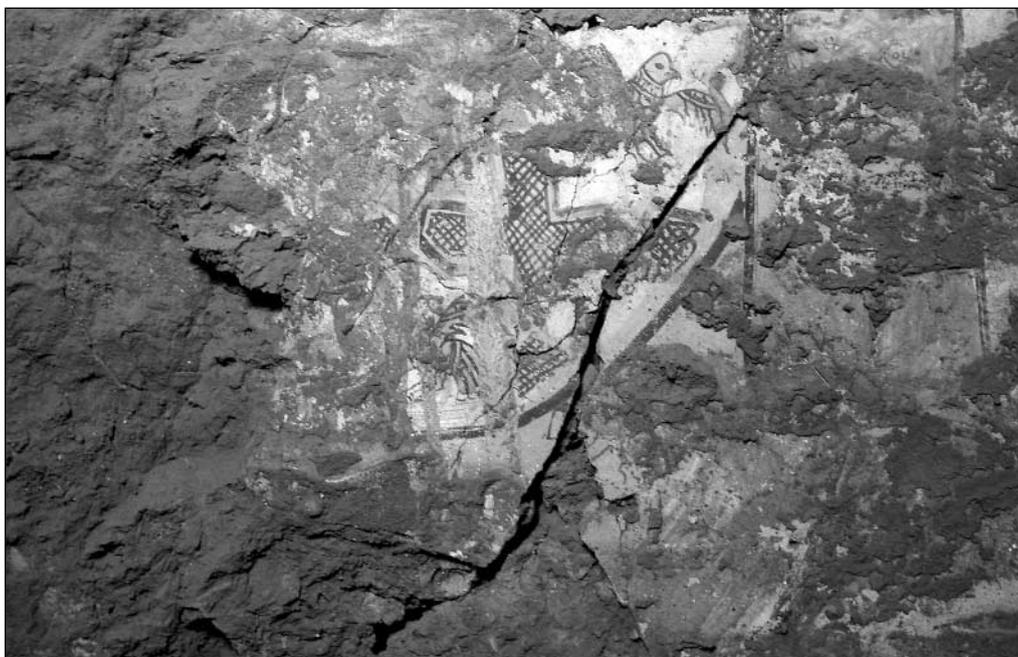
Fig. 4. Chapel 5. Earlier painting after uncovering detail (Photo C. Calaforra-Rzepka)

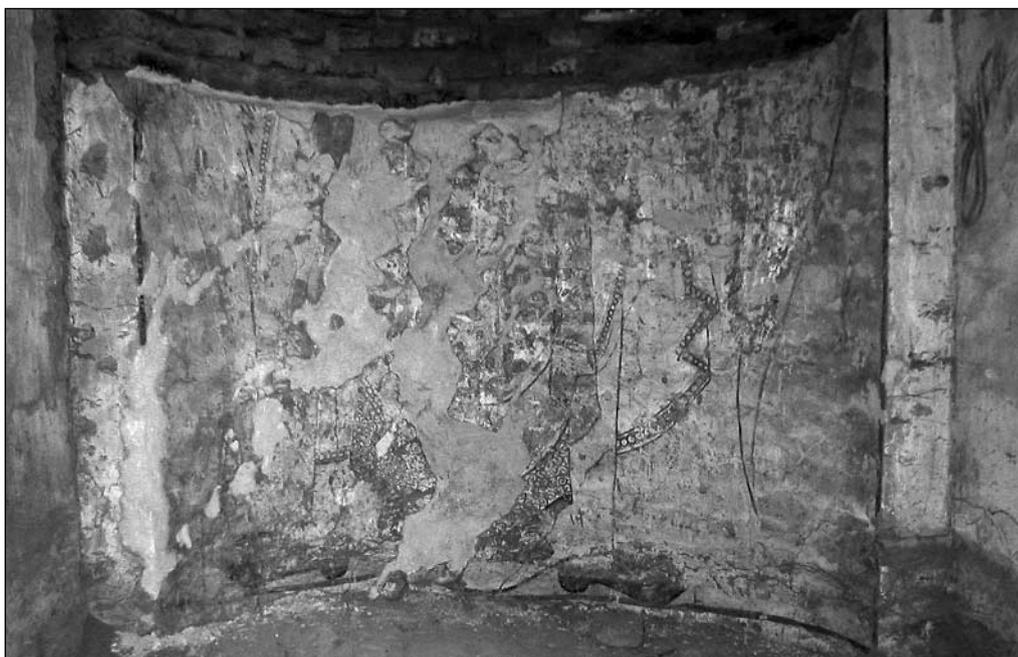
Fig. 5. Chapel 5. Earlier painting after cleaning and infilling of the gaps (Photo C. Calaforra-Rzepka)

The surfaces of both paintings were cleaned carefully with soft brushes, Wishab sponges, scalpels and cotton swabs soaked in acetone and consolidated with a 2% gum arabic solution in water with a small addition of ethanol for better penetration of the consolidator. The gum arabic solution consolidated the powdered fragments well, but increased the flaking of the delaminated paint layer. Consequently, the flaking parts were consolidated with a PRIMAL AC 33 solution (1:3 in water) with better result. To fill in the pockets in the plaster, kaolin-sand mortar was used with a small addition of gum arabic for better adhesion to the original support [Figs. 5, 8-9]. The new paintings that had been unearthed on the walls of the Lower Church were first cleaned carefully with soft brushes, Wishab sponges, scalpels and cotton swabs with acetone and consolidated with a 2%

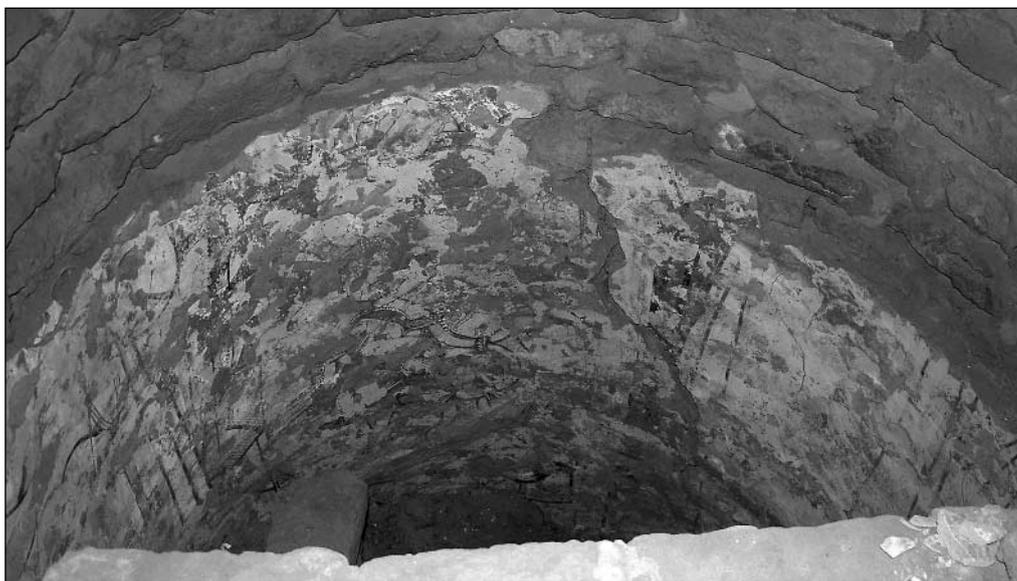
Fig. 6. Chapel 6. During the dismantling of the blocking wall: later painting with partial facing and the earlier painting uncovered (Photo C. Calaforra-Rzepka)

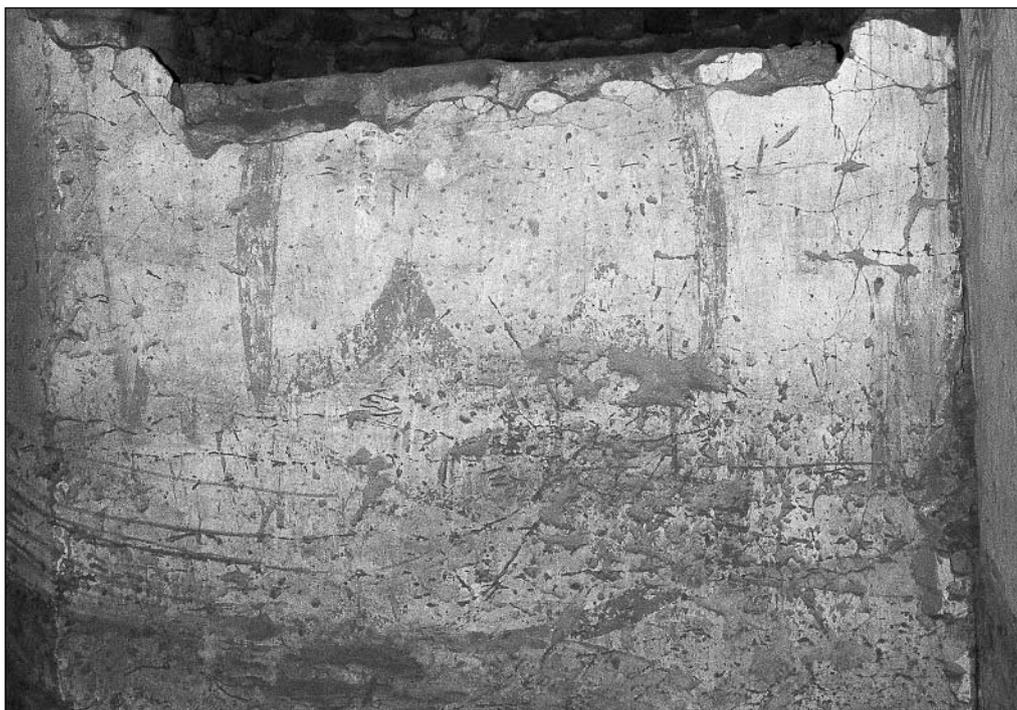
Fig. 7. Chapel 6. Later painting in situ (Photo C. Calaforra-Rzepka)

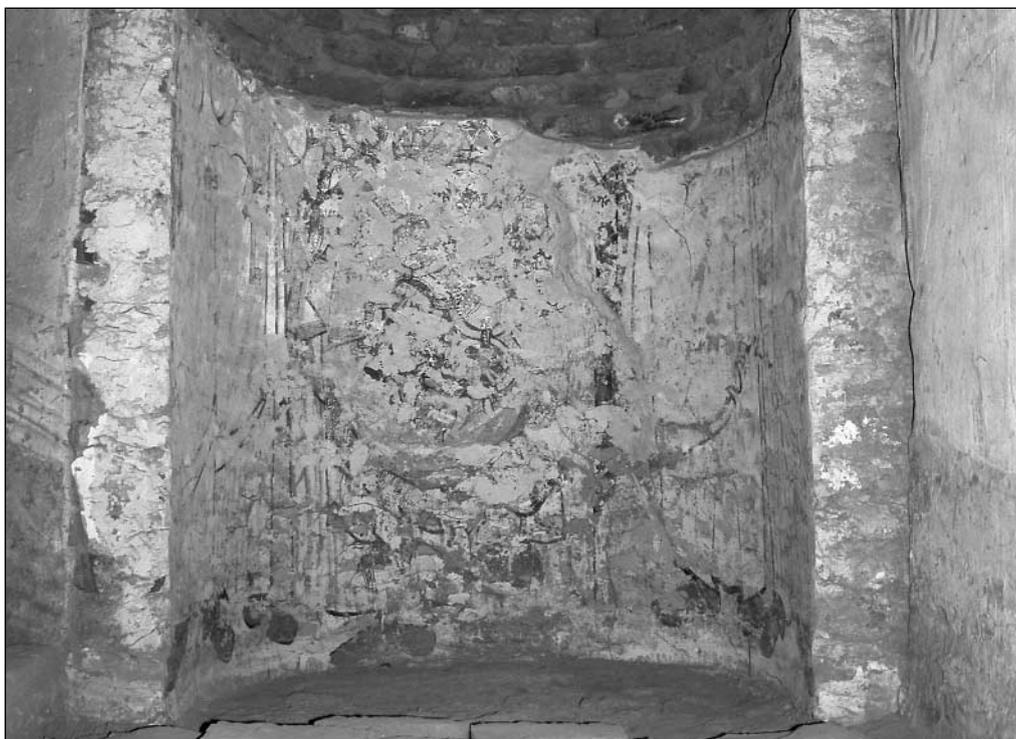
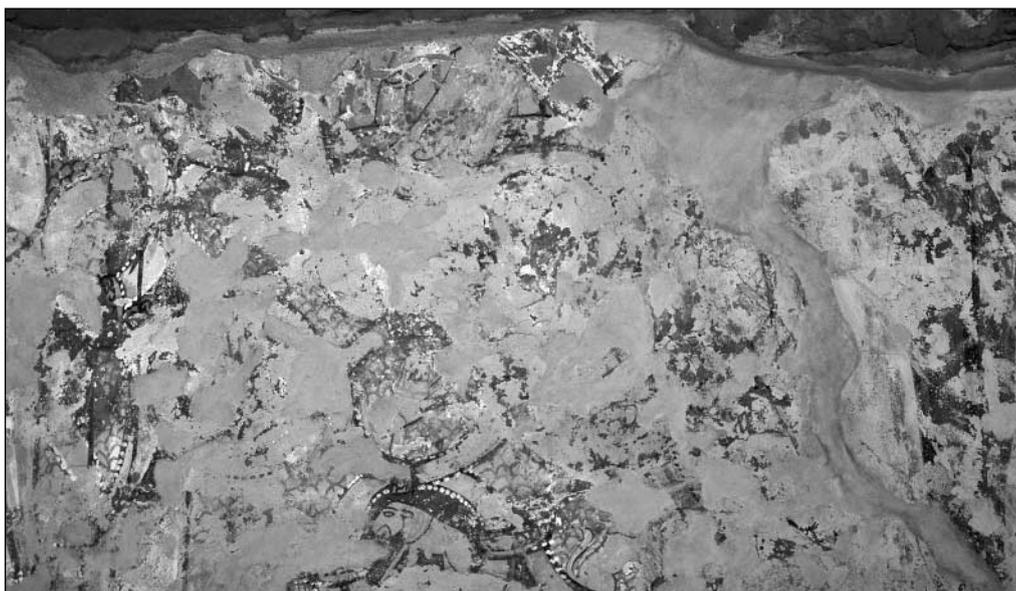
*Fig. 8-9. Chapel 6. Earlier painting after cleaning and infilling of the gaps and detail (below)
(Photo C. Calaforra-Rzepka)*

PARALOID B72 solution in toluene. Flaking parts of the paint layer were consolidated with PRIMAL AC 33 solution (1:3 in water). For infillings, kaolin-sand mortar was used with a small addition of gum arabic for

better adhesion to the original support. Salt crystals were dry cleaned from the surface without desalinization compresses, as the risk of damage from water use is very high in this part of the Lower Church.
