## APPENDIX 1

OLD DONGOLA 2006:  
CONSERVATION REPORT

Dorota Moryto-Naumiuk

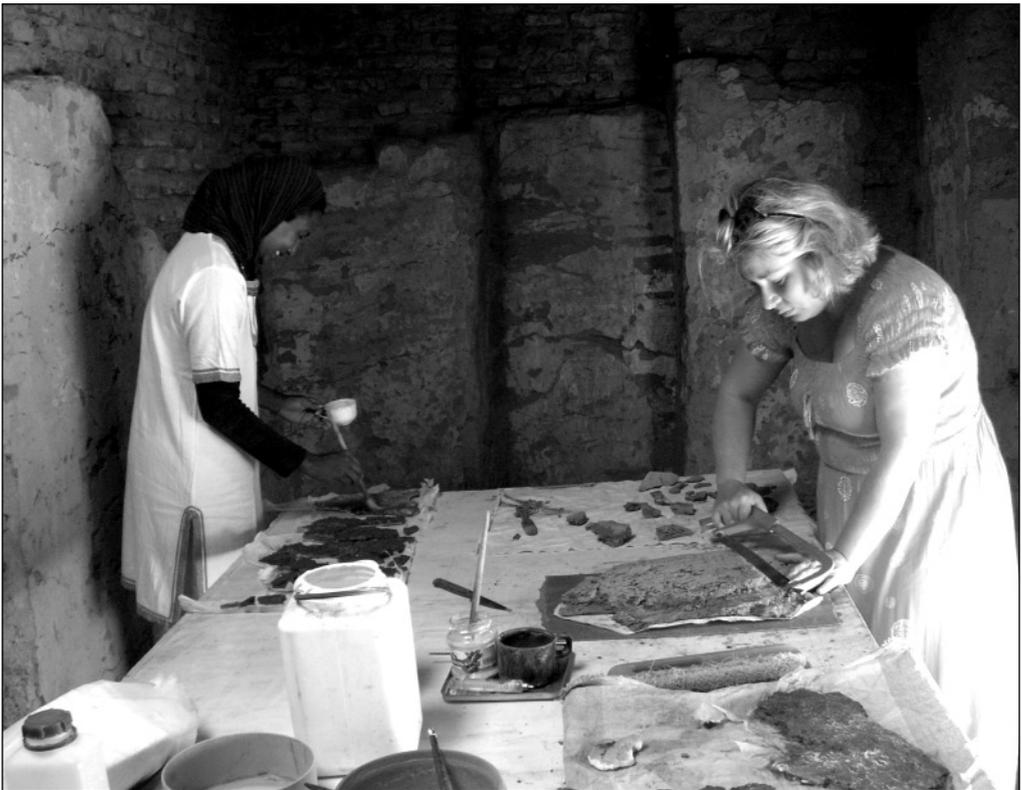
*Fig. 1. Work on the murals in a makeshift conservation atelier at the site (Photo M. Martens-Czarnecka)*
