# MARINA EL-ALAMEIN CONSERVATION WORK, 1999

Stanisław Medeksza

The site of the ancient town of Marina el-Alamein – Houses H 9 and H 9a, as well as H 10, H 10a and H 19 – was for the fifth time the object of conservation activities conducted by a Polish-Egyptian expedition between March 16 and May 30, 1999.<sup>1)</sup>

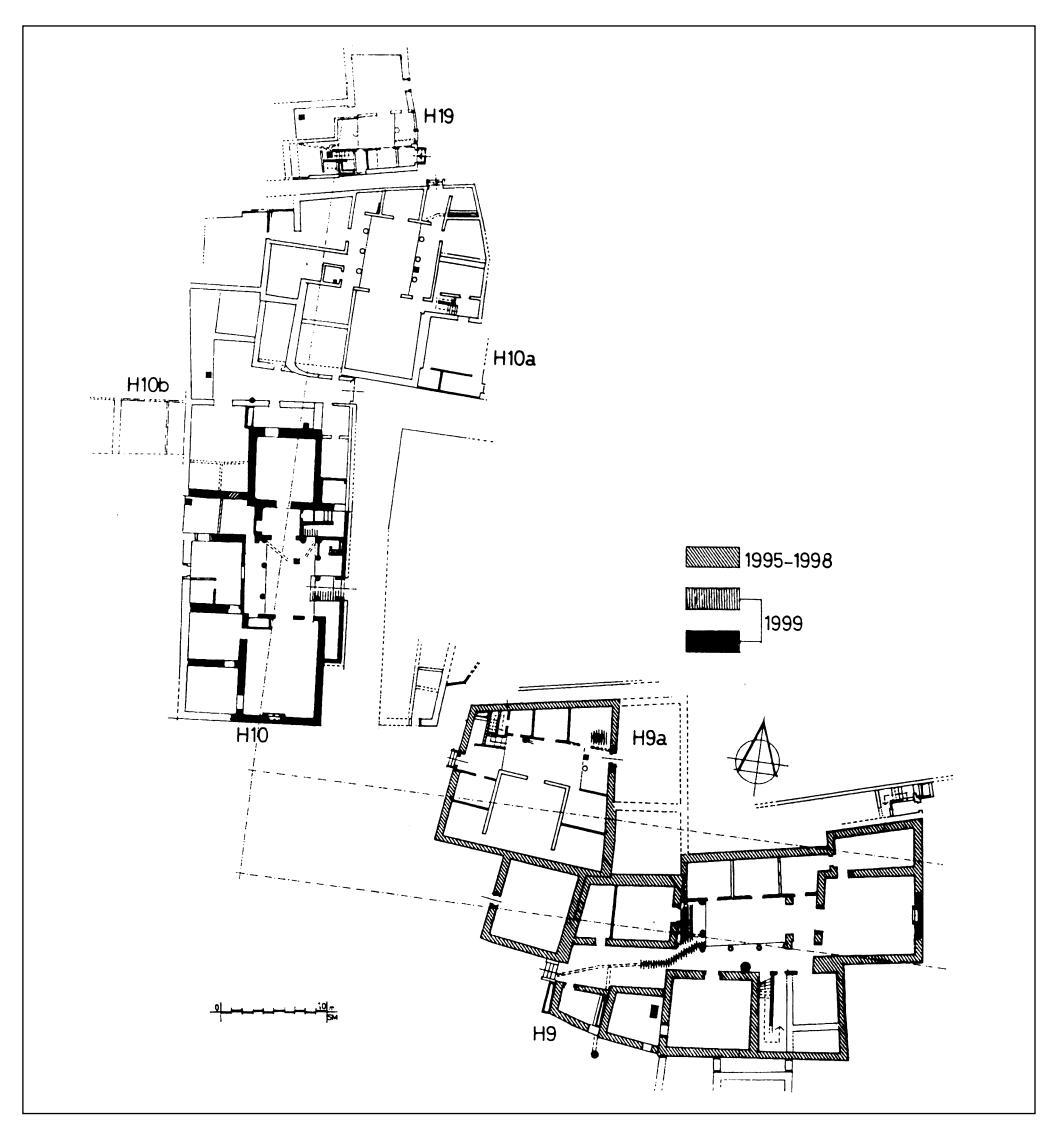
*Fig. 1.* Houses H 9 and H 10. Conservation work carried out in the 1999 season (Drawing S. Medeksza)

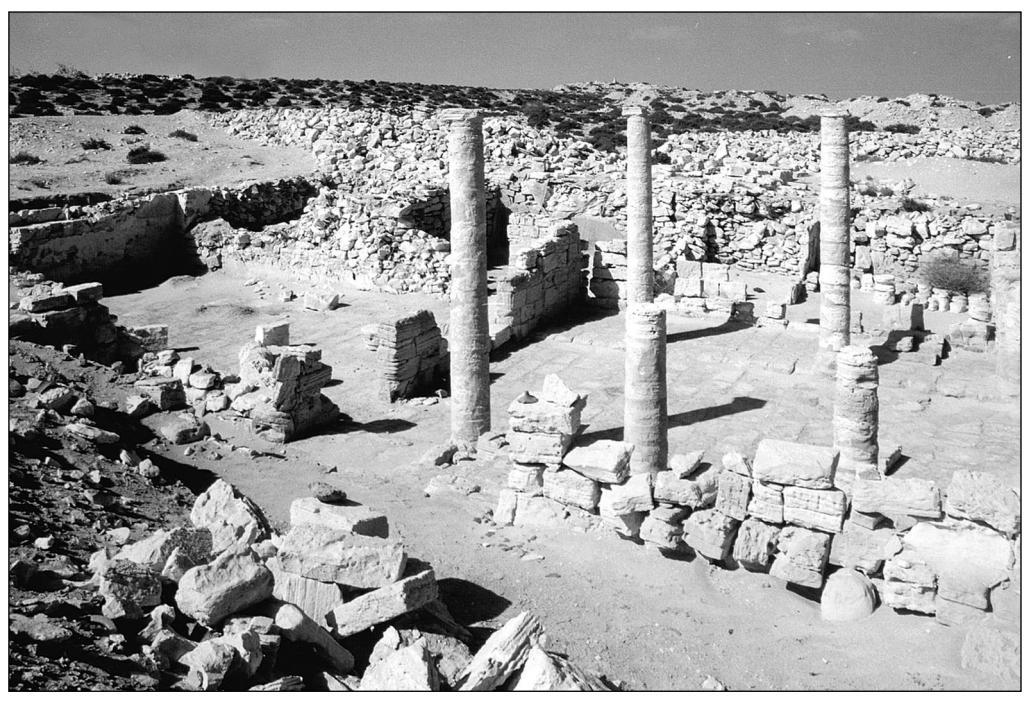
The niche discovered last year in room 2 (Fig. 3) was now restored (Fig. 4), the mural removed to be displayed in the future onsite museum. The only step taken was to insert the two blocks directly supporting the columns of the niche. No effort was made to recreate in detail the ornamental profile of the parapet, eroded beyond recognition, but about 90% of the original decoration of the niche has been preserved (Fig. 5). Nevertheless, the structure was found unsound, the blocks of the engaged columns being only shallowly inserted into the original wall structure. Every second element of the columns was reinforced, using steel rods and epoxy resins, to bond the niche to the wall behind it. The inside of the niche, once decorated with paintings, has been finished in plaster.

Fig. 3. House H 10. Portico courtyard and room 2 with relics of niche before restoration. View from the northeast (Photo R. Czerner)

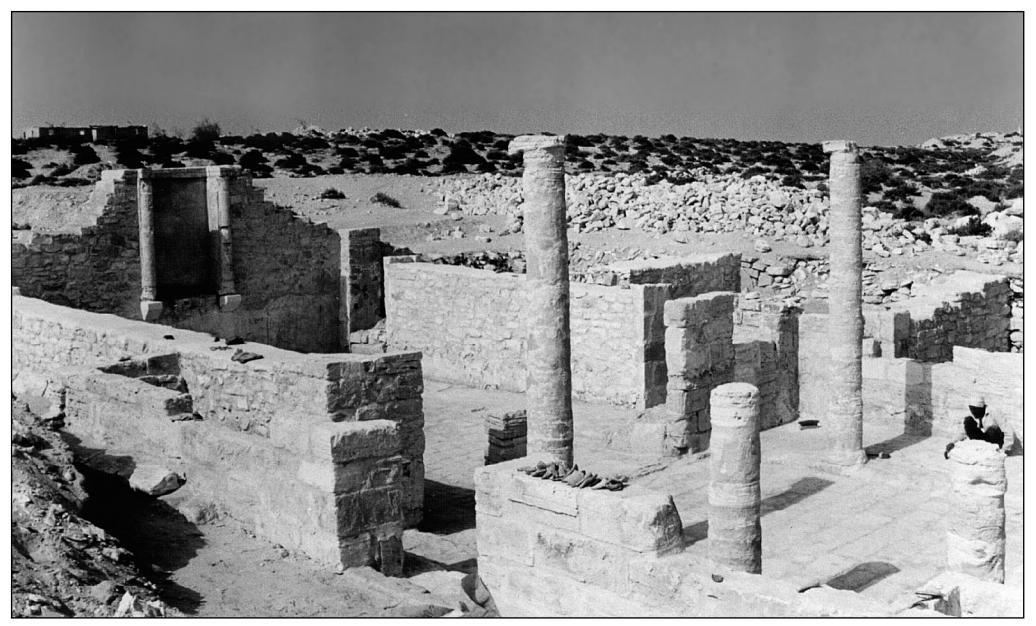
Fig. 4. House H 10. Portico courtyard and room 2 with relics of niche after restoration. View from the northeast (Photo S. Medeksza)

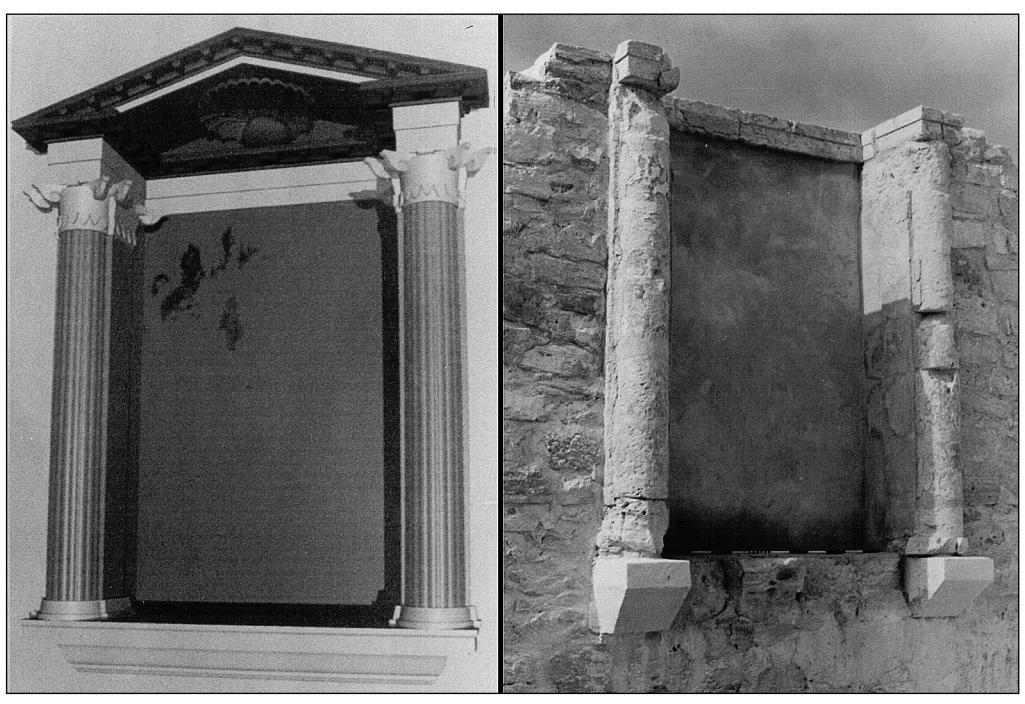
The cornices and conch, preserved in 70%, will be restored in the coming season, when it will be possible to recreate most of the missing stucco elements (*Fig.*  $\theta$ ).

Fig. 6. House H 10, room 2. Niche viewed from the north. Computer reconstruction on the left (Rendering R. Czerner). The niche after anastylosis in 1999 on the right (Photo P. Zambrzycki)

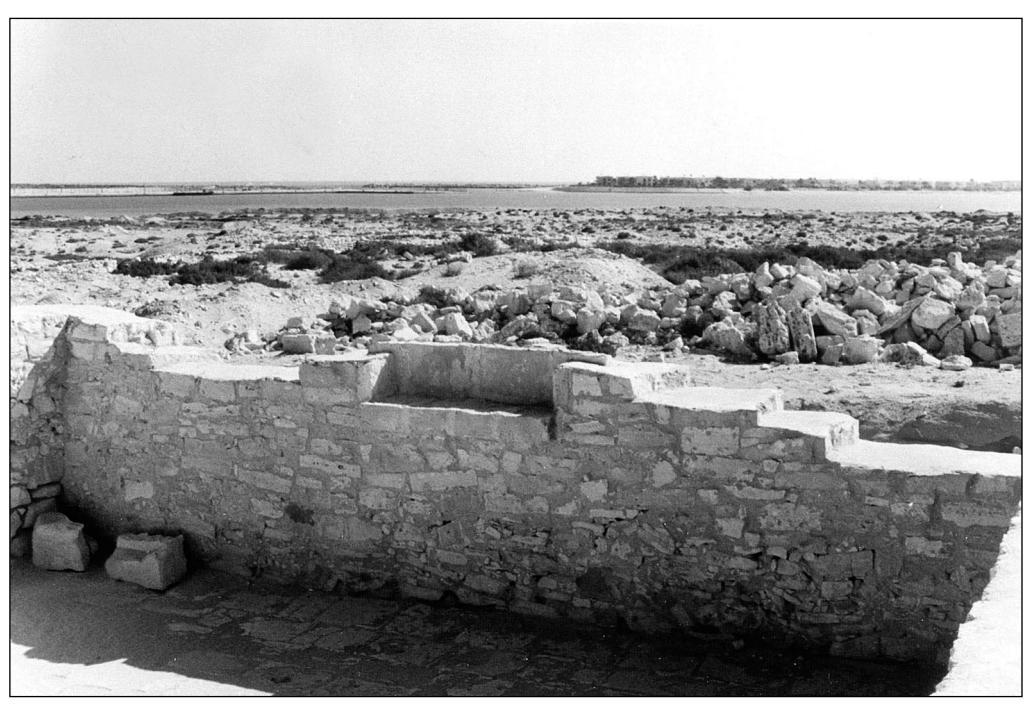
HOUSES H 9 AND H 9A The major work in House H 9 (*Fig. 9*; cf. also *Figs. 1, 2*) was the restoration of a niche in room 14, made possible by last year's fortuitous discovery of the niche in House H 10. The niche, which had been excavated several years ago (*Fig.* 10),<sup>3)</sup> had suffered considerably from lying out in the open. It now proved impossible to use all the original elements; the northern column had to be reconstructed entirely, and there is little chance for saving the conch (*Fig.* 11).

Fig. 9. House H 9, room 14. Wall with the setting of the niche before restoration (Photo R. Czerner)

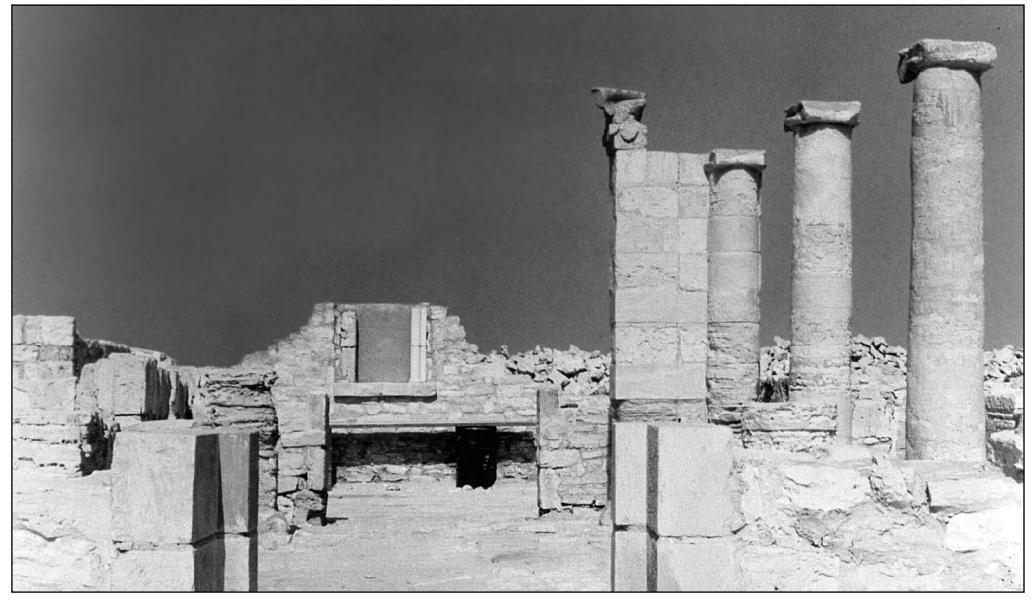
*Fig. 10. House H 9. View of the reconstructed niche from the west, in line with the principal axis of the complex (Photo S. Medeksza)*
