**DEIR EL-BAHARI  
THE EPIGRAPHIC MISSION  
TO THE HATSHEPSUT TEMPLE, 1994**

**Janusz Karkowski**

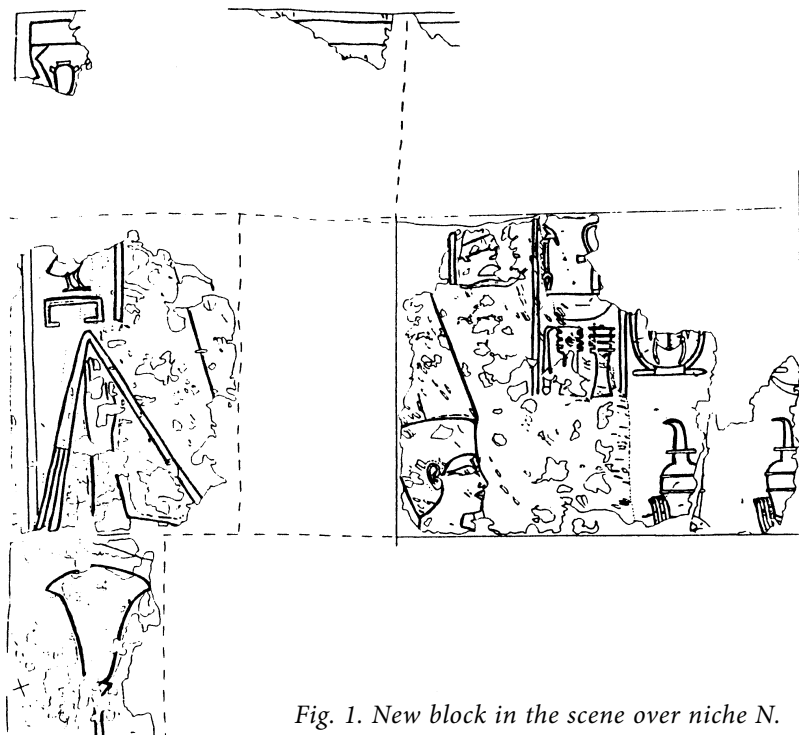
*Fig. 1. New block in the scene over niche N.*

portable statues of the same kind that were depicted on the upper court walls as part of the procession with the bark of Amun. The southern part of the wall has been recorded in 1:1 scale. A number of fragments from this wall in temple stores was traced already in the previous year (Fig. 1). This season some additional blocks were recorded and most of them were ascribed to particular niches.

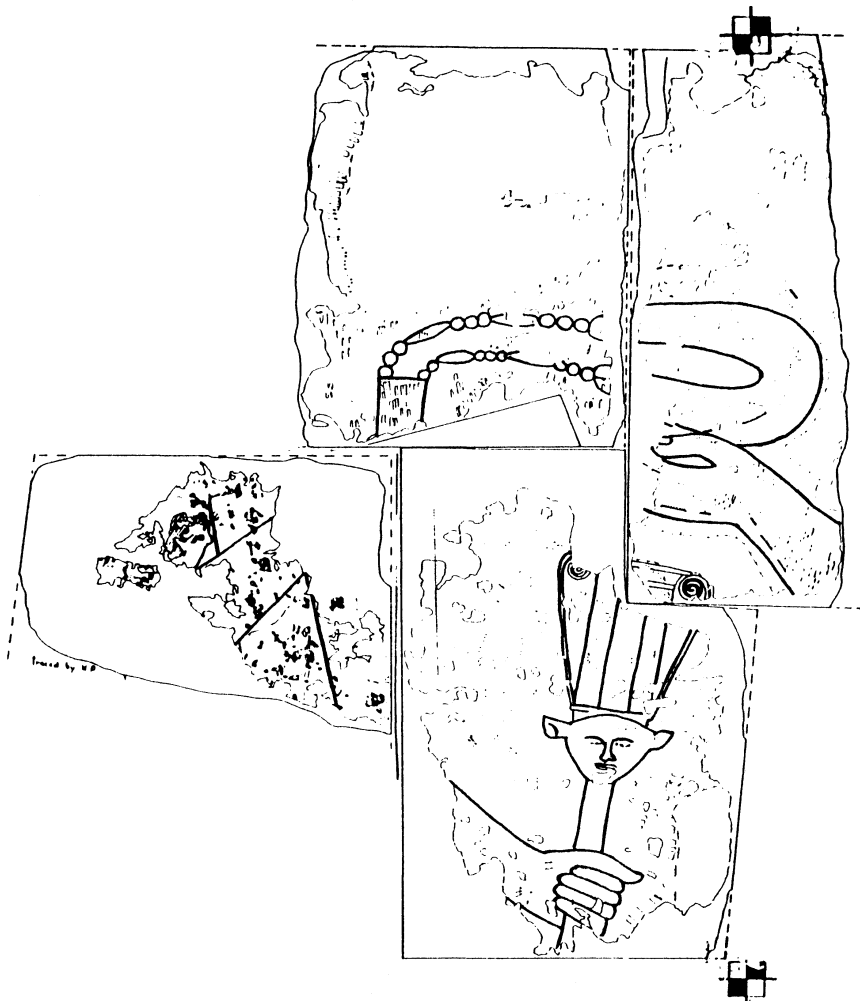
*Fig. 2. New blocks from the northern wing of the eastern wall of the outer colonnade in the Hathor Shrine. Hathor presenting a menat to Hatshepsut.*

recorded. A number of them have been ascribed to particular scenes on the colonnade walls (Fig. 2). The main difficulty in restoring the scenes results from repetition of the same element in different scenes. Thus, missing in the walls are four depictions of Hatshepsut facing right and four other facing left destroyed and changed into Tuthmosis II. The distribution of selected fragments between these depictions is advanced. During the season also the four architrave blocks replaced in the front row of the Hathor shrine by Emile Baraize were recorded and studied. It has been established that none of them belongs to the Hathor shrine.
