CONSERVATION ACTIVITIES, 2003

Zbigniew Godziejewski

THE CULT CHAPEL OF MEREFNEBEF

CHAPEL 15

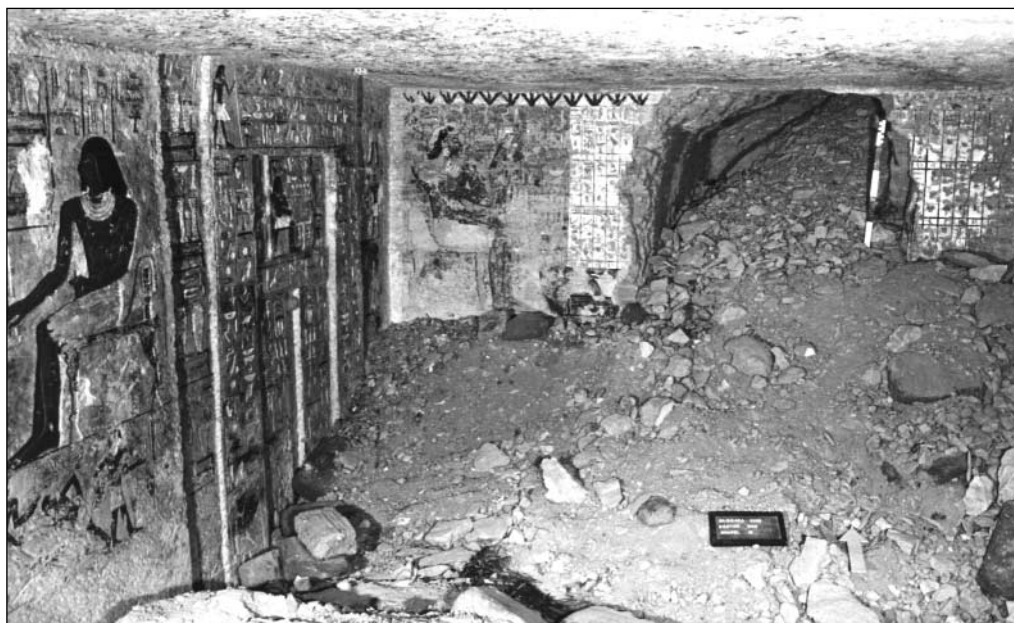
The polychromy found on the west wall just north of the entrance to the newly discovered chapel is fairly well preserved, except for some detachments and peeling of the painted layer. Large sections of the relief decorating other walls of the chapel have lost their original polychromy, bits of the painted decoration being found on the surface of the fill. The decoration of the north wall was damaged extensively, the rock here having collapsed because of a later shaft cut too close on the other side (*Figs. 1,2*). Parts of an offering list decorating this wall lay in the debris. The remains of the polychromy on the surface of these fragments were secured with a solution of PARALOID B72 in acetone with alcohol added. A reconstruction of the decoration will be attempted. On the east wall of the chapel the remains of painting are insignificant and found only in the northern end. The decoration on the south wall was never completed, the sketch lines still being visible.

*Fig. 1. Cult chapel of Ny-ankh-Nefertem, north section upon discovery
(Photo M. Jawornicki)*

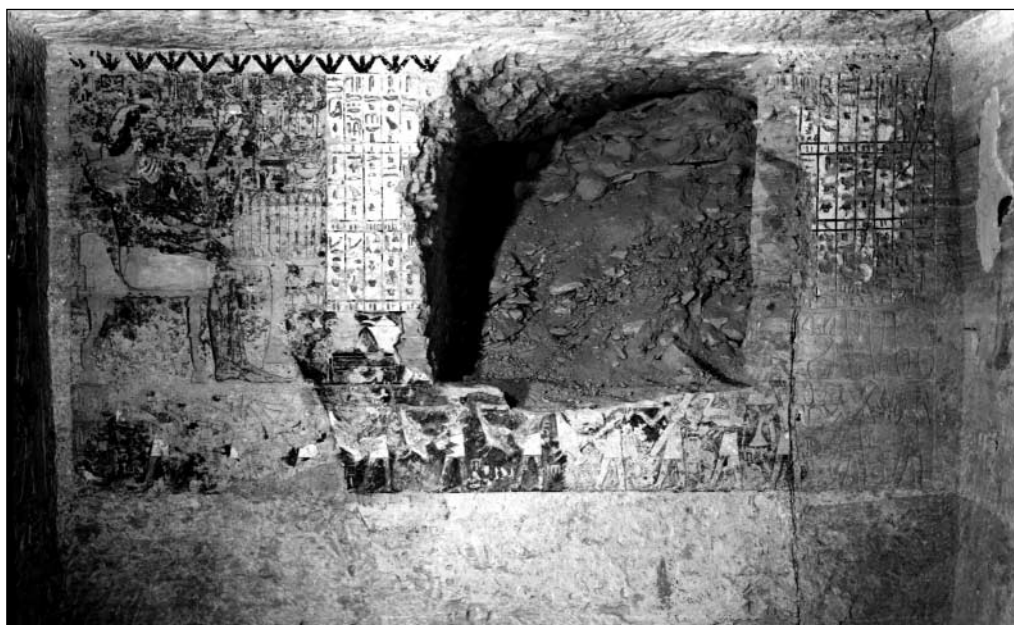
*Fig. 2. Cult chapel of Ny-ankh-Nefertem, north section after preliminary conservation
(Photo M. Jawornicki)*

The detached and disintegrating layers of painting had to be treated first. A solution of PARALOID B-72 (5-7%) in acetone with alcohol was dripped in. Melinex was then applied and the endangered parts of the polychromy pressed to the wall to mount them in place. This procedure was repeated several times as required. The mortar in particular had to be treated. The reinforced parts of the decoration had to be stuck to a matrix (as needed) using a water solution of PRIMAL E330 (6-8%) or AC-33 (10-12%). Each application of PRIMAL was preceded by dampening the area in question with a water solution of alcohol (1:1).

Detached edges of decoration executed in the mortar filling (sticking c. 0.2-0.5 mm away from the matrix) were secured with bands made of lute having PRIMAL AC-33 (10-12%) as the base and calcium carbonate chalk, fine-grained sand

(1.5:1.5:1) and pigments as fillers. The same kind of substance was used for filling easily and safely accessible voids under the surface of the mortar.
