HAWARTE

MITHRAIC WALL PAINTINGS CONSERVATION PROJECT SEASONS 2005-2006

Ewa Parandowska

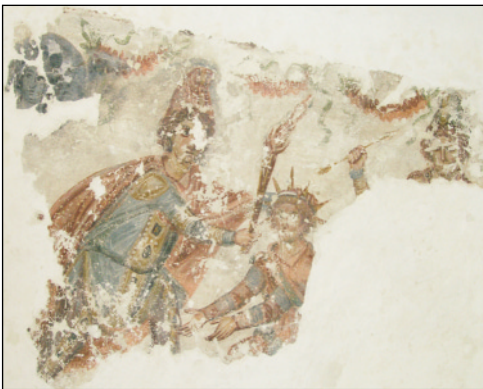
Fig. 2. Transfer of the Mithra scene from layer 1, now a separate panel on exhibition (Photo D. Zielińska)

The scene representing Mithras as Helios (conserved as a separate panel for display in 2002, cf. Parandowska 2003: 296-297) had been cut from the wall of the mithraeum with two earlier coatings of painted plaster. In 2006, layers 2 and 3 received comprehensive treatment, that is, they were separated, cleaned and consolidated. The composition turned out upon analysis to be thematically the same, although different in size and colors.
