## NEA PAPHOS

### EXCAVATING BELOW THE MOSAIC OF THE SOUTHERN PORTICO IN THE VILLA OF THESEUS

Henryk Meyza

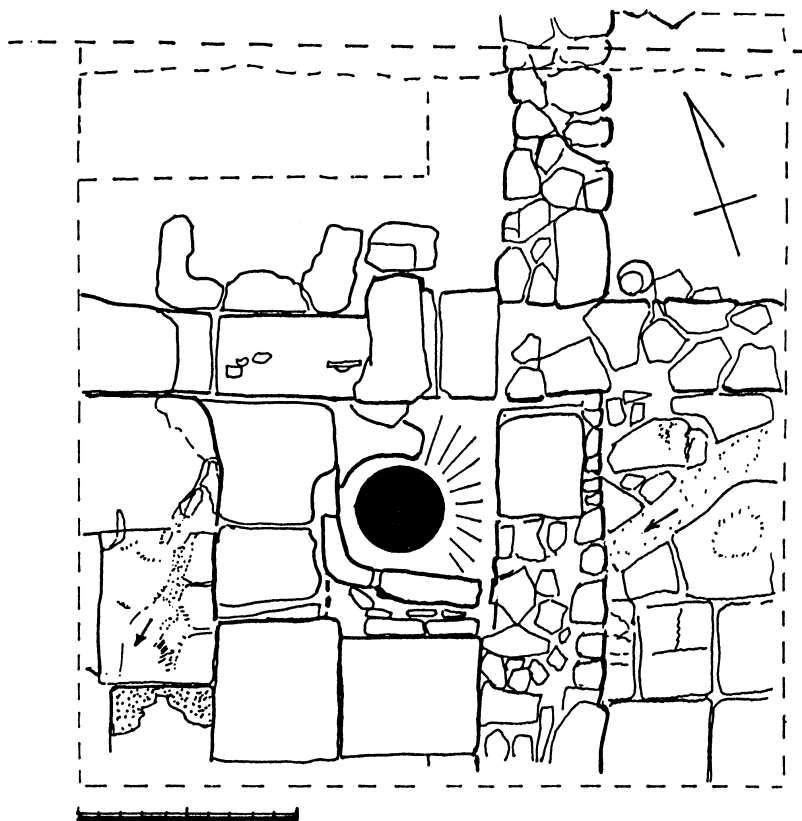
*Fig. 1. Plan of a trench in the southern portico (R.25) of the Villa of Theseus.*

The wellhead was built in the corner of two walls, of which the E-W one to the north of it (S.13) was probably a continuation of the wall uncovered in 1970 near the eastern cistern entrance. The other wall is perpendicular to it and lines the east side (S.8). The wellhead consists of a semicircular parapet (S.2) on the west, and a straight wall on the south. Whether another semicircle existed on the east is not clear. The access to the cistern itself is a narrow circular shaft cut in the calcareous bedrock. The cistern is partly filled with soil and debris; the bottom is currently at a depth of 4.80 m below the mosaic.

The trench was almost square and measured 3.23 m (E-W) by 3.26 m (N-S). While the mosaic itself had been destroyed

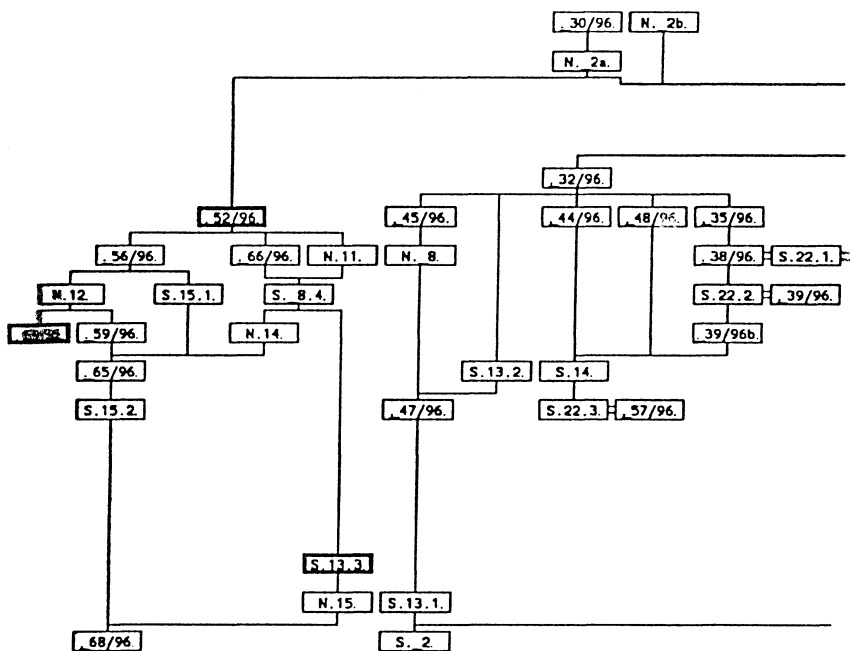
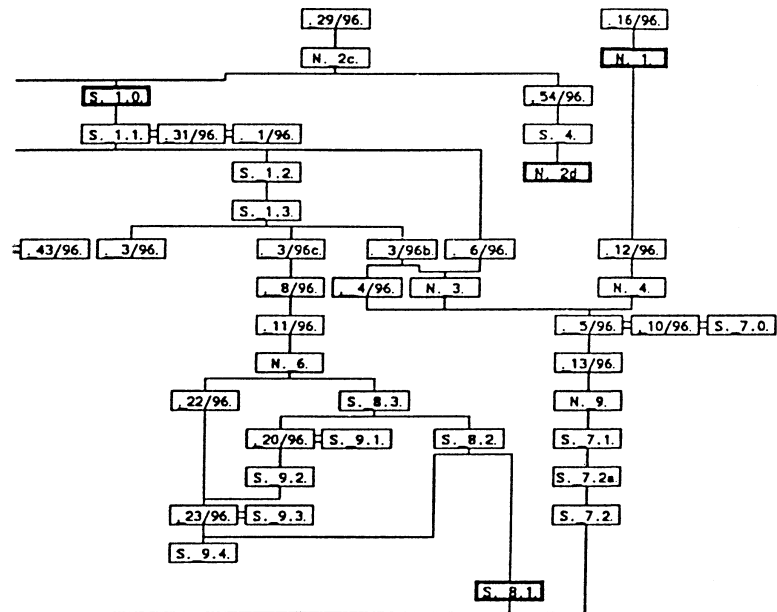
Fig. 2. Stratigraphic diagram of the trench in the southern portico (R. 25) of the Villa of Theseus.

- N.1 Hole in mosaic S.1 over west entry to S.2
- N.2a Mosaic S.1 damage in NE trench corner
- N.2b Mosaic S.1 damage by west trench edge
- N.2c Mosaic S.1 damage along the stylobate S.4
- N.2d Trench for stylobate S.4 foundation(?)
- N.3 Damaged pavement S.7 in SW trench corner
- N.4 Cut through floor/accumulation below S.7.1&2
- N.6 Erosion(?) of upper layers of S.9
- N.8 Removal of block in S.13 behind S.14
- N.9 Cut in pavement S.7, at west edge
- N.11 Cut in N-S wall S.8.4, in east face
- N.12 Pit for cooking pot in NE corner S.8 & S.13
- N.14 Trench (?) N-S for wall S.8.4
- N.15 Trench (?) E-W for wall S.13, east part

- S.1.0 opus tessellatum mosaic in R.25
- S.1.1 Waterproof(?) bedding with ceramic grog
- S.1.2 Leveling plaster of mosaic S.1
- S.1.3 Bedding for mosaic of fist-size stones

- S.2 Cistern below R.25 - wellhead
- S.4 Stylobate of south portico (R.25) of VT
- S.7.0 Hard-packed daub floor on slabs west of S.2
- S.7.1 West pavement of rectangular slabs, with gutter
