# KOM EL-DIKKA

## PRESERVATION WORK, 1997/98

Wojciech Kołątaj

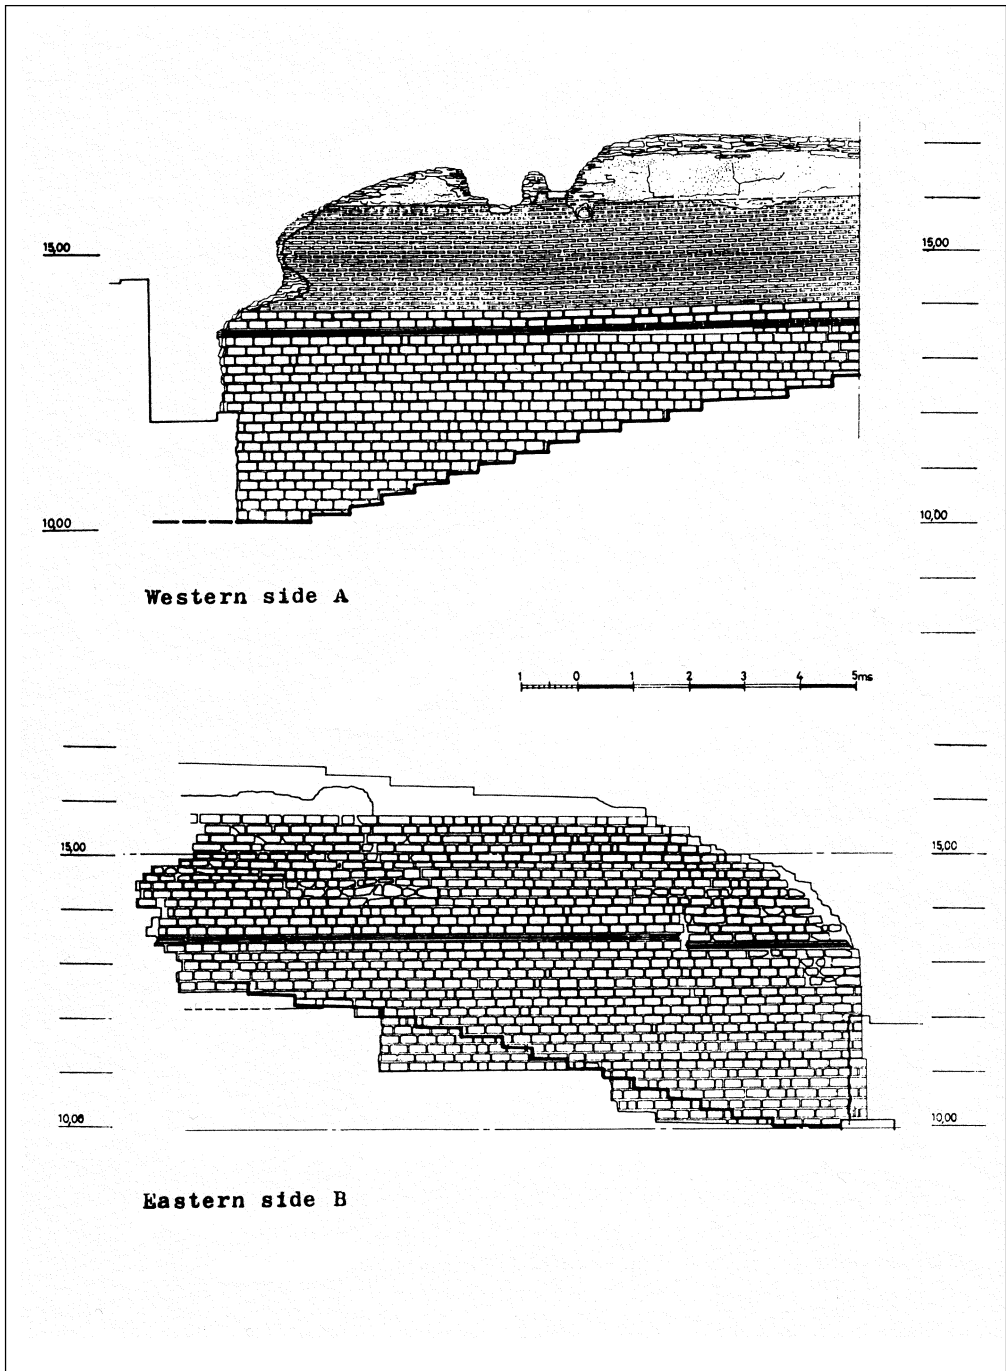
Fig. 1. Cisterns. Restored walls of the corridor  
(Drawing W. Kołataj)

Top priority was accorded the work in the area of the cisterns lying immediately adjacent to the access route to the projected mosaics pavilion. The western wall of the corridor-ramp, 26 m<sup>2</sup> (Figs 1, 2, 3), as well as the south drawing wells (Figs 4, 5) were protected and restored where necessary. The restoration of the crown of the wall separating the Cisterns from street R4 was completed and a staircase was constructed

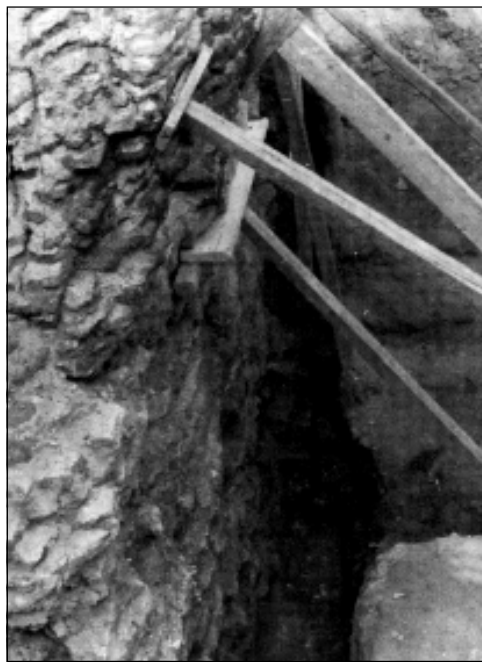
*Fig. 2. Cisterns. Western wall of the corridor before restoration (Photo W. Kołtąj)*

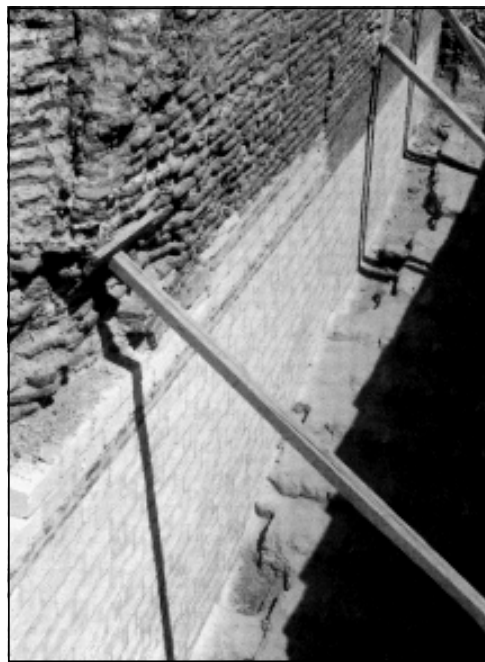
*Fig. 3. Cisterns. Western wall of the corridor after restoration (Photo W. Kołtąj)*

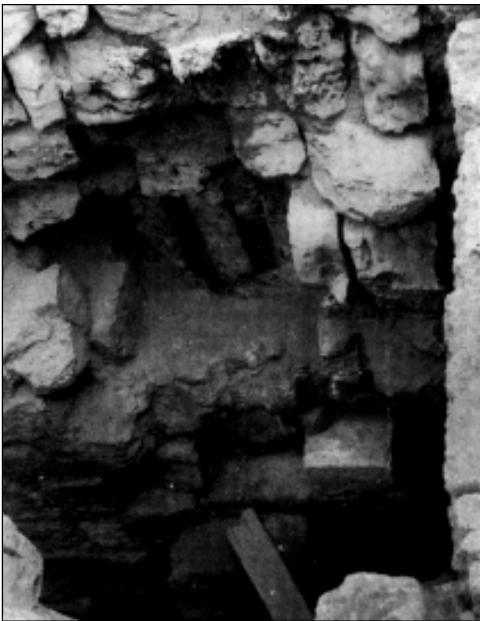
Fig. 4. Cisterns. South double wall before restoration (Photo W. Kołtątaj)

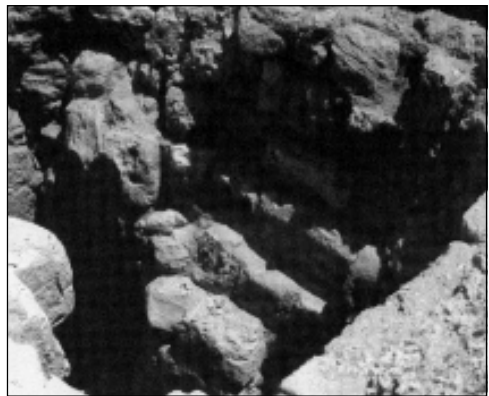
Fig. 5. Cisterns. South double wall after restoration (Photo W. Kołtątaj)

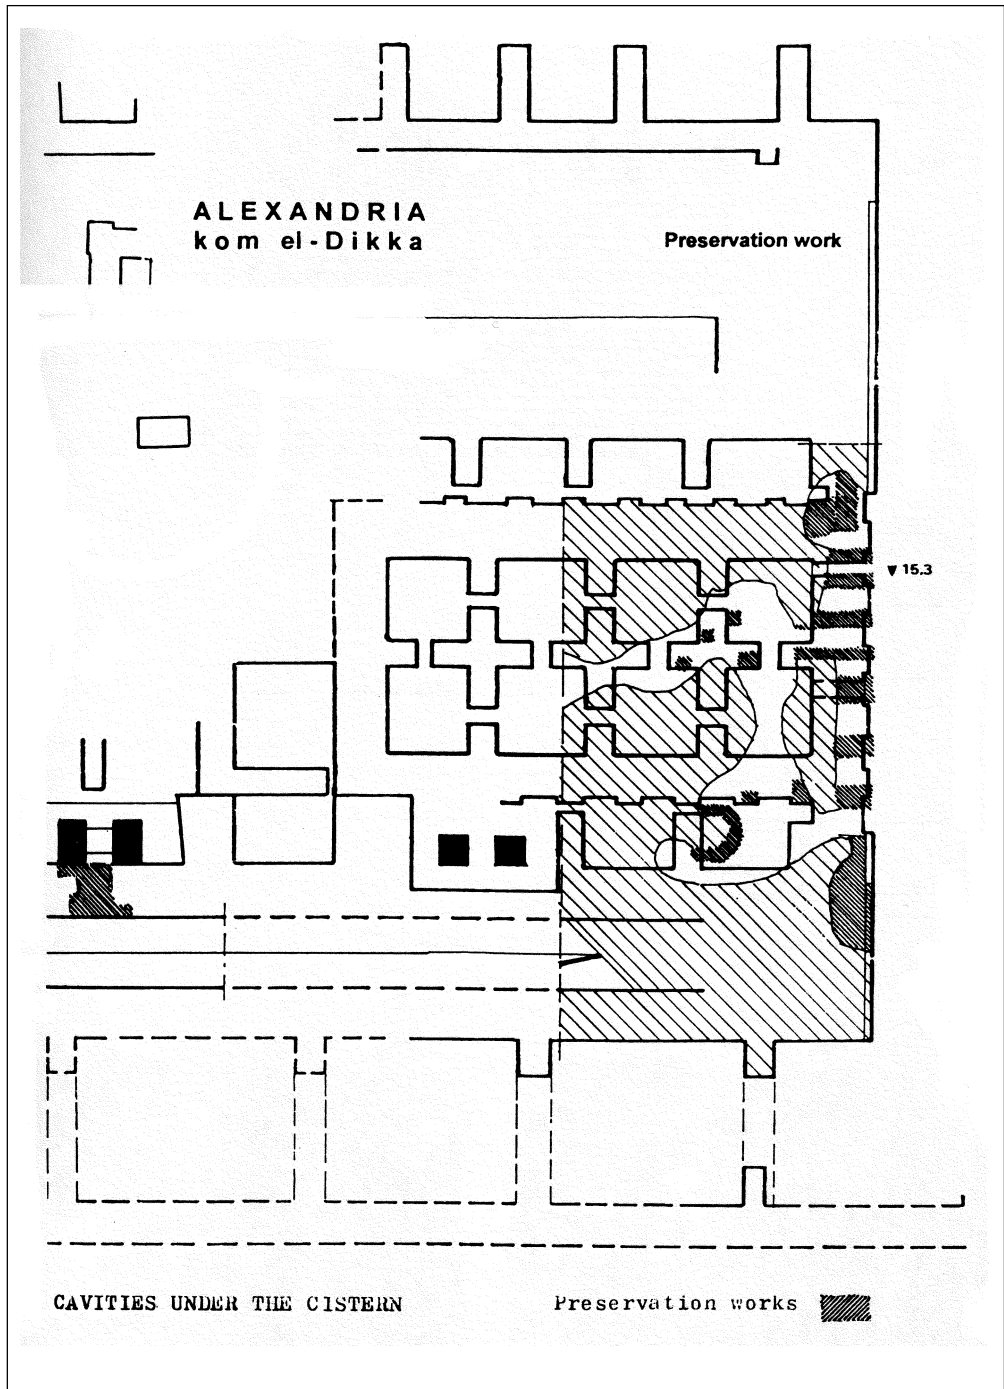
Fig. 6. Cisterns. Protection of the substructure  
(Drawing W. Kolqatj)

along its southern edges. The consolidation of the cavities under the Cisterns was completed (Fig. 6) and a fragment of the wall fallen from the northern facade of the structure was put back in place (Figs 1, 8, 9).

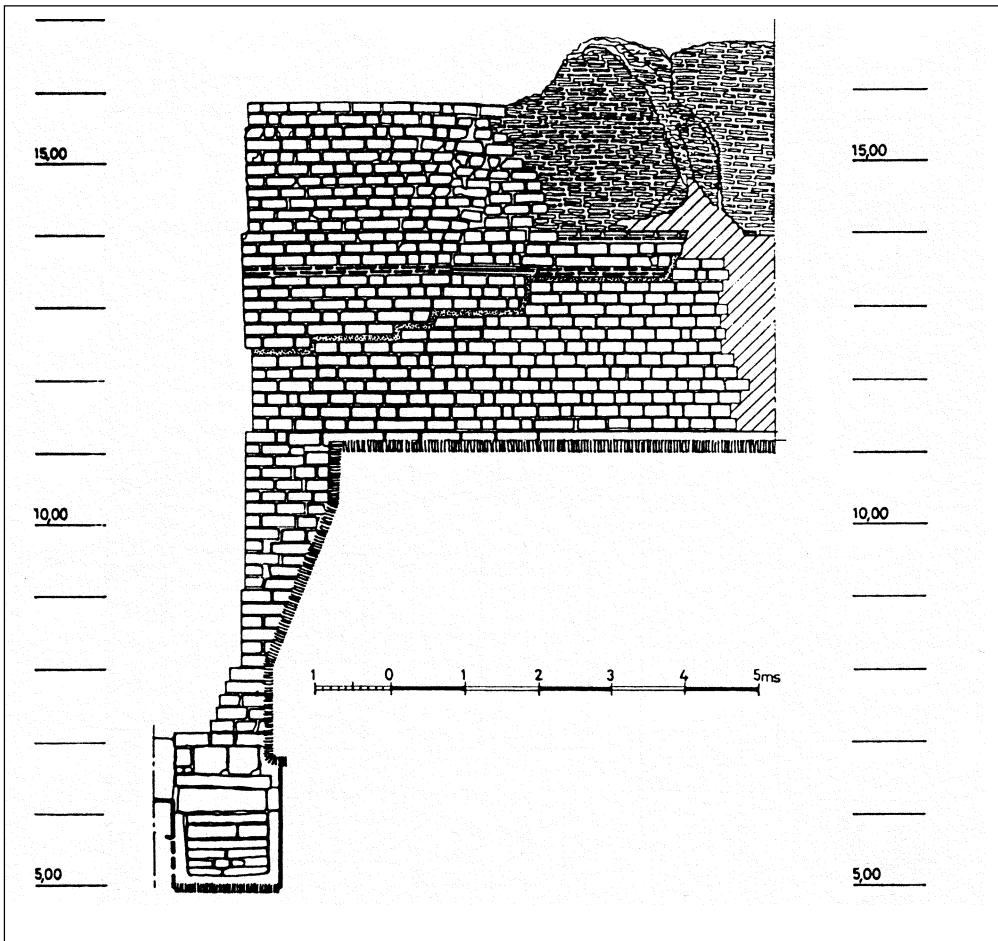
Fig. 8. Cisterns. Restored corner of the northern facade  
(Drawing W. Kolqataj)

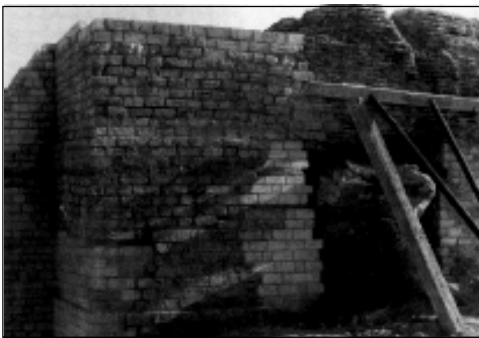
Fig. 8. Cisterns. Northeastern corner before  
restoration (Photo W. Kolqataj)

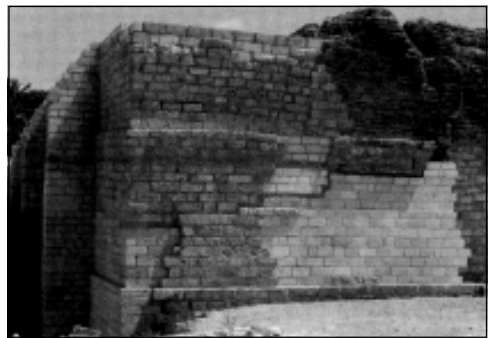
Fig. 9. Cisterns. Northeastern corner after  
restoration (Photo W. Kolqataj)

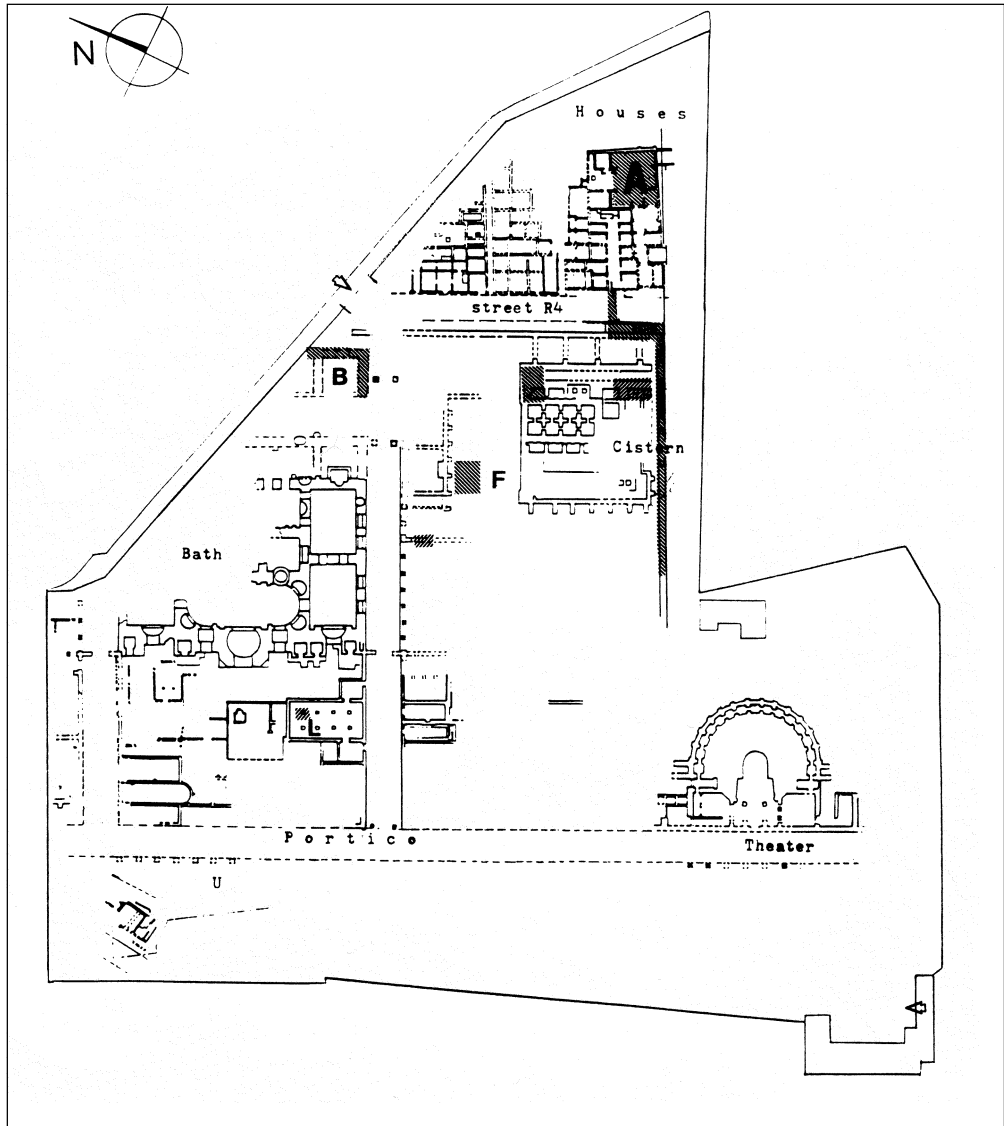
Fig. 10. General plan of the site with areas of preservation work in 1997-1998  
(Drawing W. Kołtąj)

cluded raising the tripod, connecting the parts of the broken column etc. In connection with the clearing of the entire length of the south passage of the Baths and the execution of the southern tourist path, a previously protected and restored column was raised in the peristyle of the bath latrine. A capital was mounted on top of this column (Fig. 10:L).

portico passage of the Baths have been designed. The plundered foundations and floors of the frigidarium on this side were cleared, preparing ground for work in the future season (Figs 10:B; 12).

Work on the conservation of the mosaic floors has begun and is planned to proceed all through the summer months (Fig. 10: A).

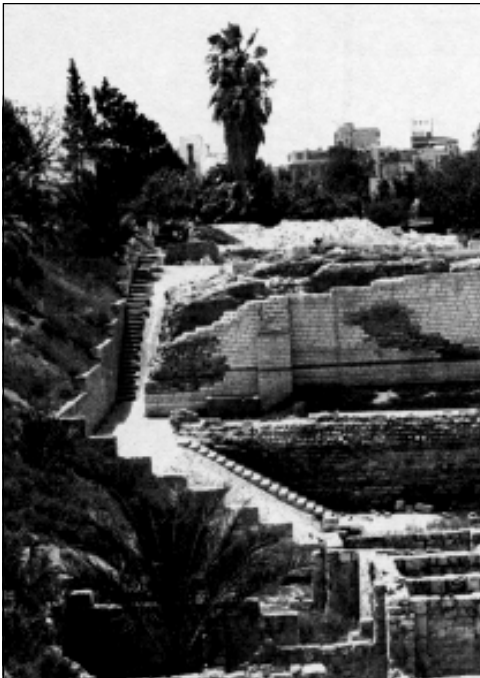
Fig. 11. Tourist path along the southern limits of the site (Photo W. Kolqataj)

The tourist walkway along the southern limits of the site, from the Theater to street R4 and the mosaics shelter (120 m), was completed, including pavement, steps, casing walls and sloping work (Fig. 11).

Currently, a water supply pipe is being installed along this walkway, enabling extension of the green area along the southern border of the site. The steps leading down from the gate in Safia Zaghloul Street to the south

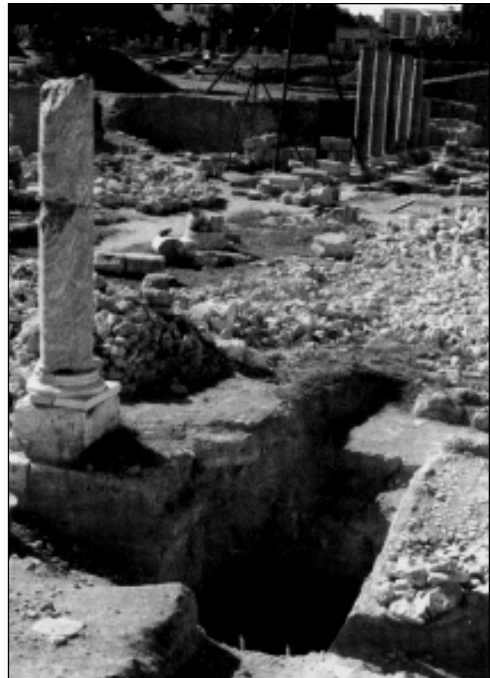
Fig. 12. Baths. Southeastern corner of the frigidarium after cleaning (Photo W. Kolqataj)
