# HAWARTE

## THIRD INTERIM REPORT ON THE WORK IN THE MITHRAEUM

Michał Gawlikowski

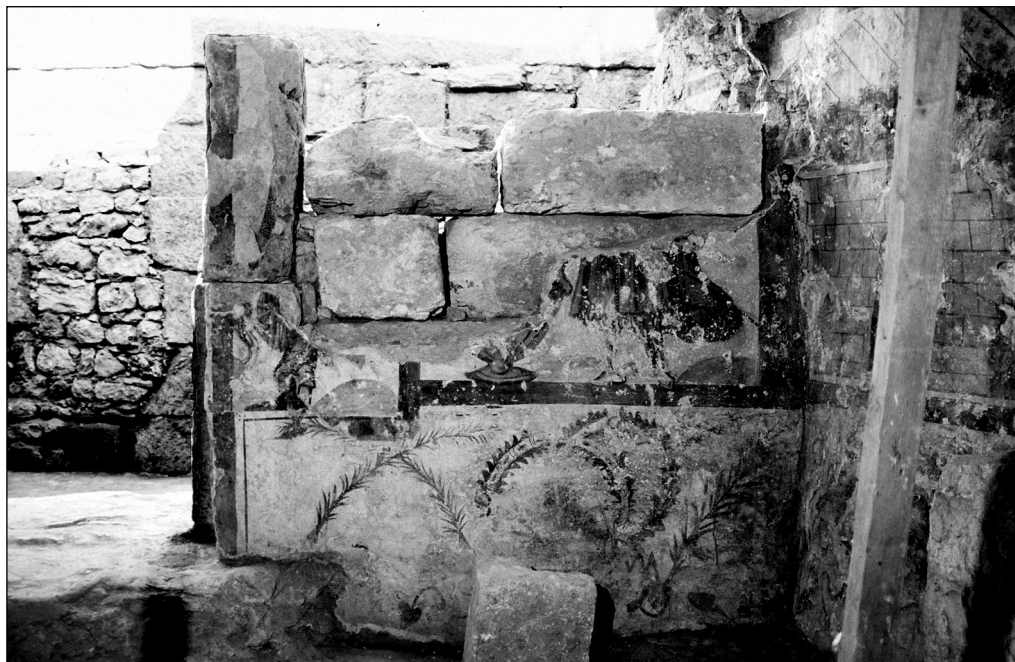
*Fig. 1. The passage from the main room to the vestibule with the partly restored northern jamb (Photo T. Szmagier)*

the narthex and the nave. As the latter was dismantled in 1999, recovering some stones belonging to the original structure, it now became possible to restore the dividing wall of the mithraeum nearly completely; in particular, two doorjambs were erected to their full height. One of them still bears some painted plaster.

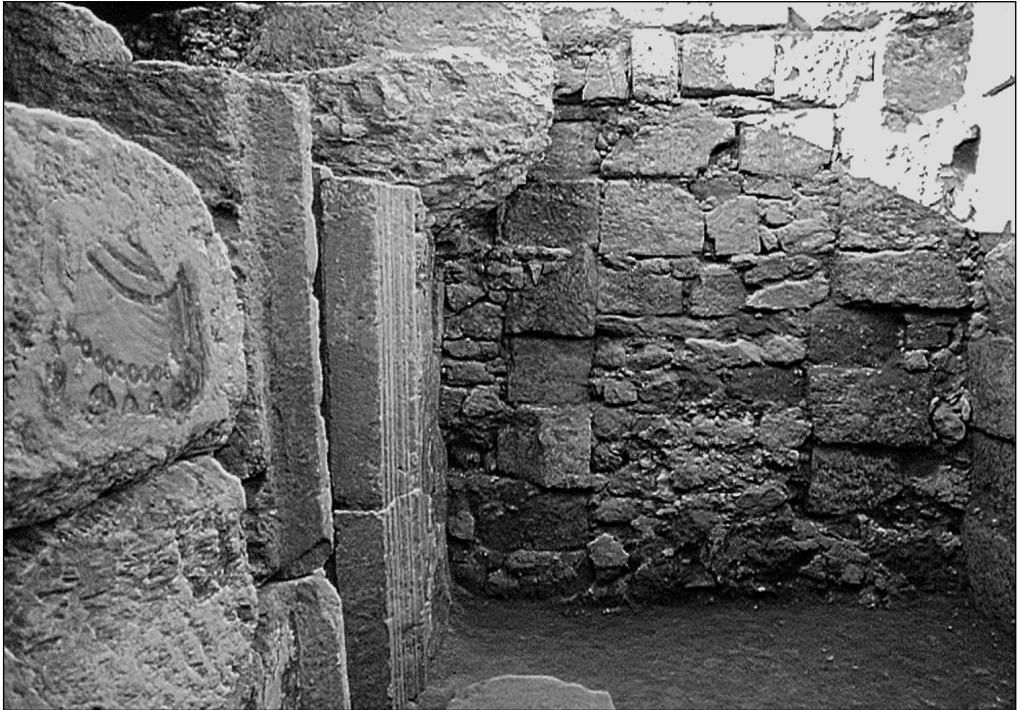
*Fig. 2. The excavated part of Room B with the restored jambs and the later foundation to the south (Photo T. Szmagier)*

Under the mosaic level a trench was excavated on both sides of a foundation dug into the mosaic by the builders of the second church. This done, we found ourselves between the exposed foundations of the church on the west and south (*Fig. 2*), some 4 m below the level of the earlier mosaic, and the original east and north walls of the mithraeum vestibule (Room B). The fill

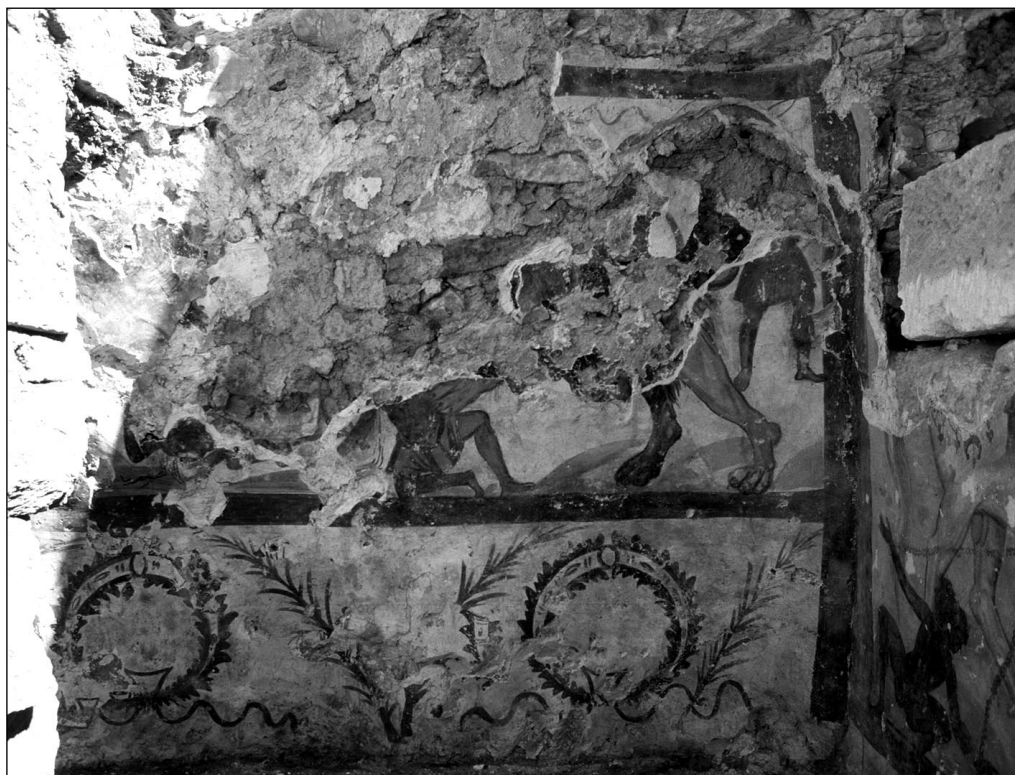
*Fig. 3. The north wall of Room B with remains of the lion painting  
(Photo T. Szmagier)*

The north wall, which is bedrock with small stones and tiles filling the cavities (seen already in 1999) was exposed again and consolidated. The painting is badly damaged due to the poor quality of the support, but the subject is clear: two facing lions tear apart little black men, presumably representing some evil forces (*Fig. 3*). It was estimated that the original west wall of this room runs not further than 50 cm behind the foundation of the church facade.

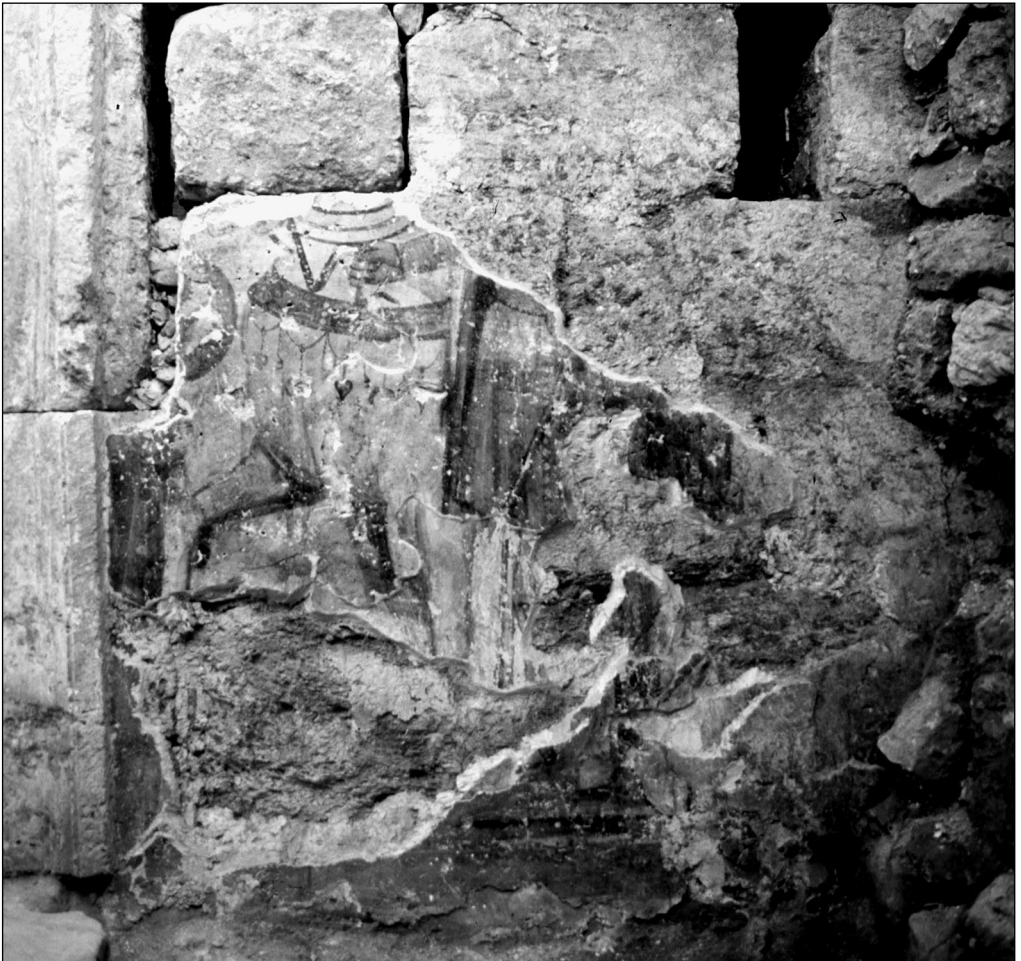
*Fig. 4. The horseman to the right of the entrance to the main room  
(Photo T. Szmagier)*

Right and left of the doorway leading from vestibule B into the main room A, there are some very unusual paintings. The one on the left was cleared already during the last season. It represents a dismounted horseman holding on a chain a monstrous creature: a naked black man with two heads. We had initially assumed this to be Mithra himself, but now another horseman, practically a mirror projection, has appeared on the other side of the door (*Fig. 4*). The part of the wall where his prisoner would have been depicted is not preserved, but every other detail is mirrored from one side to the other. There were two layers of painting representing consecutively the same subject. The two horsemen were apparently conceived as guardians of the entrance to the main room of the mithraeum, warding off the forces of evil.
