KOM EL-DIKKA

PRESERVATION WORK, 2000/2001

Wojciech Kołataj

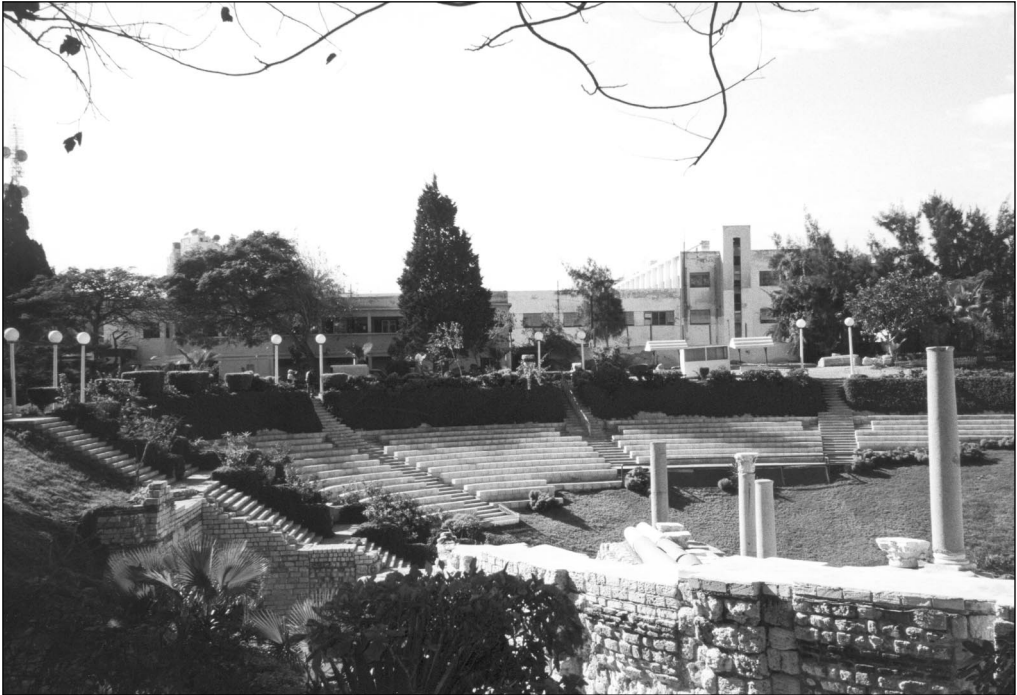
Fig. 1. New auditorium erected west of the ruins of the ancient theatre (back wall visible in the foreground) (Photo W. Kołtątaj)

The abrupt decision of the Egyptian authorities, in August 2000, to build a new auditorium on the slope opposite the ancient theatre on the Kom el-Dikka site came as a total surprise. Within three weeks, during the summer break in archaeological work, a big part of the stone-built auditorium was erected (*Fig. 1*), as well as a showy staircase which extends the Roman street in front of the theatre to the south. Thus, an architectural conception that I had proposed several years ago has finally been given shape (see previous reports in PAM).

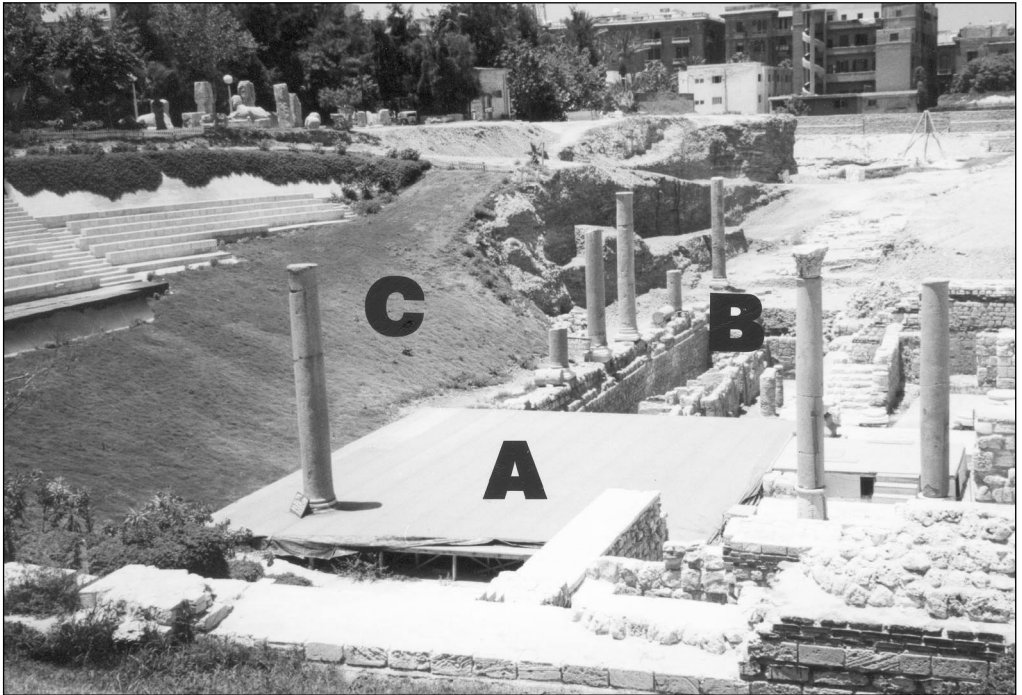
Fig. 2. Area west of the ancient theatre: A, B, C problem areas requiring a solution in the future (Photo W. Kołtataj)

- How to construct the new wooden stage-platform so that it does not inter-

fere with the tourist flow (*Fig. 2: A*)?

- How to connect the newly excavated area and the future mosaic-floors display in this area with the modern structure (*Fig. 2: B*)?
- How to extend, if at all, the new auditorium to the north (*Fig. 2: C*)?
- How to drain away rainfall water?
- Why the material used in the new structure is not of appropriate quality?

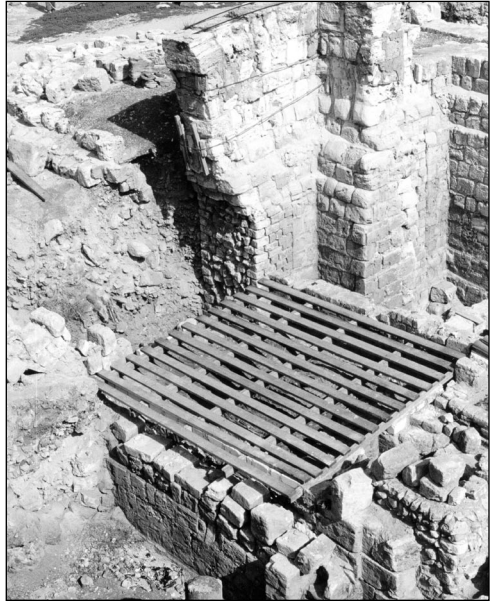
Fig. 3. Roman baths. Western section of the southern outer wall before anastylosis (Photo W. Kotłtaj)

In the bath, the southern outer wall of the complex in the western section was completed. Major parts of this wall were reconstructed using original blocks found during excavations (*Figs. 3, 4*). Nearby, one of the underground vaulted chambers (probably the eastern entrance to the underground service area) was protected and partially reconstructed. The work will be finished next season once the existing part of the outer wall has been cleaned and examined archaeologically. The cellar, fitted

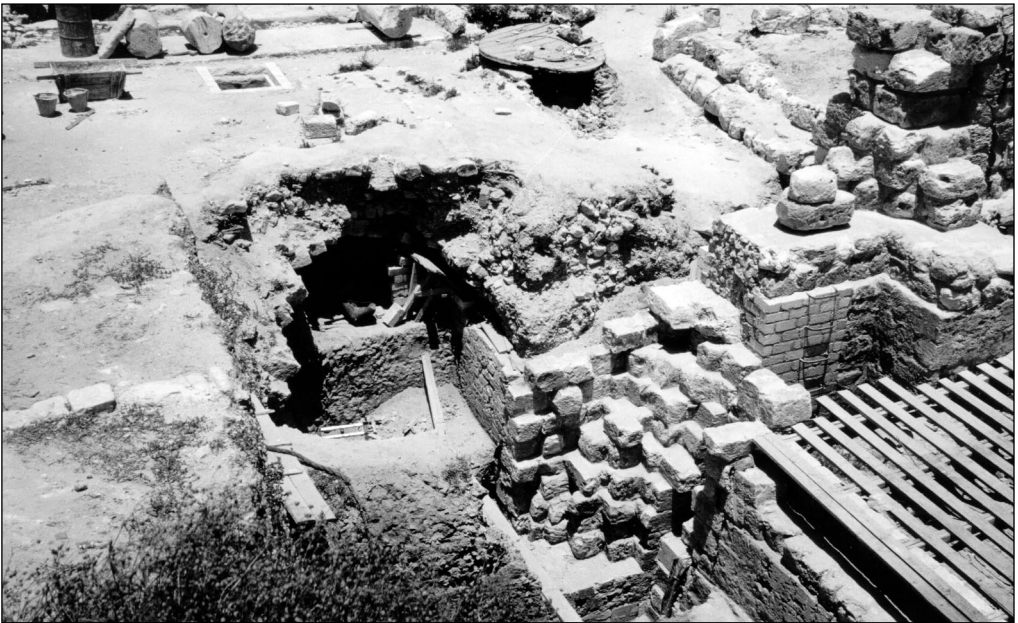
Fig. 4. Roman baths. Western section of the southern outer wall after anastylosis (Photo W. Kotłtaj)

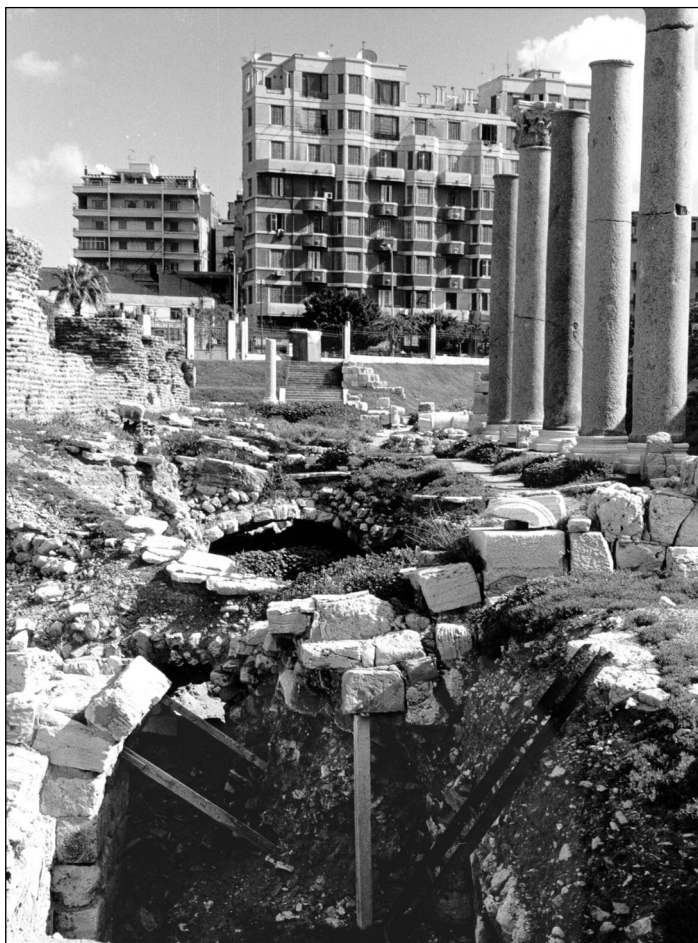
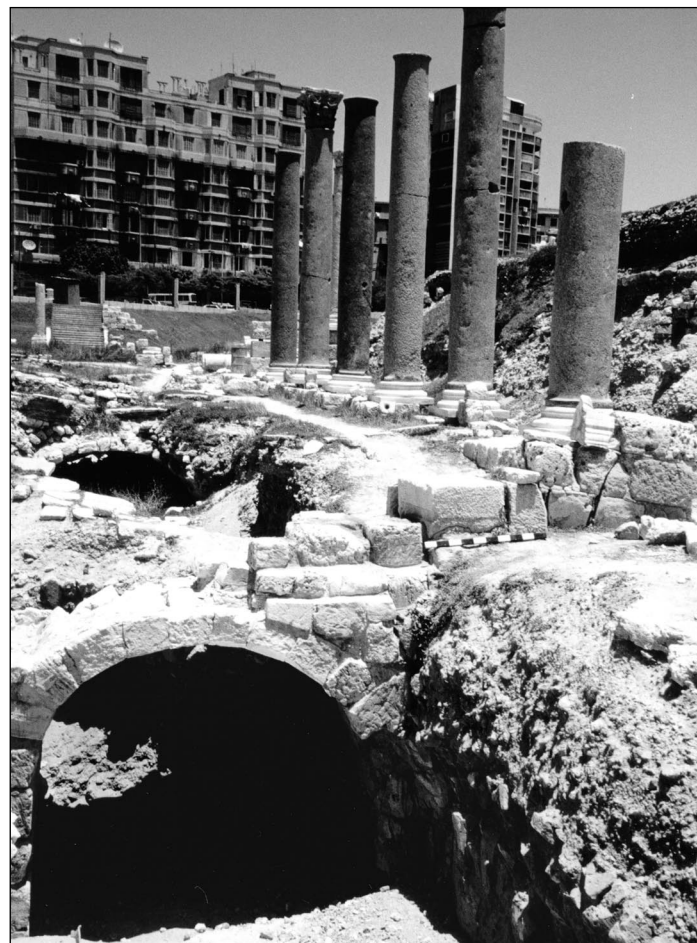
Fig. 5. Roman Baths. Gateway arch of the southern section of the underground service area corridor before (left) and after reconstruction (Photo W. Kotłaj)

In the southern section of the corridor of the underground service area, in its western part, a gateway arch was protected and partially rebuilt (*Fig. 5*).

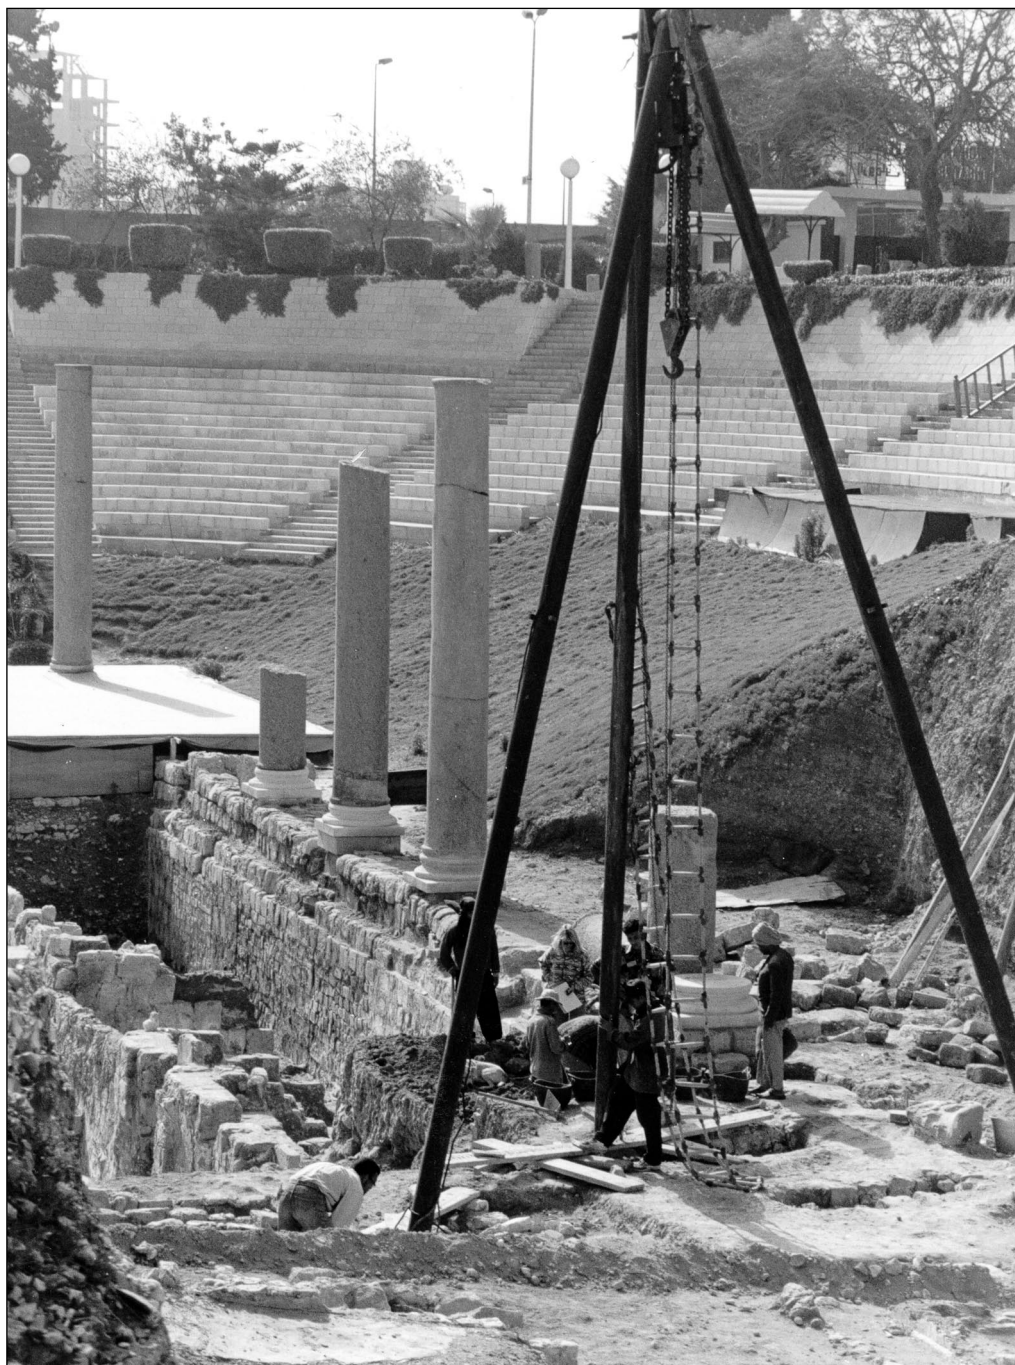
*Fig. 6. Theater Portico. Raising another two columns discovered during excavations of the portico
(Photo W. Kolqataj)*

In the theatre portico, the planned anastylosis of the two newly uncovered columns took place (*Fig. 6*) and preparations were made to raise three other columns in the coming season (two of them in the northern wing of the portico). In the Villa of the Birds shelter, a new rainwater gutter at the southeastern corner was installed in order to better protect that part of the structure against rising damp.
