KOM EL-DIKKA

EXCAVATION AND PRESERVATION WORK, 2003/2004

Grzegorz Majcherek

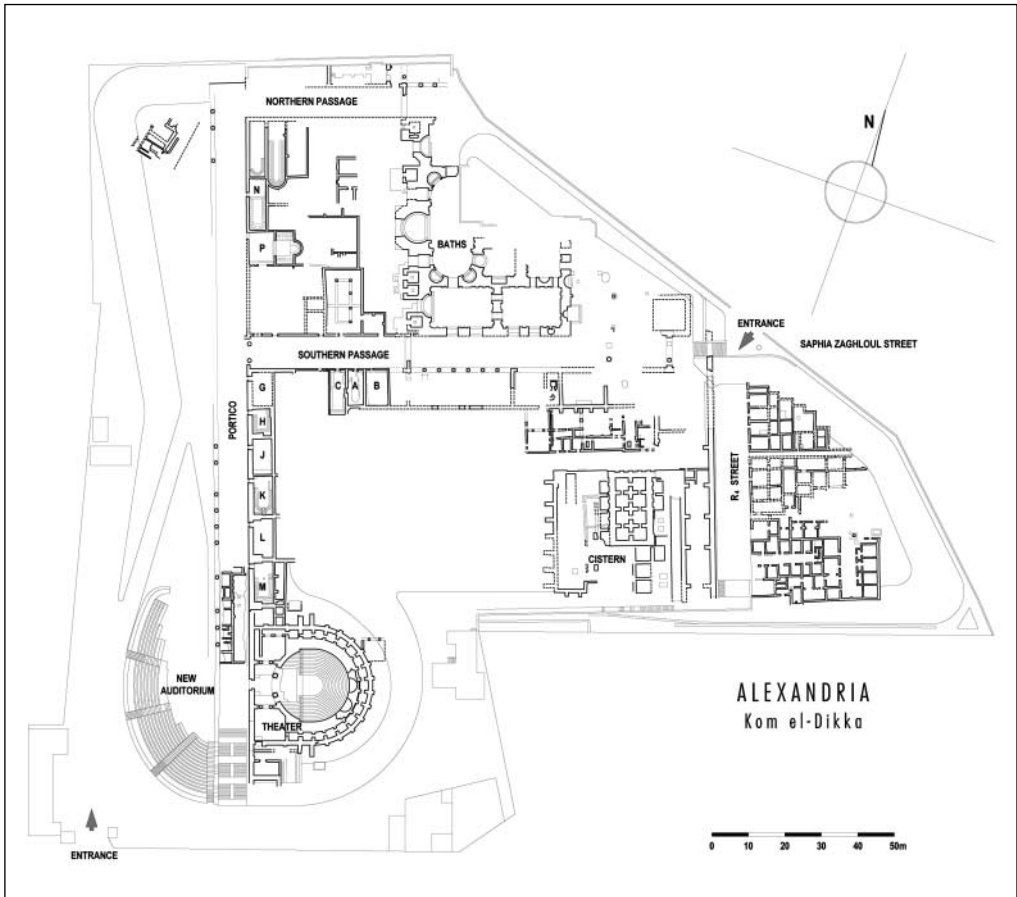
Fig. 1. General plan of the site
(Drawing W. Kotztaj)

pected along the entire length of the portico and this initial assumption has now been fully confirmed as another three halls (H, J and N) were excavated this season [Fig. 1].

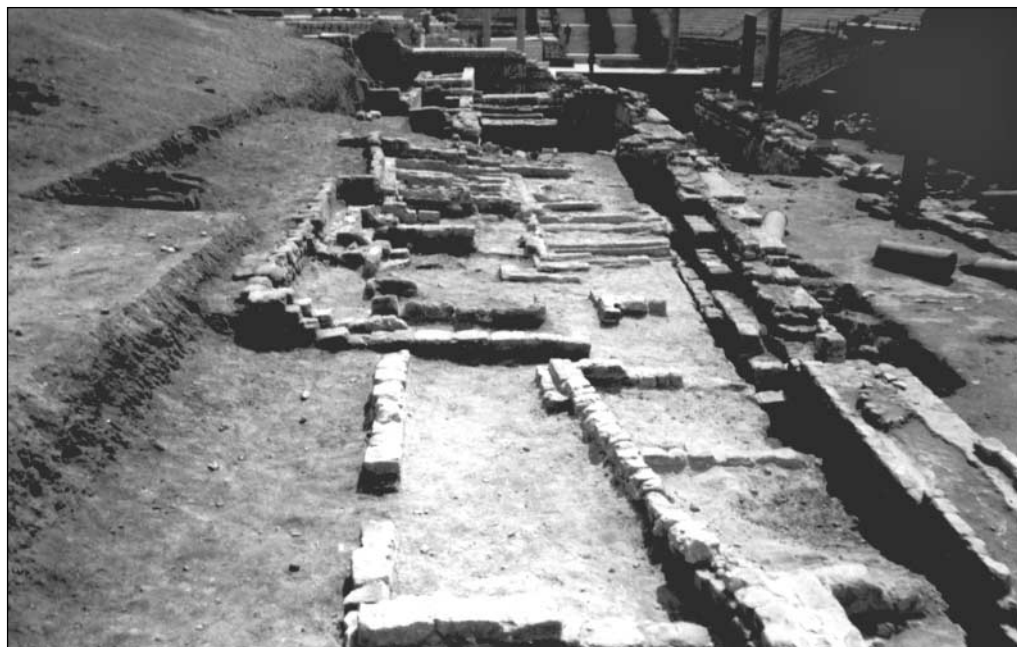
The upper strata in the area of planned work corresponded to a vast Moslem cemetery, which is known to cover virtually the entire site. Some twenty or so graves of the so-called Upper Necropolis (nos. H 10-17 and H 41-48) were cleared within the trench confines (8 x 20 m) [Fig. 2]. They were, however, largely damaged by later robbing activities. In some cases, the superstructures were utterly destroyed, exposing burial chambers underneath. In the southern part of the trench, an extension of the perimeter wall surrounding a group of previously excavated graves was cleared. The accompanying strata yielded the usual assortment of artifacts: medieval glazed pottery both Egyptian and imported, some lamps and glass finds, all dated to the 10th-12th century AD.³ Two fragmentar-

*Fig. 2. Area H. Moslem Upper Necropolis looking south
(Photo G. Majcherek)*

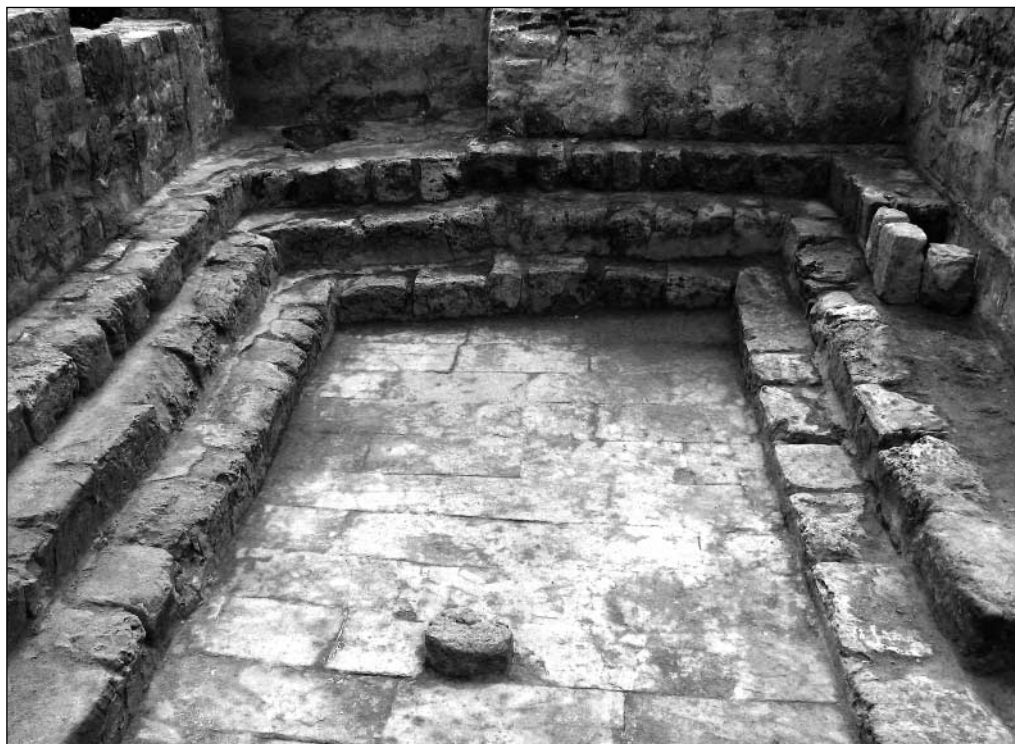
Fig. 3. Auditorium H. View from the north
(Photo G. Majcherek)

torium [Fig. 3]. It has proved the smallest of the excavated halls, measuring roughly 5.10 x 6.70 m. Three rows of benches ran straight along the three walls. The southern end was higher, accommodating a seat for the lecturer. The benches (0.30-0.35 m high) survived almost intact in the southern and eastern part of the hall. Of those lining the western wall, the topmost row is gone, but the dismantled stones have left clearly visible imprints. The inner face of the southern wall was not aligned with the portico back wall buttress, which is recessed by 0.70 m. This irregularity caused some problems in planning the benches on the south. The resulting recess was filled with rubble and plastered, creating a kind of platform that ran even with the topmost

row of benches. The floor was made of regular, carefully laid limestone pavers. Nearer to the door, again almost in the middle of the hall, there was a small hexagonal limestone block rising conspicuously above floor level. As in the case of Hall J, it is likely to have something to do with the oratorical function of the room. Yet another puzzling installation was noted next to the north wall. It was a small, elongated basin (0.80 x 2.65 m), its walls lined with waterproof plaster. There was neither a solid bottom nor an outlet. The purpose of this basin remains enigmatic, especially in view of the assumed function of the hall.

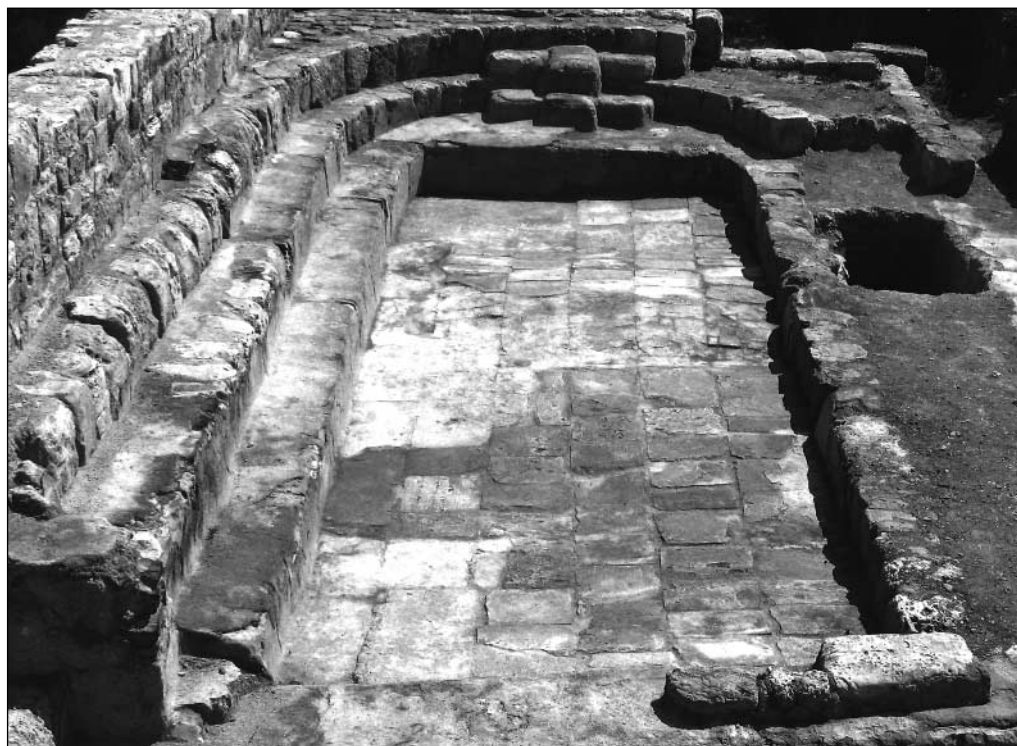
Fig. 4. Auditorium N. View from north
(Photo G. Majcherek)

Yet another auditorium (N) was cleared immediately below the medieval cemetery level. It was an elongated structure (approximately 14.25 m long), clearly divided into the auditorium proper and preceding anteroom. The latter almost square room (5.00 x 5.10 m), accessed from the Theatre Portico, opened into the auditorium through a wide doorway. The lecture hall (approx. 8.75 m long) was furnished with three built rows of stone benches placed along the walls and an apsidal ending on the south [Fig. 4]. Remnants of an elevated seat and the low steps leading to it occupied the center of the apse. The western stretch of benches was found almost totally dismantled. Remnants of a single bench were preserved also in the vestibule. The floor in both rooms, badly damaged by later burials, was paved with regular limestone slabs.

0.90-1.70 m above floor level. The west (back wall of the portico) and south walls were shaved off practically at ground level. The damages were apparently due to medieval plundering.

The newly uncovered auditorium N also received immediate attention. First, the missing facing of the eastern wall was repaired over a distance of some 14 m. The wall had suffered badly from weathering and damages caused by medieval burials. All the missing or eroded stones were replaced with new ones. The wall was rebuilt to a maximum height of some 1.60-1.80 m in places and the wall coping additionally reinforced to prevent water penetration. Some of the benches along the northern wall were found to be quite well preserved with only minor reparation needed, while the southern part of the auditorium had been almost entirely robbed out. The

necessity to rebuild also a huge adjoining facade wall excluded immediate restoration of the benches. Only the lowermost run of seats and a fragment of the southern apsidal ending could be restored.

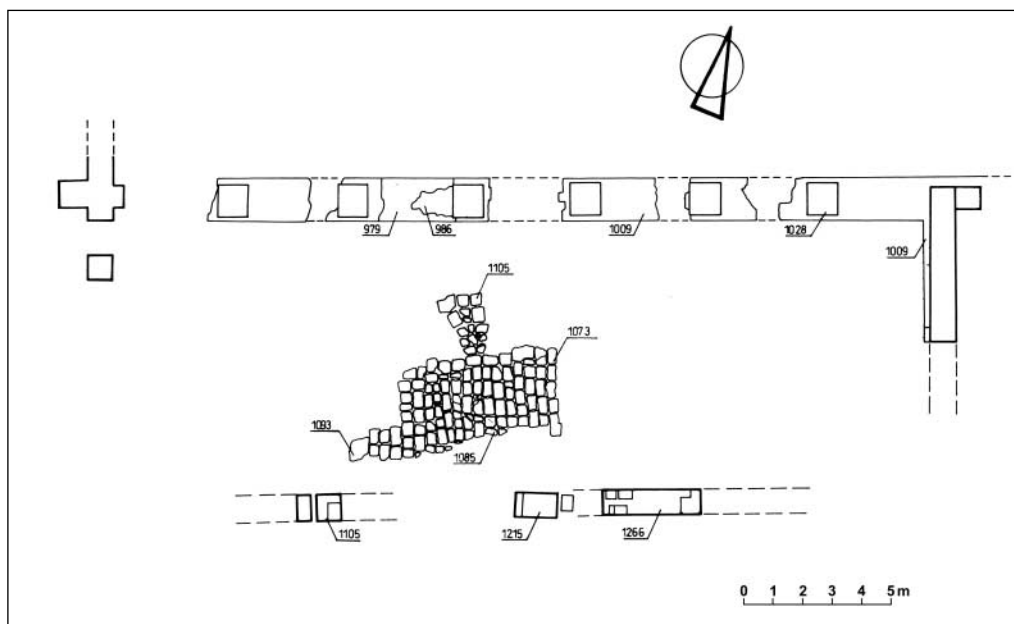
The layout of the palestra was thus marked out on the ground; the facility was found to measure approximately 9 x 27 m and to be surrounded with porticoes on the north, east and presumably also west (assuming a symmetry of design) [*Fig. 5*]. These rather modest dimensions, standing in telling opposition to the overall size of the bath complex, conform well to Late Roman practice and find numerous parallels in bathhouses excavated in the Eastern Mediterranean.

Fig. 5. Southern palestra of the bath
(Drawing M. Krawczyk)

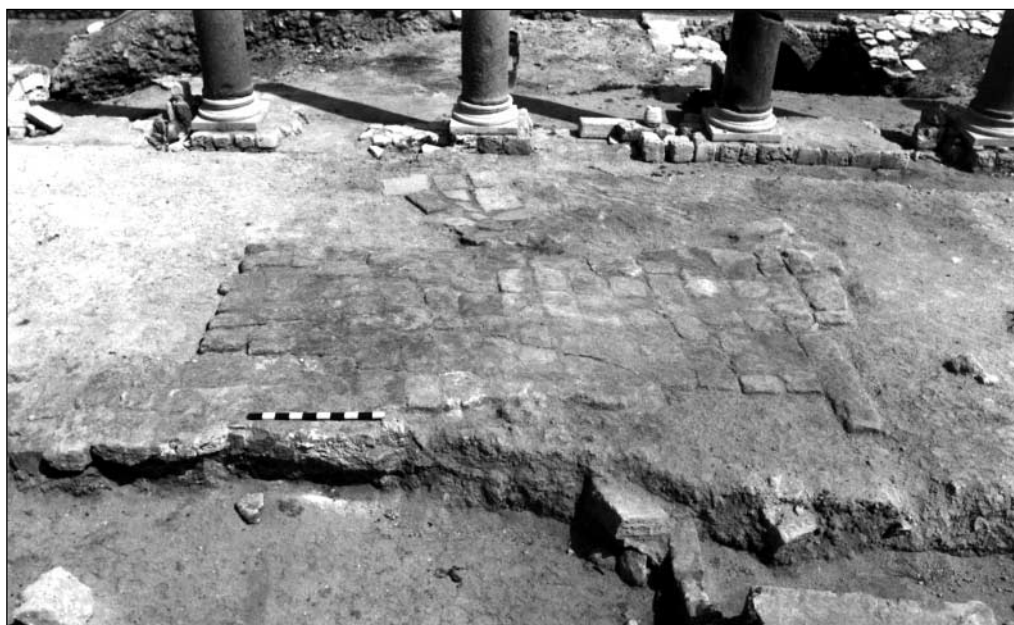
The work was halted temporarily at a level approximately 11.00 m above sea level, where a large stretch of flagstone paving was cleared [*Fig. 6*]. The paving is

Fig. 6. Flagstone paving of the southern palestra of the bath
(Photo G. Majcherek)

preserved only in the central part of the area, in other locations it had been apparently removed leaving a rubble substructure. The paving rises some 1.20 m above the level of the portico flagging and can hardly be linked to the latest phase of the bath. Pre-

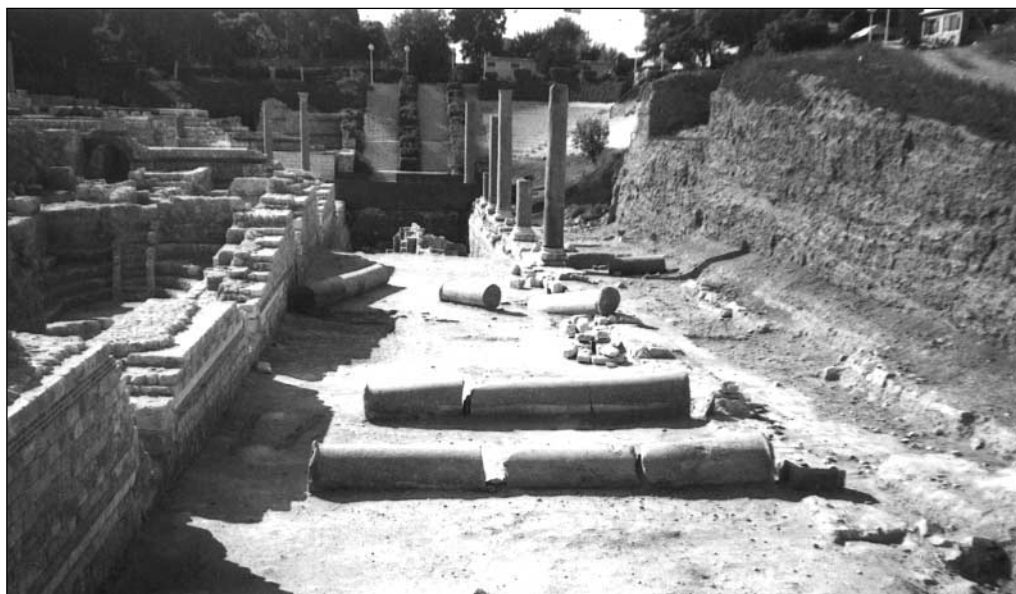
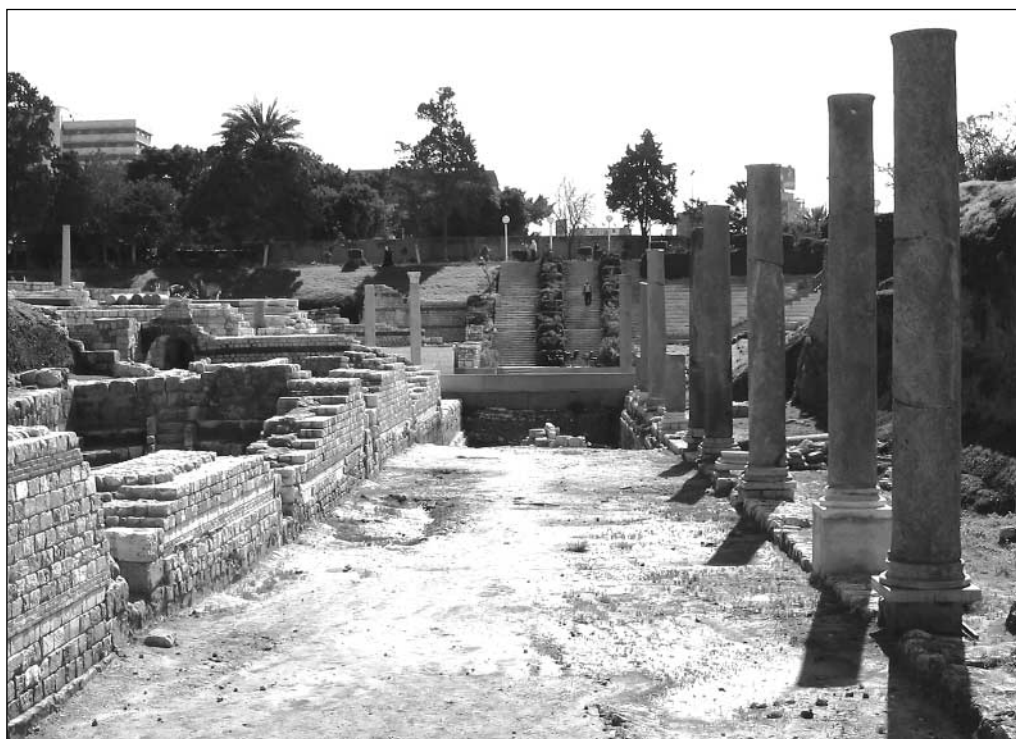
The anastylosis of the portico was the most important operation undertaken this season. Two recent field campaigns resulted in the clearing of c. 40 m of the portico.⁸ Four toppled and broken granite columns were found lying immediately on top of the extant pavement of the portico [Fig. 7 top]. Since the adjacent section of the portico stylobate was found to be quite well preserved with only some minor reparation needed, it was decided to proceed with the raising of the columns to their respective original positions [Fig. 7 bottom]. All the original marble bases were missing, so limestone replacements had to be manufactured. One of the columns, however, turned out to be shorter than the others; originally, it must have stood on a low pedestal to compensate for the missing height. A pedestal of two large blocks was constructed to accommodate it. The land configuration and easy access to the area in question allowed the lifting operation to be carried out using a crane instead of the traditional tripod and pulley device.⁹

*Fig. 7. Theatre Portico before (top) and after restoration, looking south
(Photo G. Majcherek)*

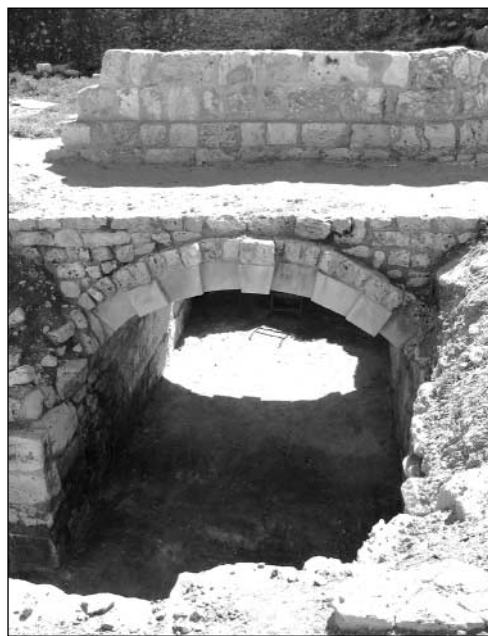
The operation that was technically perhaps the most demanding and certainly the most time consuming was the restructuring of the damaged vault over the southwestern entrance chamber of the subterranean service area. The vault had collapsed apparently under the heavy load of a Late Roman wall built across it and was found resting on a thick deposit of ashes and bath refuse. The wall itself had subsided and been deflected considerably. Following detailed recording in drawing and photo-

Fig. 8. Restored vault in the southern passage of the bath, looking south (Photo G. Majcherek)

graphy, this wall was dismantled, the fill cleared and the lateral walls of the chamber inspected for damages. Disintegrated blocks were replaced with new ones and the voids were filled with new mortar, making the construction structurally sound again. Since all the extant stone elements of the original vault were either heavily weathered or utterly destroyed, it proved necessary to rebuild the vault with new blocks cut to the required dimensions. The restored fragment

of the vault is approximately 4.50 m long. In the next stage of the operation, the dismantled wall was reassembled in its original position and the outer coating of the vault restored of smaller, randomly arranged stones [Fig. 8]. The restoration of this vault was essential in view of the planned visitors' route that is to run along the southern facade of the baths. The gap between the western and eastern part of the passage was thus bridged.

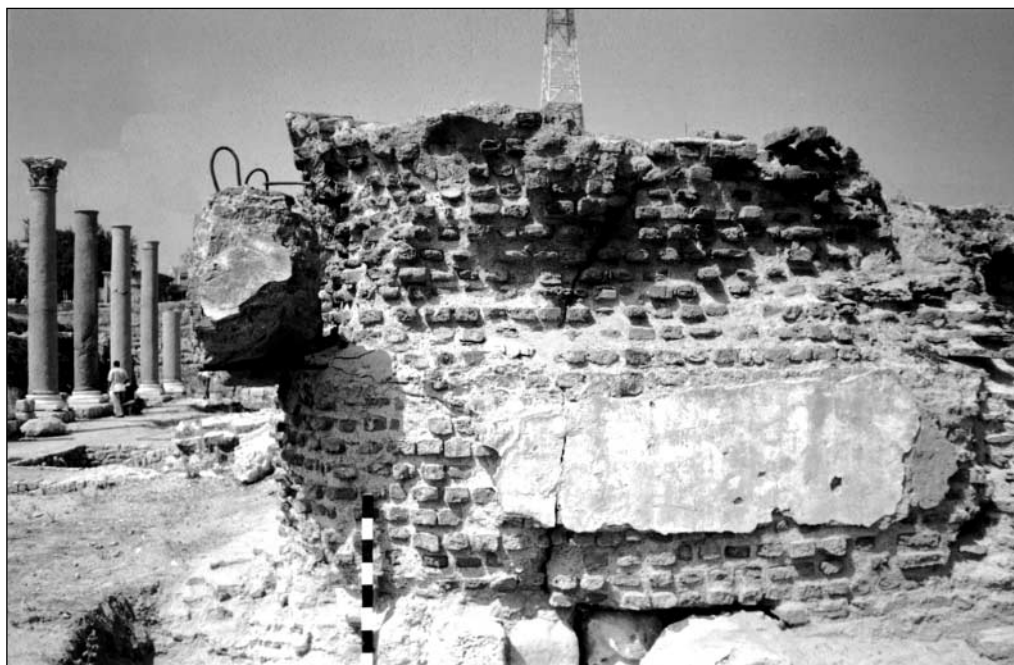
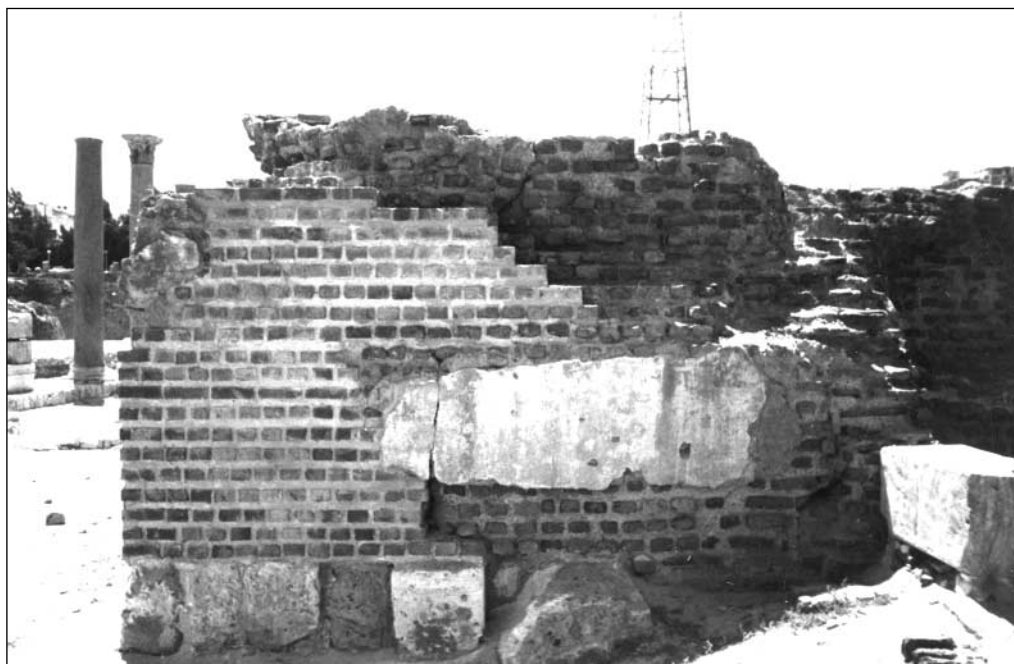
Fig. 9. The southeastern corner of the bath before (top) and after restoration (Photo G. Majcherek)

The already well advanced restoration program for the bath complex focused on the southern part of the complex. The southeastern corner of the edifice was restored in the manner of the original construction. The corner turned out to be severely damaged and the stone from the foundations robbed out sometime in medieval times [Fig. 9 top]. In the past, a large section of the original brick-made corner had been anchored with steel rods to the extant core of the wall.¹⁰ It was decided now to rebuild the entire corner, in an effort not only to restore its original appearance, but also to support this hanging fragment. A test pit revealed poorly preserved remains of stone foundations. They were rebuilt with large limestone blocks, whereupon the red-brick facing was carefully restored up to c. 2.50 m above the original occupation level [Fig. 9 bottom]. The hanging segment of the original wall now rested securely on the newly built structure, and the supporting steel rods were removed.

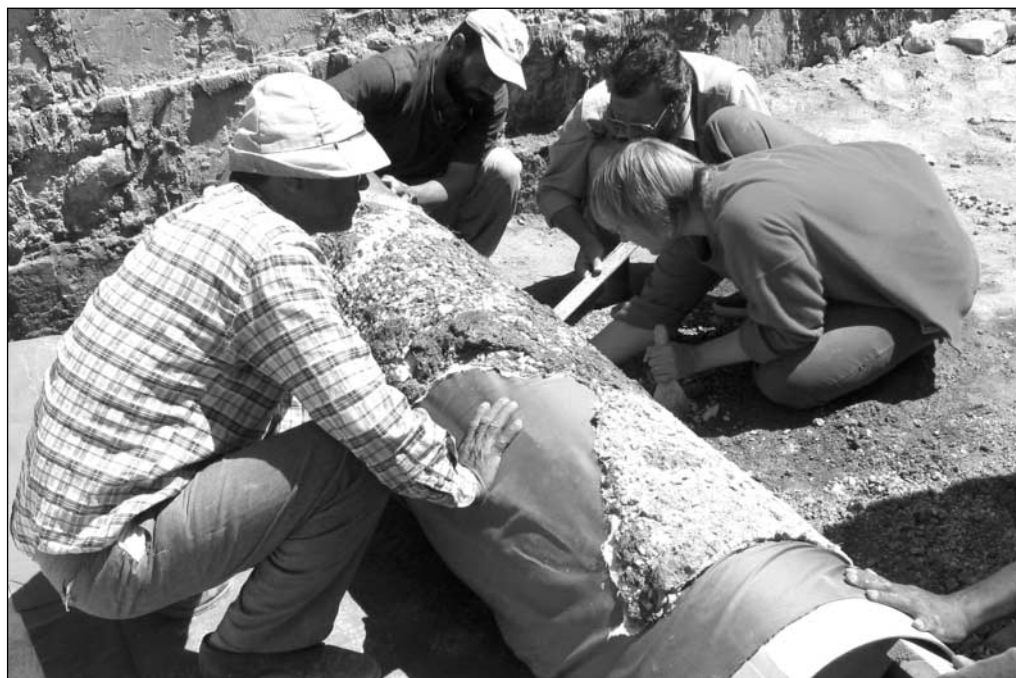
discovery in 2000, the mosaic had been seriously threatened with seasonal water seeping in from the surrounding escarpment, causing irreparable damages to the sur-

Fig. 10. Transferring the mosaic
(Photo A. Chabiera)

face.¹² In view of its size (3.90 x 1.90 m), the mosaic could not be removed in one piece. It was decided to cut it into two smaller sections, positioning the cutting lines to follow basic pattern designs.

Standard conservation procedures were applied during the operation.¹³ To facilitate the process, two rows of tesserae were removed along the dividing line. The surface of each section was cleaned and then rinsed with 5% ammonia water and acetone. The surface was then fixed with two layers of cotton gauze and reinforced with canvas, all soaked in PVA. Both sections were then

carefully detached from the bedding and gradually rolled onto a specially prepared wooden drum (c. 0.60 m in diameter) [Fig. 10]. The mosaic was then transferred to an on-site field laboratory where conservation treatment was continued. Remains of the bedding adhering to the underside were removed and the back of the mosaic was impregnated with a 7% solution of PRIMAL AC-33.
