# KOM EL-DIKKA

## EXCAVATION AND PRESERVATION WORK PRELIMINARY REPORT, 2004/2005

Grzegorz Majcherek

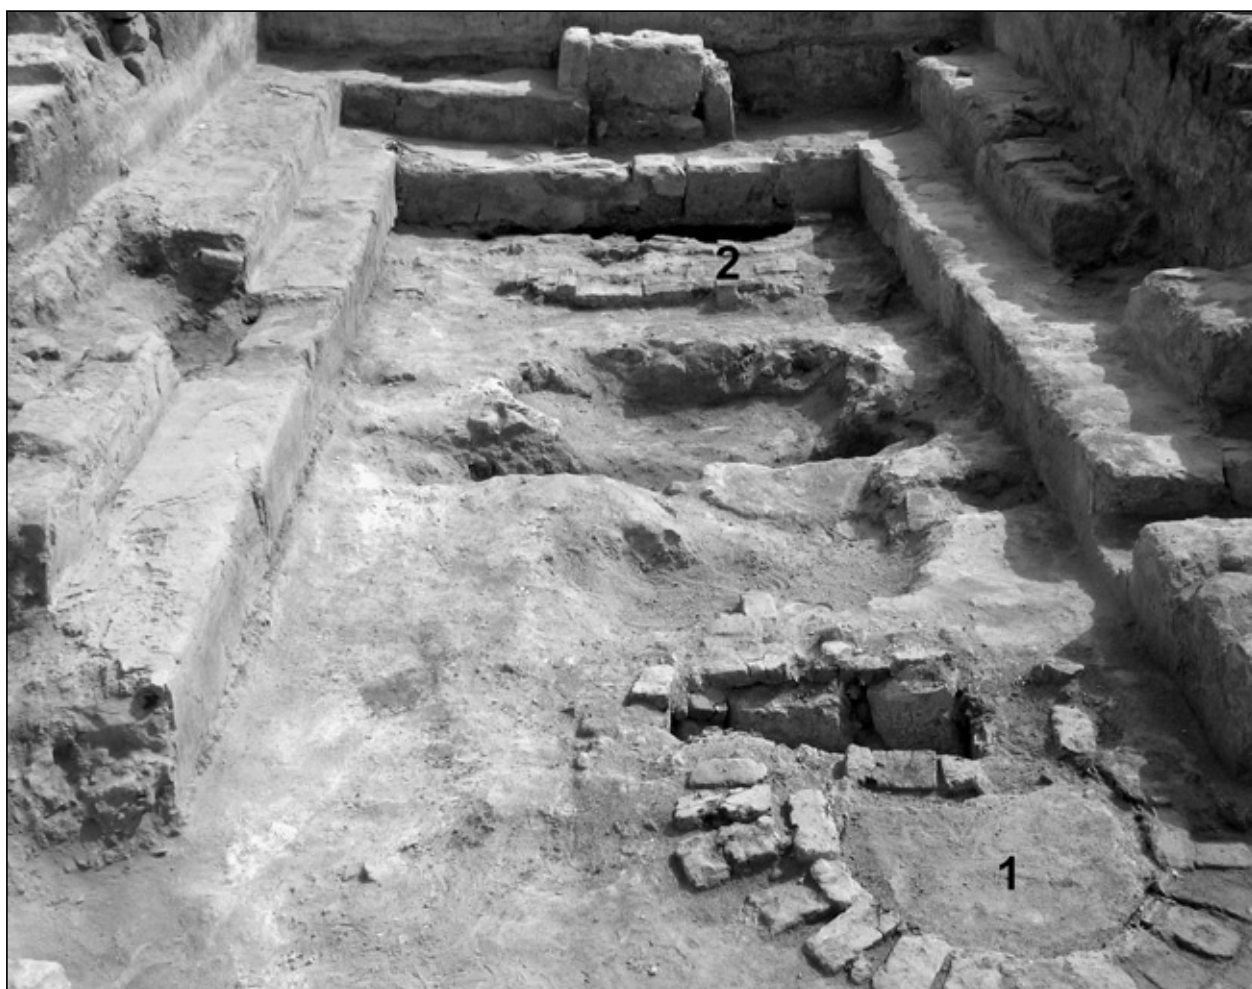
Auditorium G is located at the very corner of the southern run, next to the bath entrance [Fig. 4]. In similarity to the previously discovered units, it was built as a large rectangular hall (9.50 x 4.75 m), taking advantage of structures already existing in the area, i.e., the backwall of the portico. In the course of excavation it was found that its eastern wall also belonged to an earlier urban phase. Although large sections of these walls had been robbed out, it was apparent that it was huge (1.55 m thick), possibly forming part of some unknown building that had once stood behind the portico.

two small brick-made circular furnaces were cleared; one placed near the entrance and the other at the back of the hall, partly sealed by the adjacent benches. Both were apparently used as glass furnaces – glass slag was found in abundance nearby and the inner walls bore evidence of vitrification. They apparently predated the auditorium, suggesting that the area had been used as an industrial zone. These findings confirm the surprising isolation of the area behind the portico until the end of the 5th century and it is extremely difficult to reconcile an industrial establishment of this sort with the traditional function of a portico. The construction of

*Fig. 4. Late Roman auditorium G with remains of glass furnaces cleared at floor level (Photo G. Majcherek)*

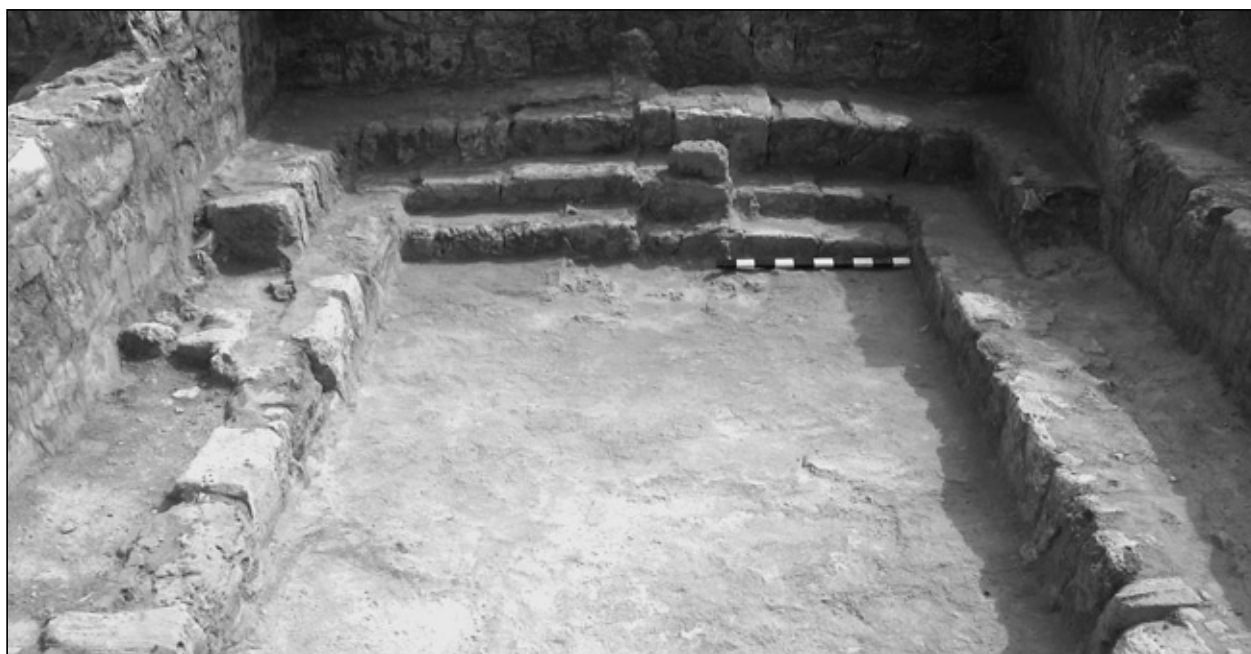
*Fig. 5. Auditorium D, view from the entrance*  
(Photo G. Majcherek)

two rows of masonry benches built along the longer sides and a raised platform (made of three benches) at the back [Fig. 5]. The monumental seat encountered in other halls was not preserved, but clearly visible imprints and leftover plastering pointed to the existence of steps originally leading up to it. As a rule, the benches were made of a single row of large blocks, but in several sections larger blocks cut from the brick walls of abandoned structures, most probably the bathhouse or cisterns, were reused – a phenomenon previously noted also in other constructions of the Late Roman age. Plastering, which was the rule on the benches, covered and evened out all the irregularities. Interestingly enough, the auditorium is not entered directly from the bath passage and it is separated by a continuous wall from another chamber which is. It is not yet clear whether this latter room was an anteroom from the start or was partitioned off at a later date.

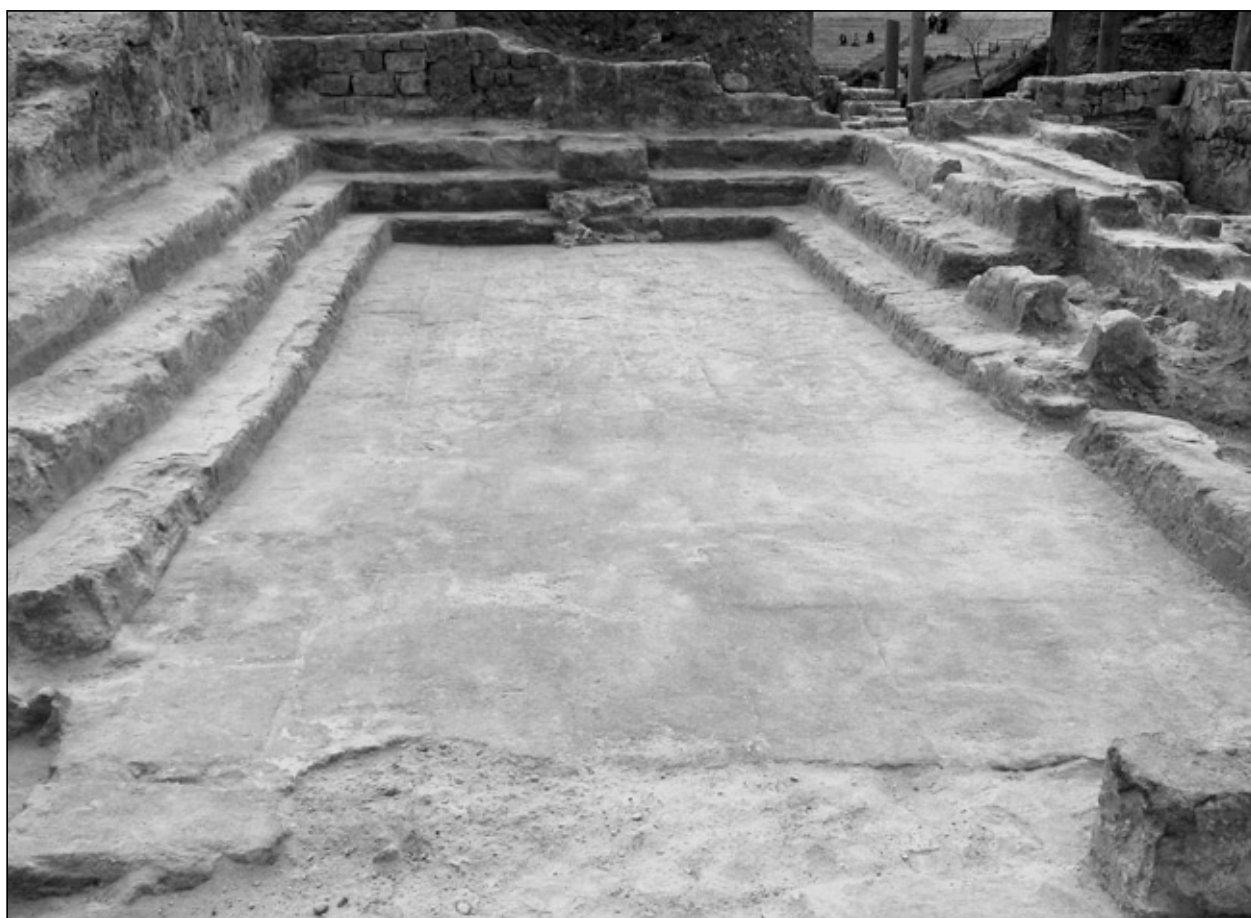
*Fig. 6. Auditorium F, view from the entrance*  
(Photo G. Majcherek)

Auditorium F, so far the largest one (12.70 x 5.50 m), appears to depart from the typical layout of lecture halls forming the southern group [Fig. 6]. The principal difference in plan is the presence of a clearly separated small anteroom (approx. 1.80 m deep). The internal arrangement of hall F, however, follows the conventional layout, with three rows of benches around the walls and a raised dais at the back. The floor was made of carefully laid limestone slabs and was almost wholly preserved. The level of the floor was found to be approximately 0.85–0.90 m higher than the floor in neighboring auditorium G. The reason

for such a substantial difference was discovered when exploring the underfloor layers. In the northwestern corner of hall F, remains of a sewage channel were cleared. The channel, built along the wall, was some 2.60 m deep. Yet another section of it was also cleared in the northeastern corner of the structure. It became apparent that this was a large public latrine, most probably belonging to the bath complex. Once the latrine had gone out of use, the channels were filled and an auditorium built on top of it. Material recovered from the fill consisted mostly of badly corroded coins and a large number of pottery sherds, both Egyptian and imported, giving a *terminus post quem* for the building of the auditorium. It seems that the latrine went out of use by the end of the 5th century AD. The date of the abandonment and destruction of the lecture halls is no less ambiguous and it is closely linked to the appearance of the first graves of the Lower Necropolis. As indicated above, the dating material from the fill consists mostly of residual pottery, obscuring possible chronological conclusions; nonetheless, the absence of Early Islamic (Coptic) glazed wares is conspicuous. Two fragmentarily preserved Saint Menas ampullae, pottery and glass finds,<sup>8</sup> point to the mid 7th century as the most probable date for the abandonment of these auditoria.

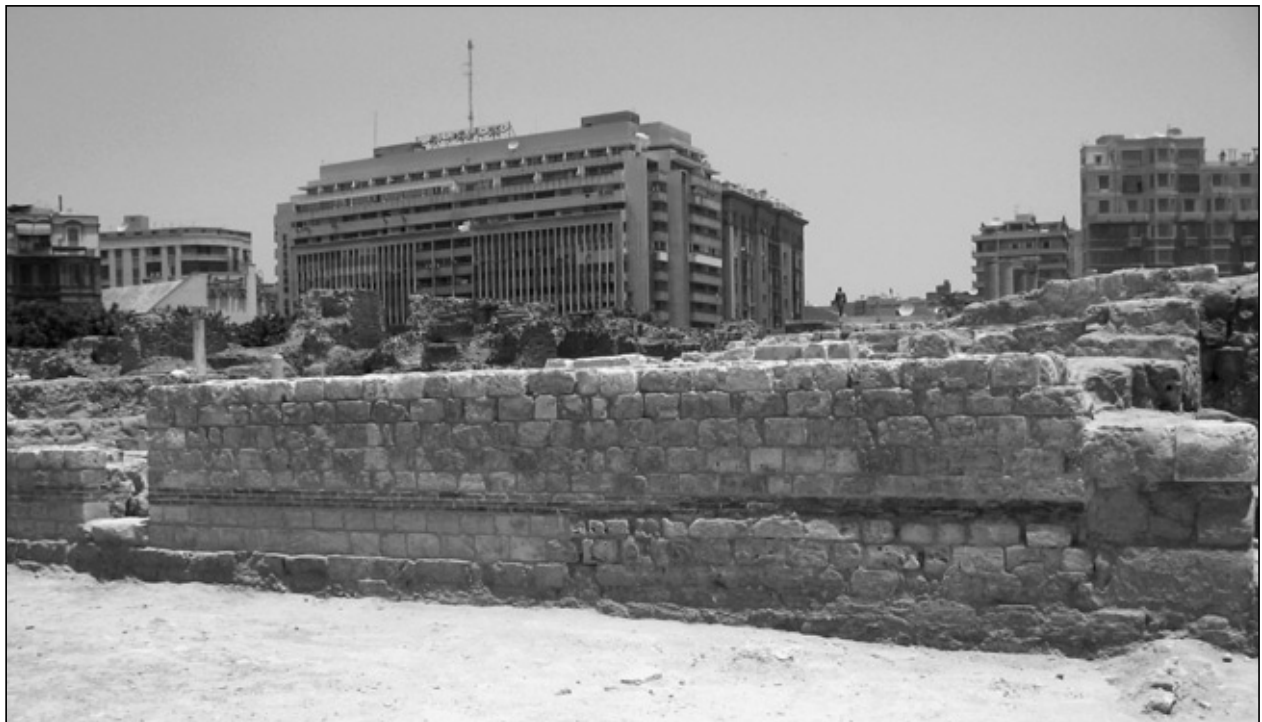
*Fig. 7. Restored section G of the portico backwall  
(Photo G. Majcherek)*

The last remaining section of the portico wall (section G), some 12 m long, was thoroughly restored [Fig. 7]. The core of the wall, visible where most of the facing

had long been lost, was duly cleaned and stabilized with lime mortar filling all the cracks and crevices. The facing was rebuilt using mostly blocks retrieved from nearby graves and retaining their original shape and size. It was apparent that these blocks had been robbed from the backwall in medieval times to serve as handy building material for the nearby tombs. The facing was rebuilt in places up to 1.80 m above the portico pavement. The missing brick lacing was restored with new bricks cut to required dimensions. Following a general conservation principle established for the site, the newly restored wall facing, albeit done in original stones, was clearly separated from the extant original masonry with a layer of bitumen tarpaper and additionally with two slightly recessed courses of new blocks. Restoration in this section of the backwall involved also

a rebuilding of the original entrance. Both door jambs were structured in small blocks, following the original technique.

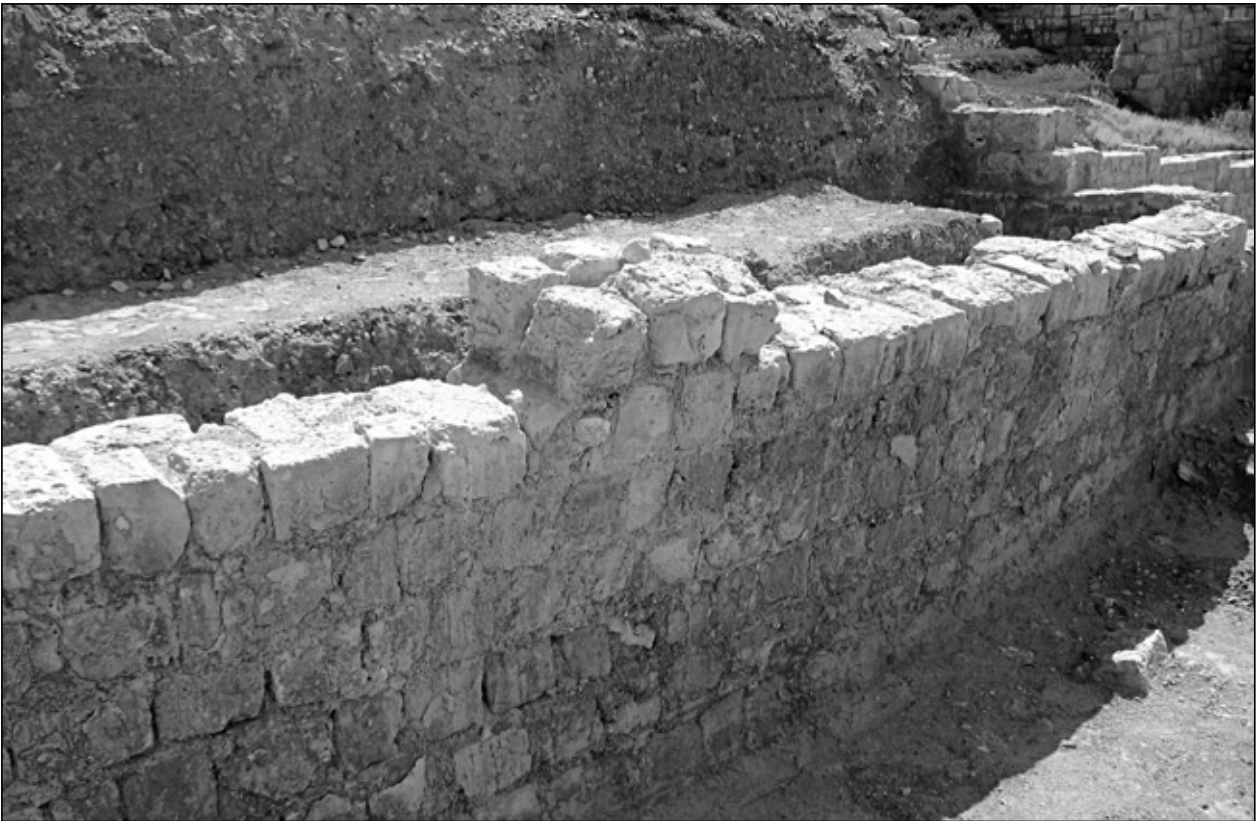
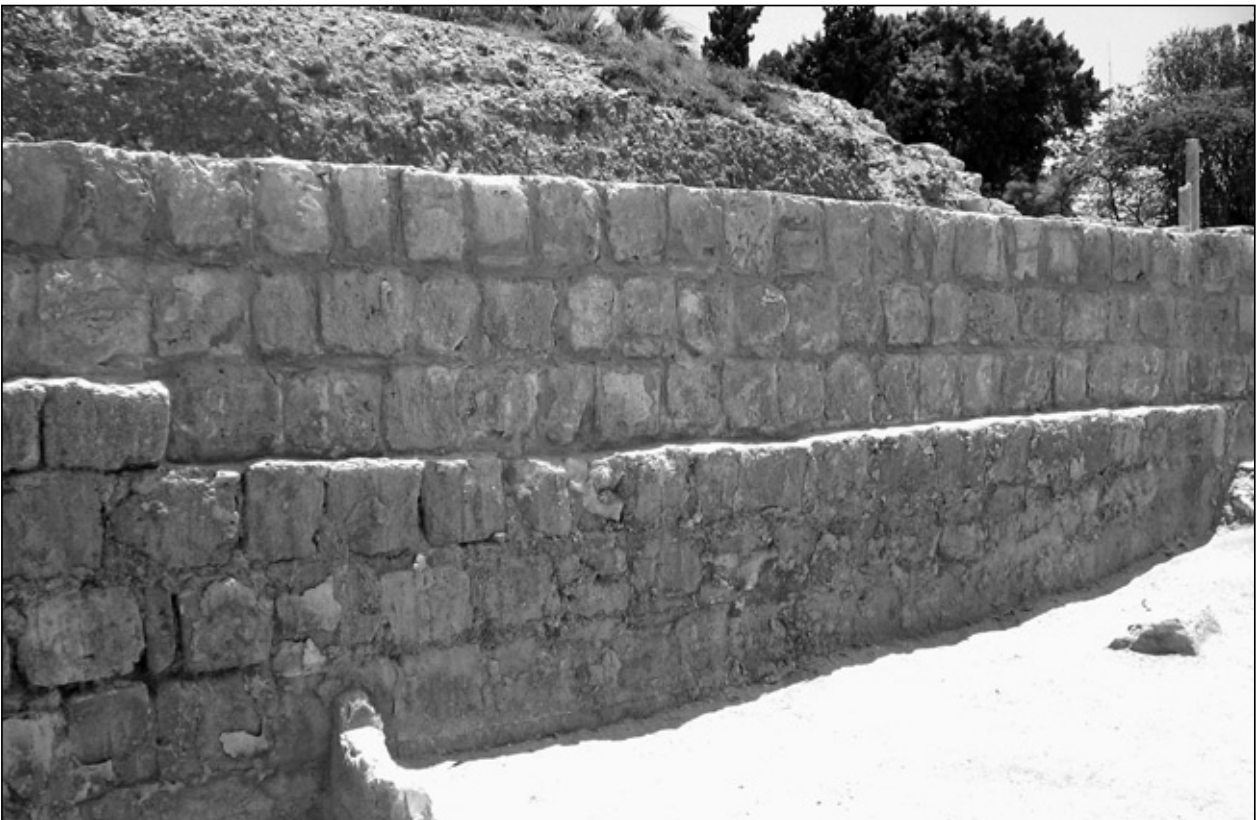
*Fig. 8. Auditorium L, eastern wall before (top) and after consolidation  
(Photo G. Majcherek)*

Auditorium L posed yet another problem. It was ascertained that the area behind the wall had been abandoned already in late antiquity, becoming a dumping ground for city waste. The process of accumulation was so rapid that ancient builders had to deal with the heavy load exerted by the growing dump. Although built of large ashlar, the east wall constructed in the 6th century had not sustained the combined load of the dump and had leaned out substantially, requiring intervention [*Fig. 8, top*]. Following photographic documentation of the most endangered section, all the stones in the topmost three courses of masonry were duly marked and the section carefully dismantled. The whole wall was then reassembled [*Fig. 8, bottom*]. In order to assure stability, some badly eroded stones were replaced with new blocks.

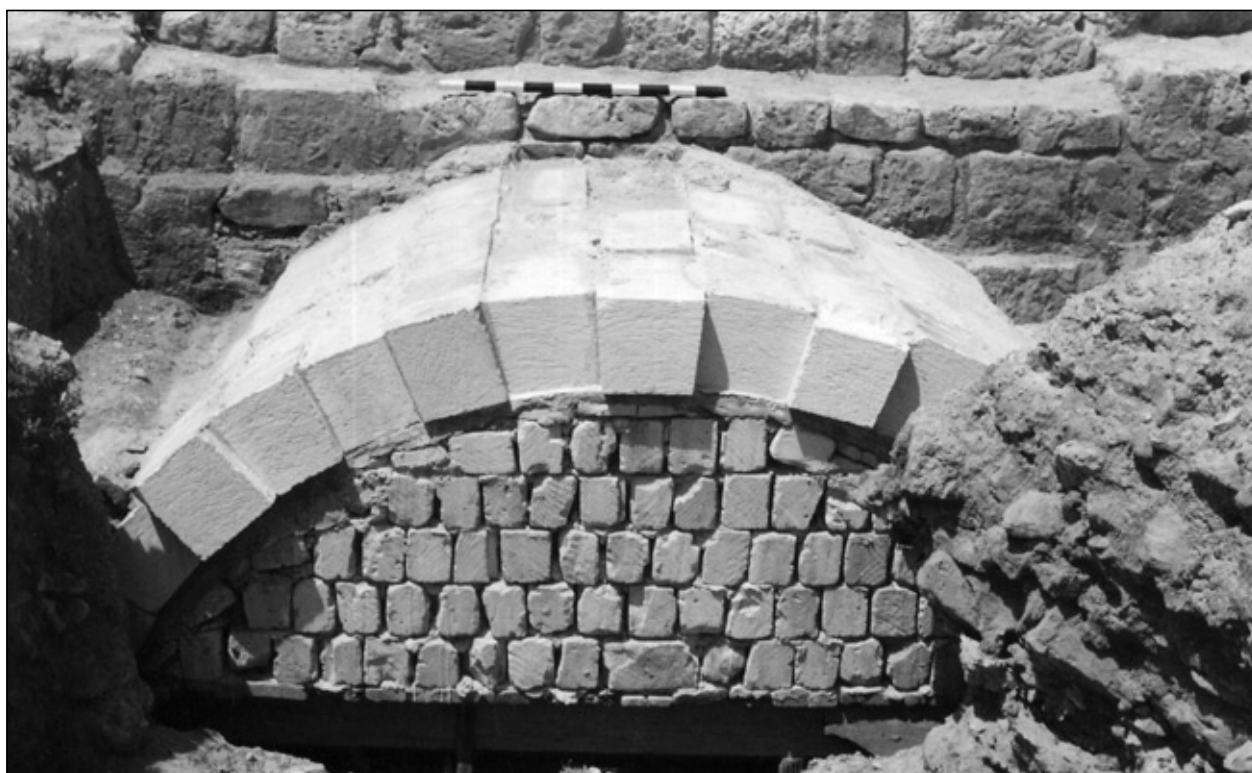
*Fig. 10. Vault next to the western gate after restoration  
(Photo G. Majcherek)*

Work was also continued in the area next to the western gate of the bath complex, where one of the adjacent vaults was consolidated and restored [*Fig. 10*].

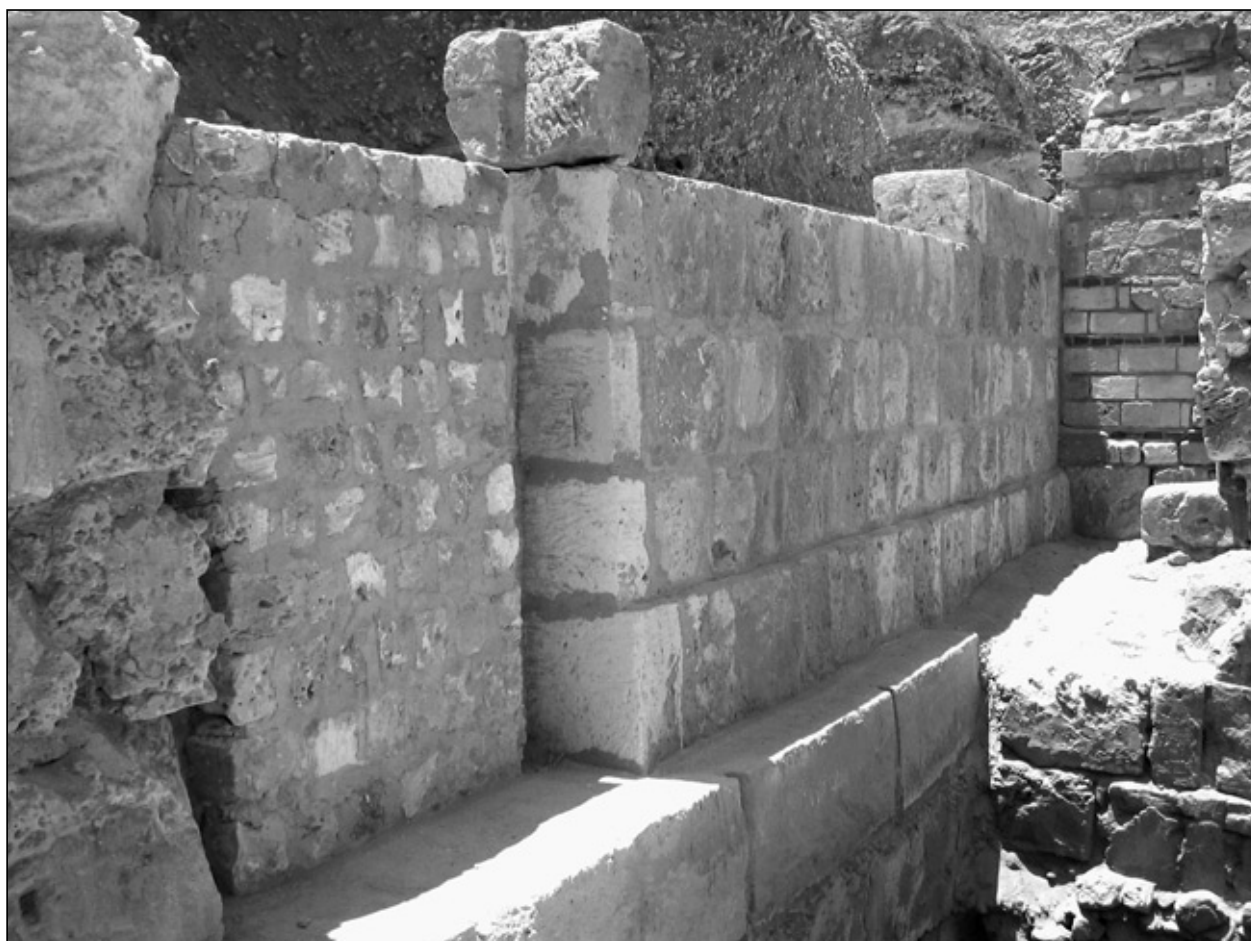
*Fig. 11. Early Roman house F, restored southern wall  
(Photo G. Majcherek)*

In area F, large fragments of two houses (FA and FB) of Early Roman date had been explored already in the 1990s.<sup>9</sup> They were built along a small E-W side street. Some fragments of these structures were already subject to conservation procedures in the previous seasons.<sup>10</sup> This year, an operation for restoring the southern elevation of these houses was initiated. The facade wall (some 0.50 m thick and 25 m long) was rather poorly preserved. Large sections of it were dismantled down to the foundation

level. Only at the eastern and western ends, the wall stood to a substantial height of approximately 3-5 courses of ashlar. The biggest problem faced by conservators was the shortage of proper stones suitable for reconstruction. Using seasoned stones stored at the site, as well as loose blocks found during excavations finally solved the issue. All the blocks were carefully chosen with regard to their quality and dimensions in order to meet restoration requirements. The wall was finally rebuilt

to a height of 4-5 courses (approx. 1.60-1.85 m). The doors were structured in the required locations according to the original archaeological evidence. Since the wall was designed also to serve as a sustaining wall for the planned escarpment along the cisterns, it was decided to block the doors in order to create a continuous barrier and to enhance its structural strength. The doors were blocked with smaller stones in an attempt to separate the original structure of the house from modern additions necessitated by the planned site exhibition [*Fig. 11*]. An additional wall dividing rooms F9 and F10, structured in pillar technique, was also thoroughly rebuilt.
