TUNA EL-GEBEL

THE 'EGYPTIAN HOUSE' MURALS CONSERVATION PROJECT FIRST SEASON IN 2005

Robert Rogal

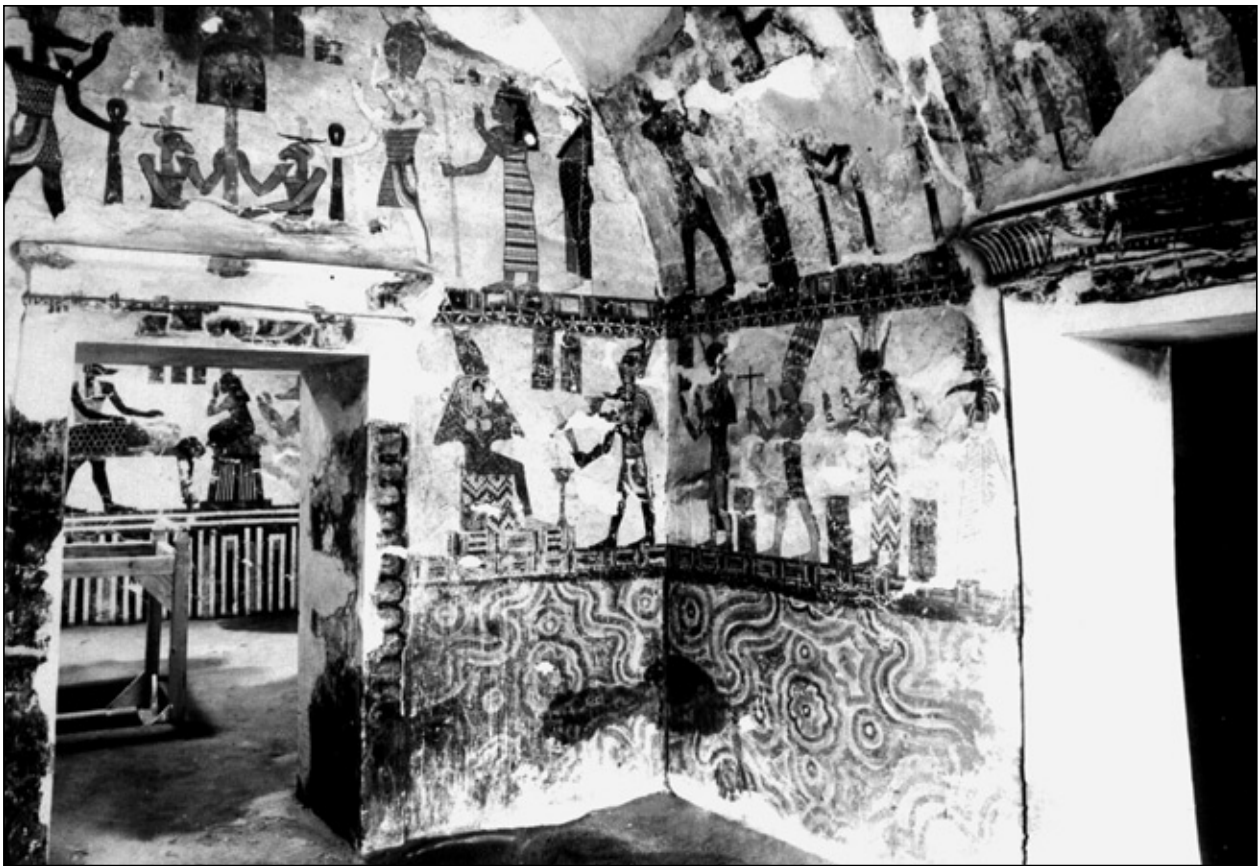
Fig. 1. Interior of Tomb No. 21 (after S. Gabra, *Rapport sur les fouilles d'Hermoupolis Ouest* (Touna el Gebel, Le Caire 1941, Pl. X)

When the tomb was discovered in 1935, its vaults were destroyed. To reconstruct them, the inside of the tomb was filled with sand, the vaults were bricked-up and then the sand was removed.³ Some bricks with traces of color, coming presumably from the original vault, are still in store in one of the rooms of the tomb. Gabra's photographs of the conditions inside the tomb upon discovery reveal the murals inside and the facade plaster to be in very good condition [Fig. 1].

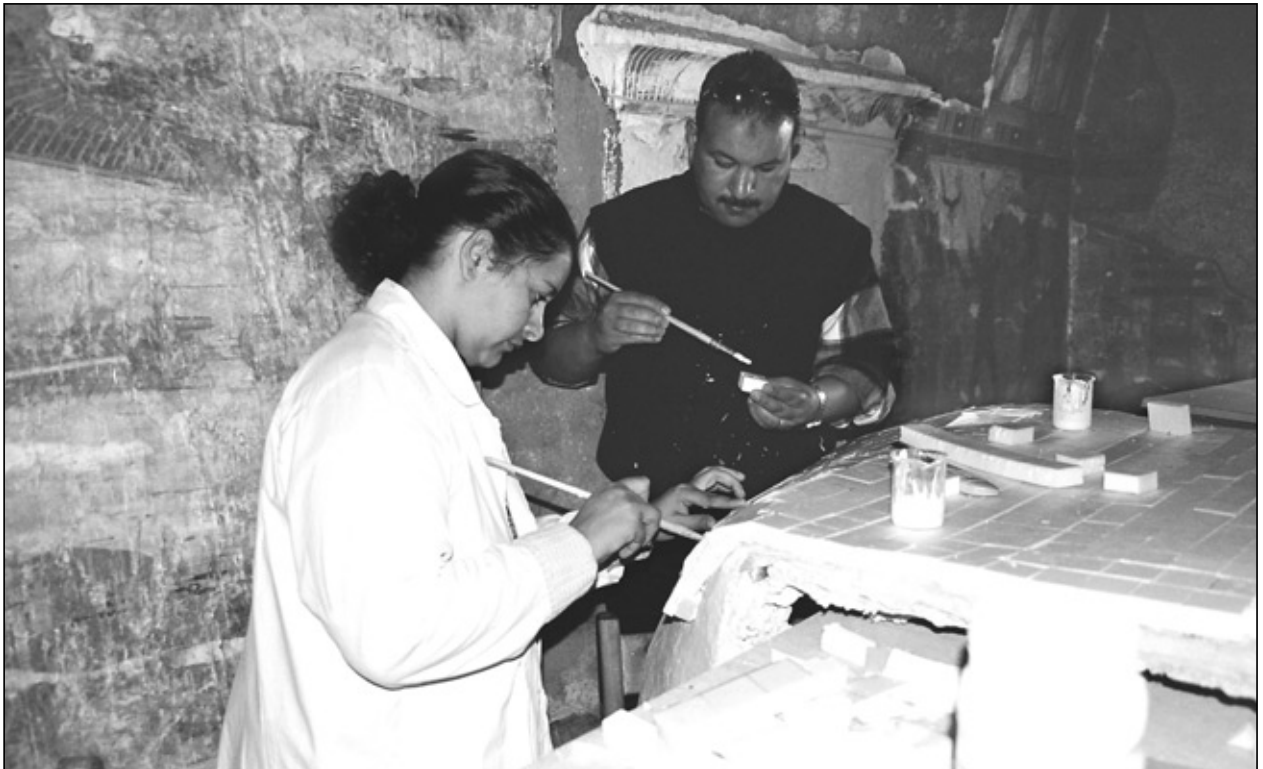
The paintings without supports demanded full conservation treatment [Fig. 2]. Their back was cleaned of residual ancient mud mortar and the excessive mortar and plaster-of-Paris applied in the past to fill in the gaps. The reverses were subsequently consolidated with 3% solution of PARALOID B-72 (Rohm & Haas, USA) in toluene. A polypropylene net was attached as a lining layer, using lime-and-sand mortar with PRIMAL AC-33 (Rohm & Haas, USA). The intervention layer consisted of polystyrene foam (ADREFOAM, product of Advechems, Egypt) attached with a water dispersion of PVA (OKAY, product of Siag Chemicals Co., Egypt). Sandwich-structured supports were built up on the reverses. The cladding was made of 450-grade fiberglass mats reinforced with epoxy resin KEMAPOXY 31/150 (CMB, Egypt). The cores were made of 4 mm FIRET COREMAT XX (Lantor BV, Holland), reinforced with the same resin as the cladding. The applied technology allowed for quick building of supports of complicated shapes and required thickness. Moreover, supports of this kind are resistant to climate and biological factors.⁵

*Fig. 2. Fragment of painting during conservation
(Photo R. Rogal)*

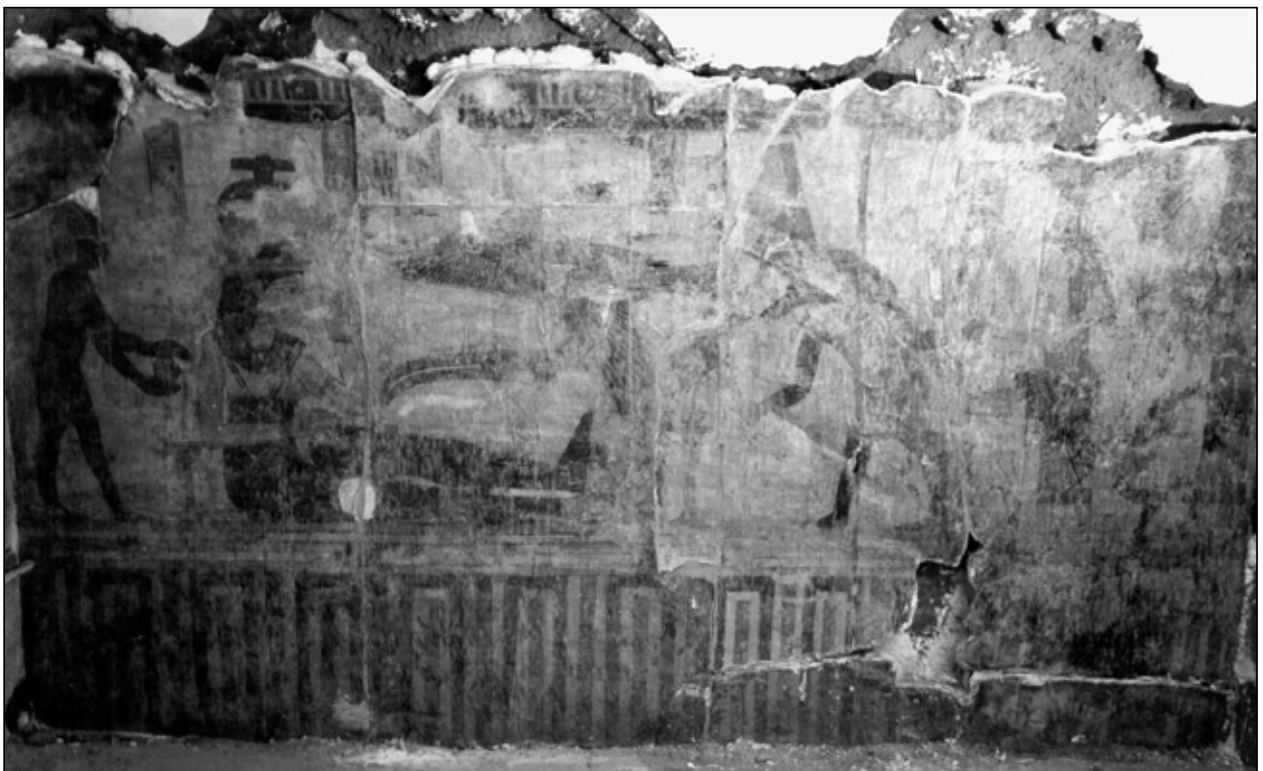
*Fig. 3. West wall of the sanctuary after remounting of the mural paintings. Condition in 2005
before removal of the facing (Photo R. Rogal)*

All the preserved paintings from the sanctuary have now been remounted in their original location [Fig. 3]. To mount paintings attached to supports made of plaster-of-Paris both the plaster and polyurethane foam (FUROFOAM, product of Den Braven Sealants, The Netherlands) were used. Paintings on sandwich-type supports were mounted with screws and foam. The protective facing has been left in

place until the repairs on the vault will be completed. The paintings from the ante-room are in various stages of conservation. Some of them, lying in several layers on the floor in the Beit el-Serir, have to be separated, which is a difficult task, requiring further time-consuming work. Other fragments have reached the stage of the treatment when the intervention layer will be applied.
