OLD DONGOLA

KOM A (ACROPOLIS), 2005

Włodzimierz Godlewski

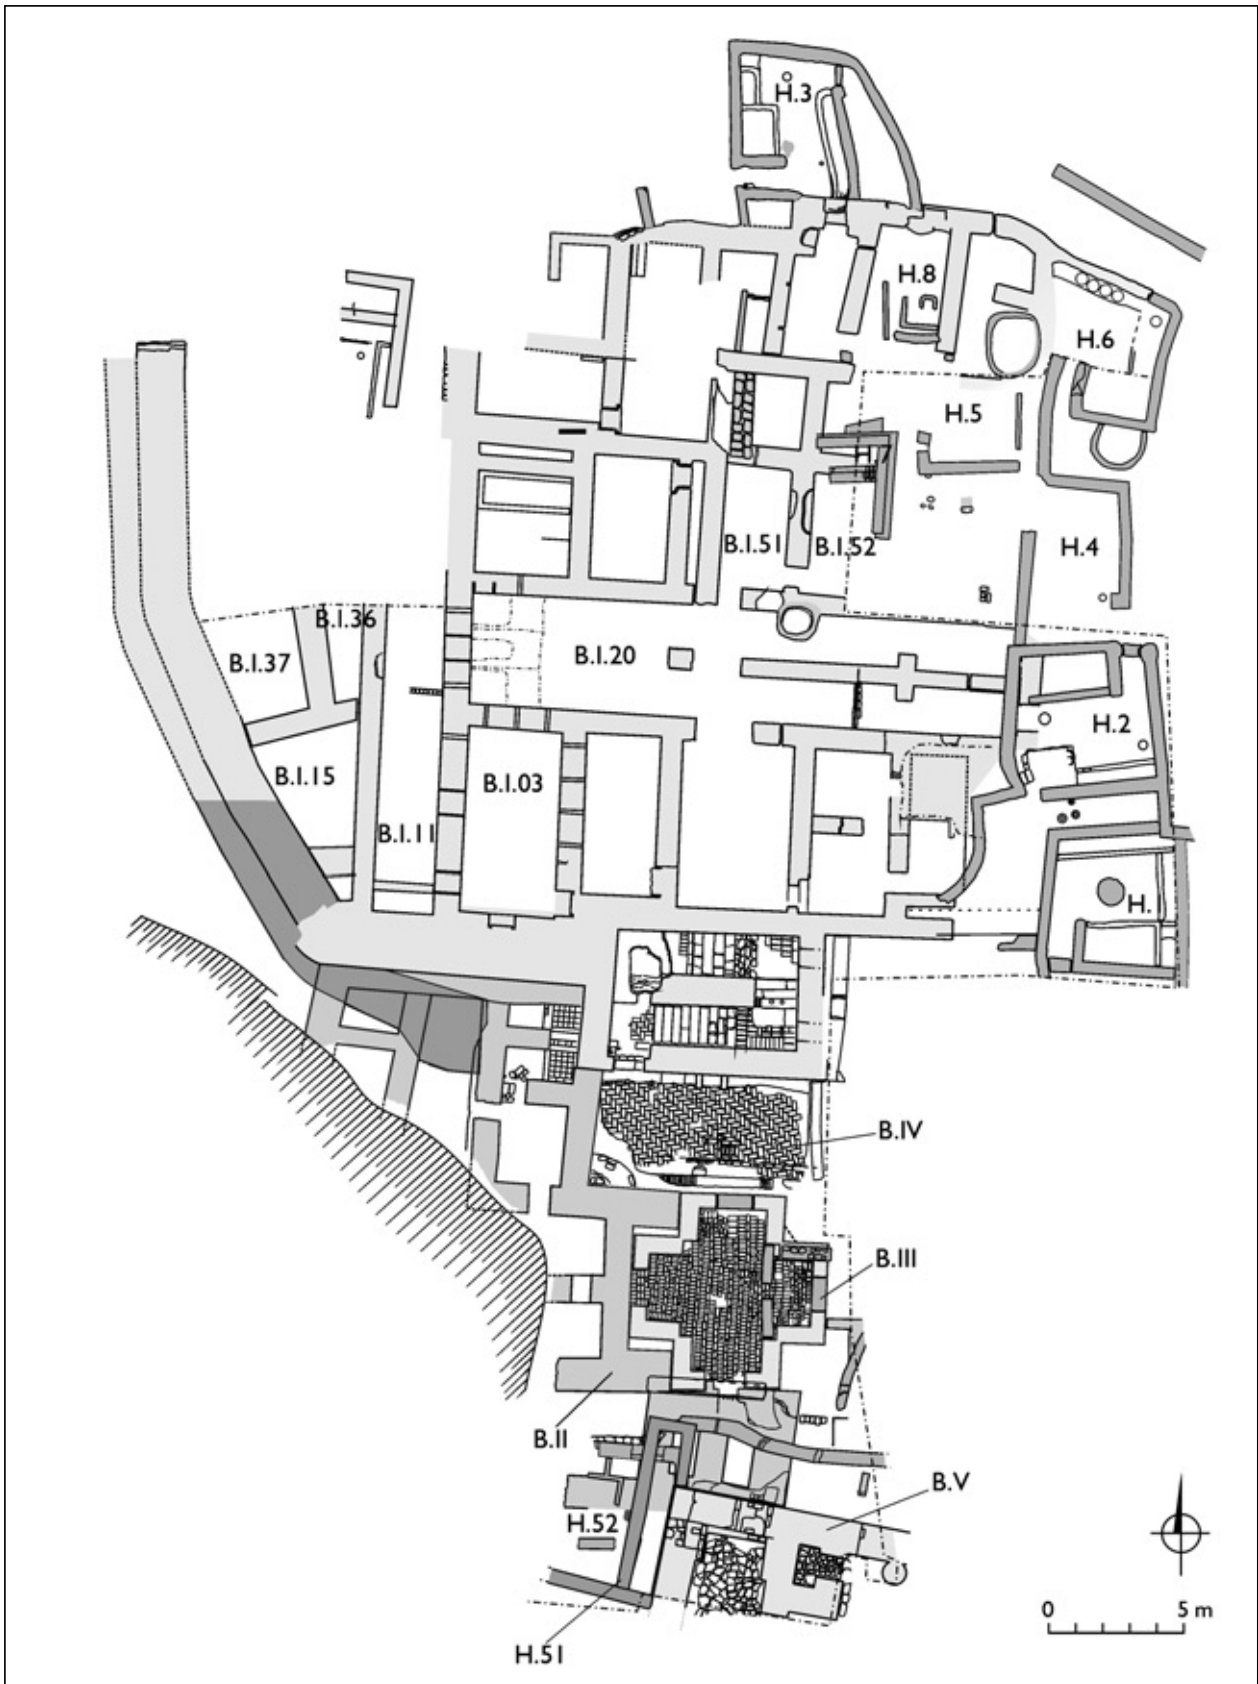
Fig. 1. Plan of buildings uncovered on site SWN on the citadel of Dongola, 2005
(Drawing W. Godlewski, M. Puzkarski, D. Zielińska)

Excavations inside the big palatial structure, which covers at least 1000 m², were concentrated on the central and eastern parts [cf. *Fig. 1*]. Post-Makurian architecture was uncovered and development in this part of the complex examined, revealing alterations of the palace interiors on the first floor made during the last phase of occupation of the building in the 14th century. In the southwestern part of the complex, ground-floor rooms B.I.20, B.I.03, B.I.11 were investigated, as well as B.I.36 and 37 by the inner wall of the fortification, to the north of B.I.15, which contained the depository of a toilet located on the first floor of the palace.

The search for the east outer wall of the building on the town side was encumbered by post-Makurian architecture surviving in this area. Some of the new structures (Houses H.1-H.2 and H.4-H.7) were founded on the rubble fill of the original palace interiors [cf. Fig. 1]. It seems, however, that the walls of the original phase were even better preserved in this part than in the west, where they had disappeared together with the post-Makurian architecture.

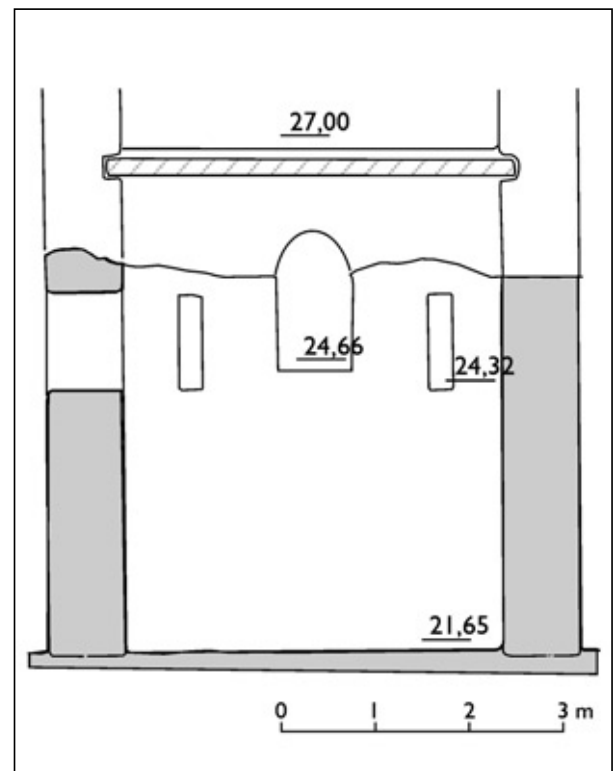
Fig. 2. West wall of room B.I.20 (Drawing W. Godlewski, D. Zielińska)

B.I.20 were furnished with several narrow slit windows (W. 0.11-0.15 m, H. 1.10 m), located high up on the wall (2.60 m above walking level) ensuring air flow between the rooms. Similar slit windows were discovered also in the walls of the corridor on the ground floor of House A.105 in the northwestern part of the citadel.⁵ Both rooms also had big arched windows on the western side, 0.90 m wide and about 2 m high, the sills on the same level as the slit windows; these were blocked as a result of the second-phase alterations in this part of the building [Fig. 2].

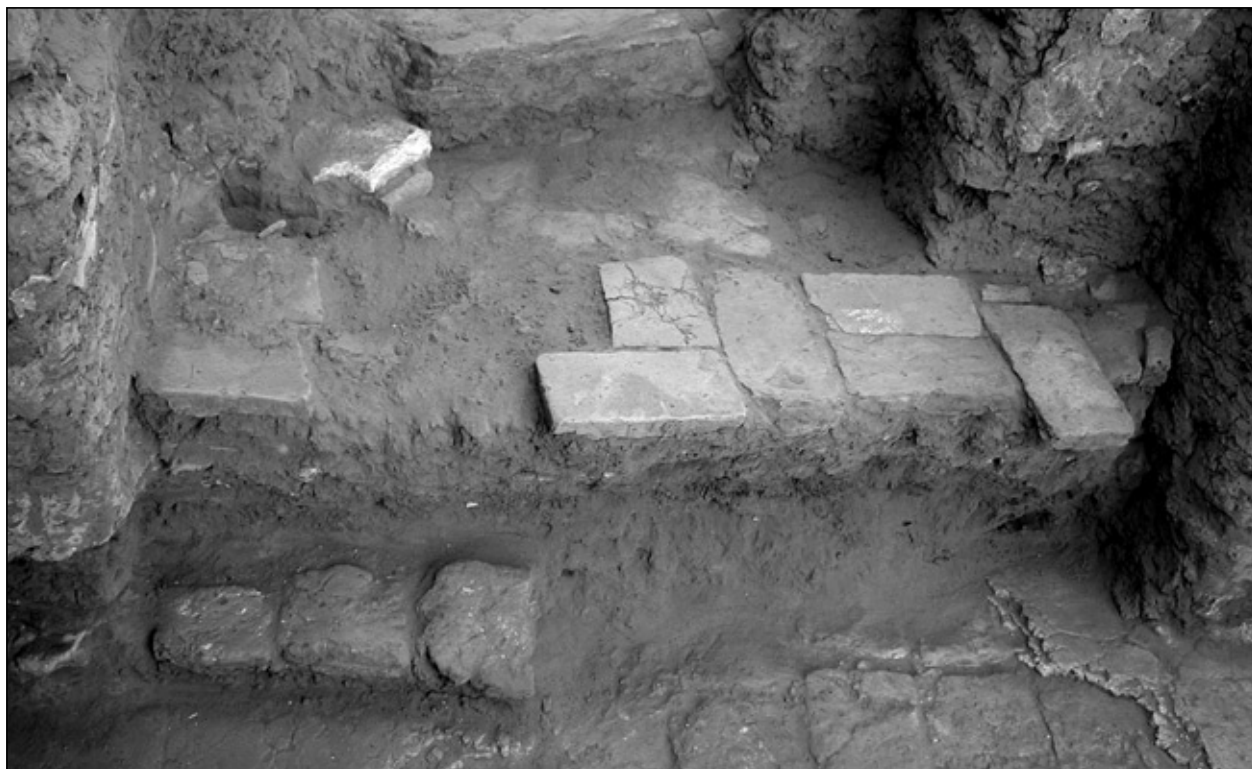
*Fig. 5. South entrance to Building B.III. Threshold beam in the entrance
(Photo W. Godlewski)*

Removal of the floor in the southern entrance revealed a kind of foundation deposit located carefully under the floor. It consisted of a large storage vessel (Add.05.225) standing upright in a pit that cut through the lower floor of B.III and a small cup used as a lamp (Add.05.224), placed inside the neck of the storage pot [Figs 5,6]. The vessel was half-filled with sand, containing also remains of a substance consumed by insects.

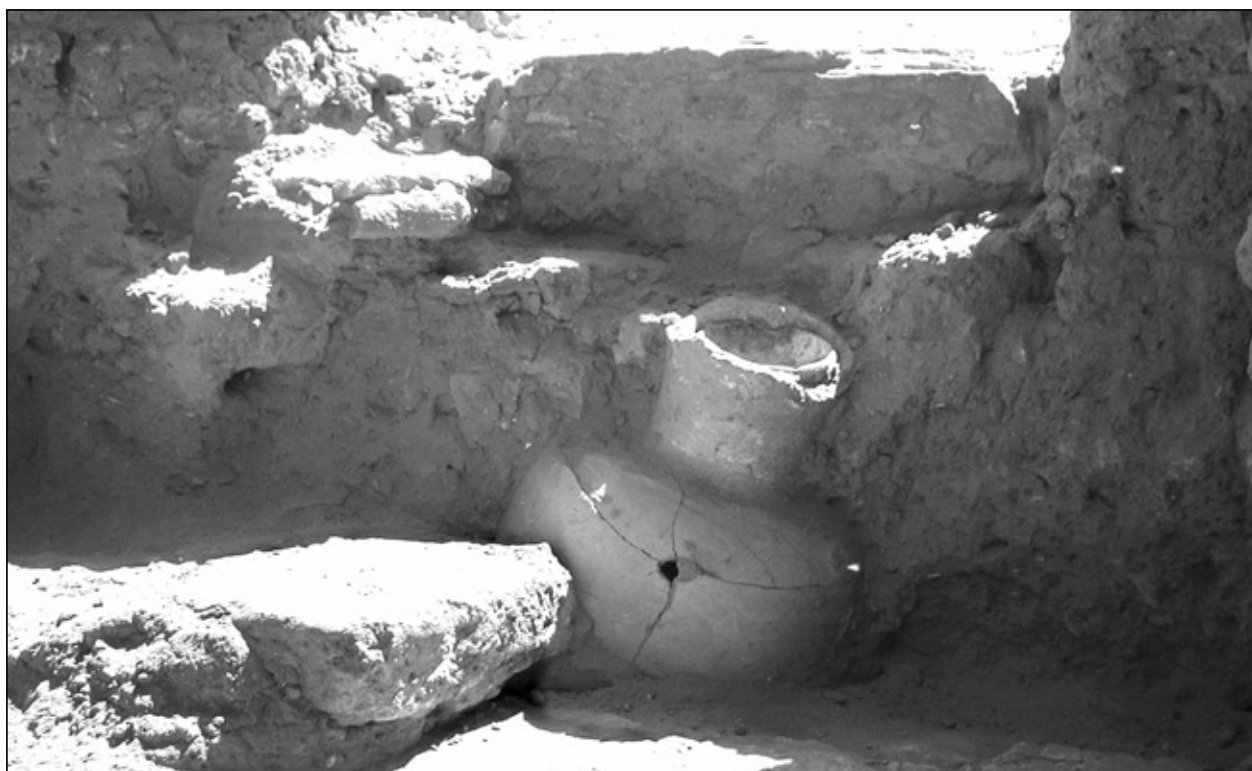
*Fig. 6. South entrance to Building B.III. Ceramic deposit found below the threshold
(Photo W. Godlewski)*

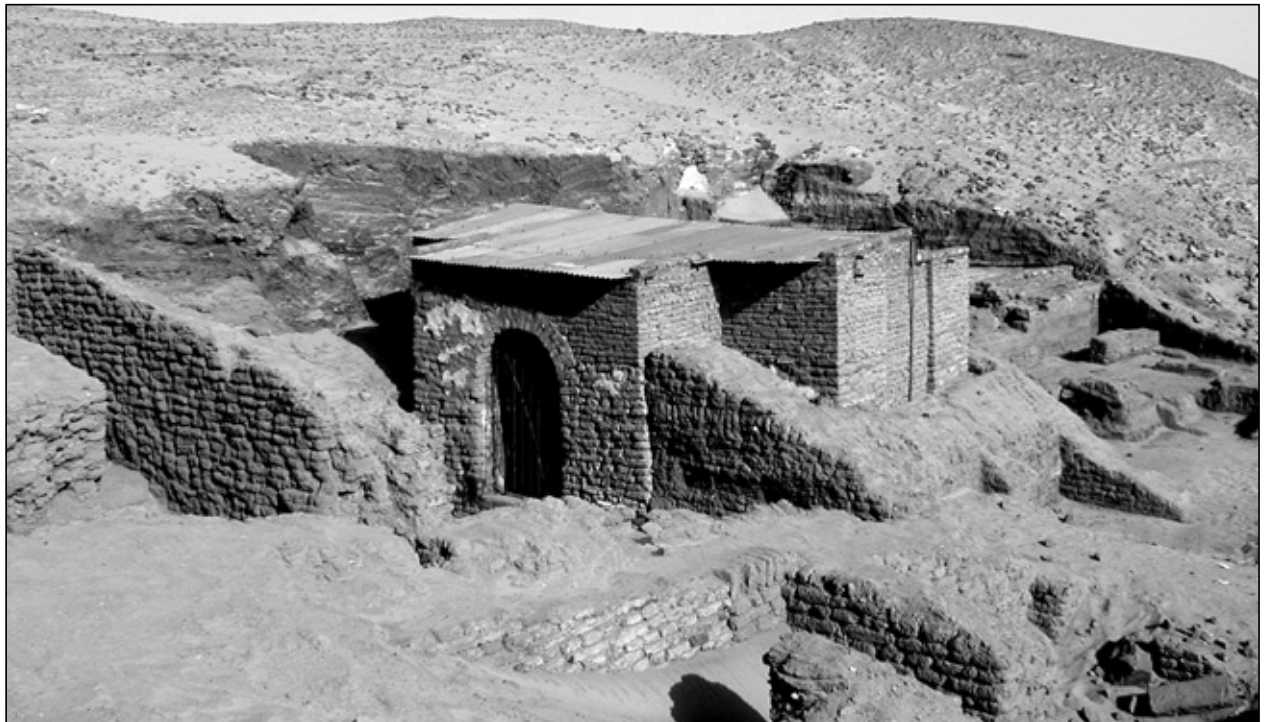
Fig. 7. Building B.III. New shelter roof, view from the northwest
(Photo W. Godlewski)

The conservation effort included repairs on the roof shelter constructed over Building B.III in 2003⁴ and damaged during recent high winds (cf. Fig. 7). Inside Building B.V, the wall tops were protected.

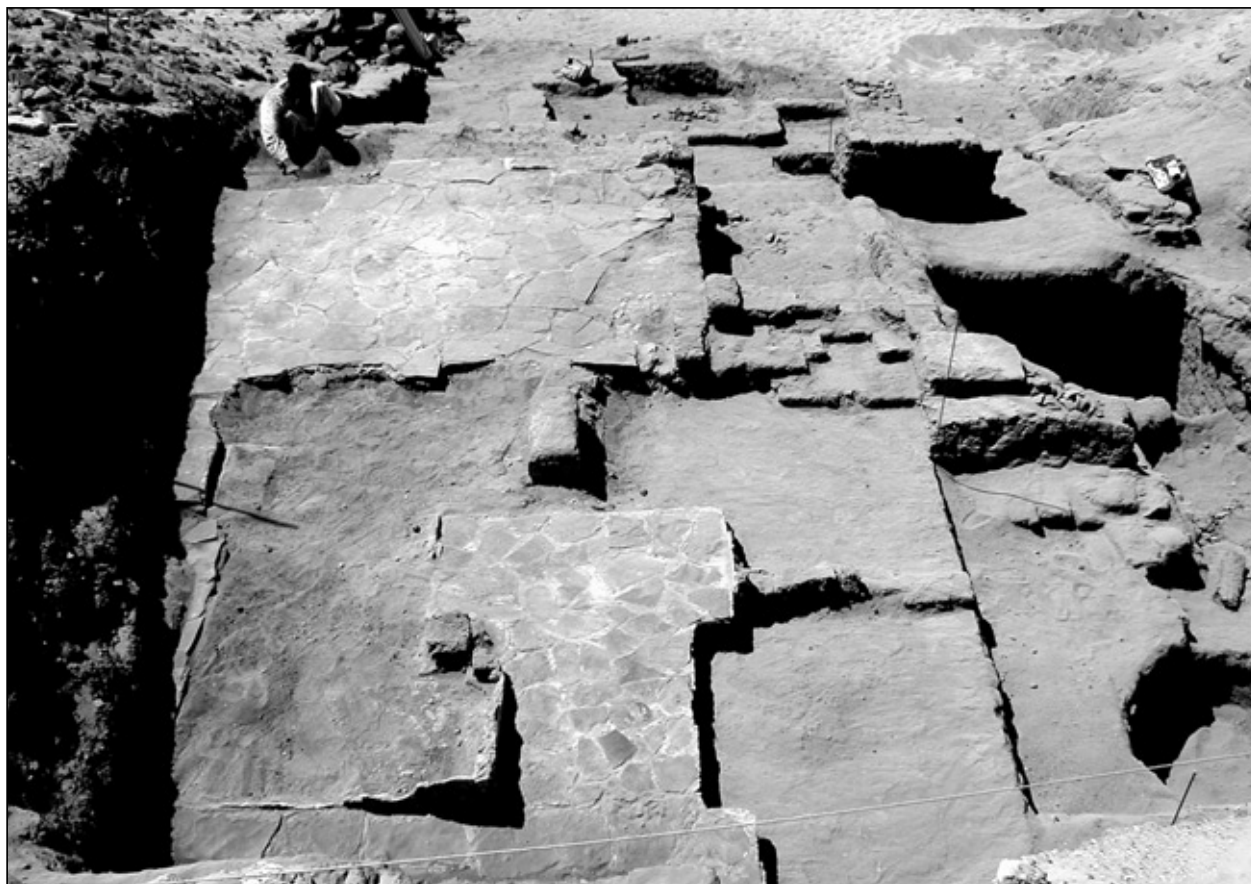
*Fig. 8. Building B.V, northwestern corner, view from above
(Photo W. Godlewski)*

Building B.V was erected just 4.00 m from the southern arm of B.III, on a high platform of undressed blocks of stone from local quarries [Fig. 8]. In the northwestern corner, the platform was all of 2.00 m high, the purpose being presumably to level the ground under the new structure. It was constructed of red brick with outer walls 1.20 m wide and vaults supported on pillars and pilasters built of brick, the latter almost fully circular in section. The stone pavement laid of undressed slabs bonded in lime mortar was found on a level 2.50 m above the pavement of the neighboring cruciform structure (B.III).

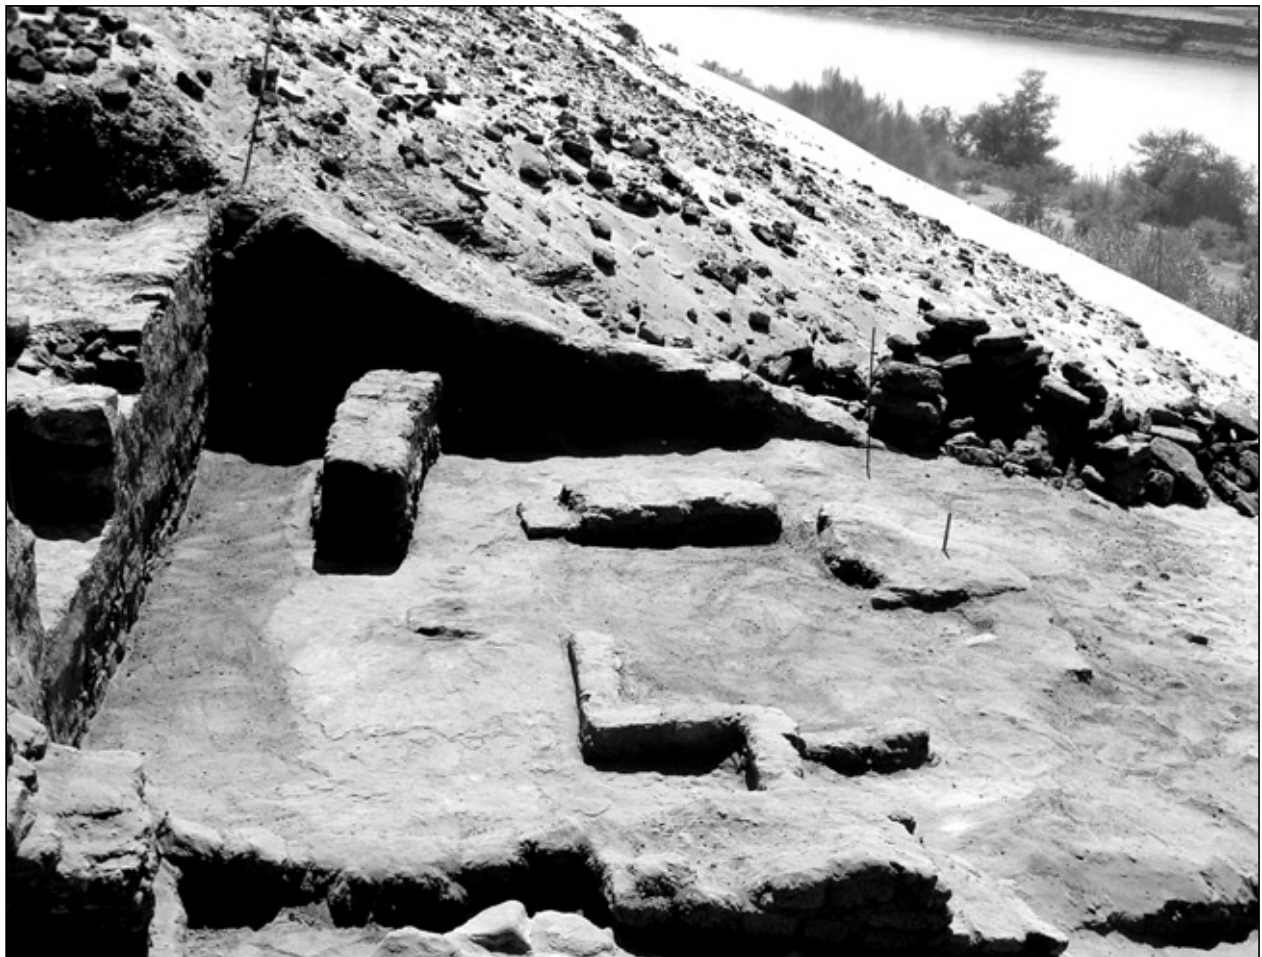
*Fig. 13. House H.52, view from above
(Photo W. Godlewski)*

An earlier house (H.52) was preserved by the western face of the platform under Building B.V. It was erected presumably in the 15th-16th century, above the destroyed walls of Building B.II. The suggested dating is based on the stratigraphy of the architecture established for this spot [*Fig. 13*].
