BANGANARTI

THE 2006 SEASON

Bogdan Żurawski

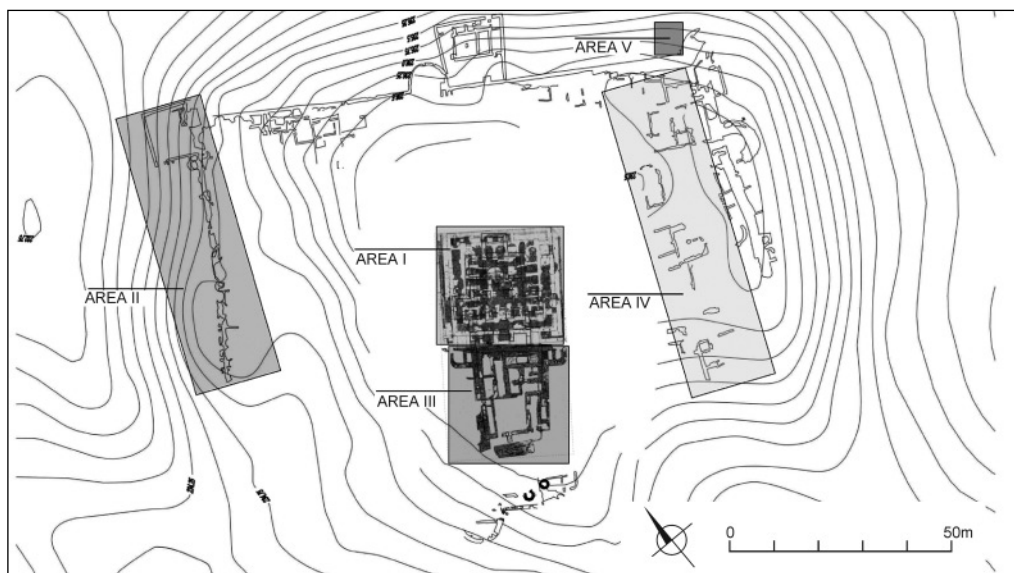
Fig. 1. *Banganarti after the 2006 season, marking location of areas of excavation*
(Drawing R. Łopaciuk)

Excavation and surface clearing proceeded in five main areas [Figs 1, 2]:

– I and III covering the church complex and Western Building, where some additional clearing and documentation work was completed;

– II, following the section of the enclosure wall northwest of the church, from about the middle of its length to the northwestern corner including the corner tower;

– IV, habitation district inside the enclosure wall to the east (clearing the tops of walls for the sake of kite photography and geodetic surveying);

– V, outside the girdle wall, north of the southeastern corner tower (planned as a pottery trench for stratigraphic study)

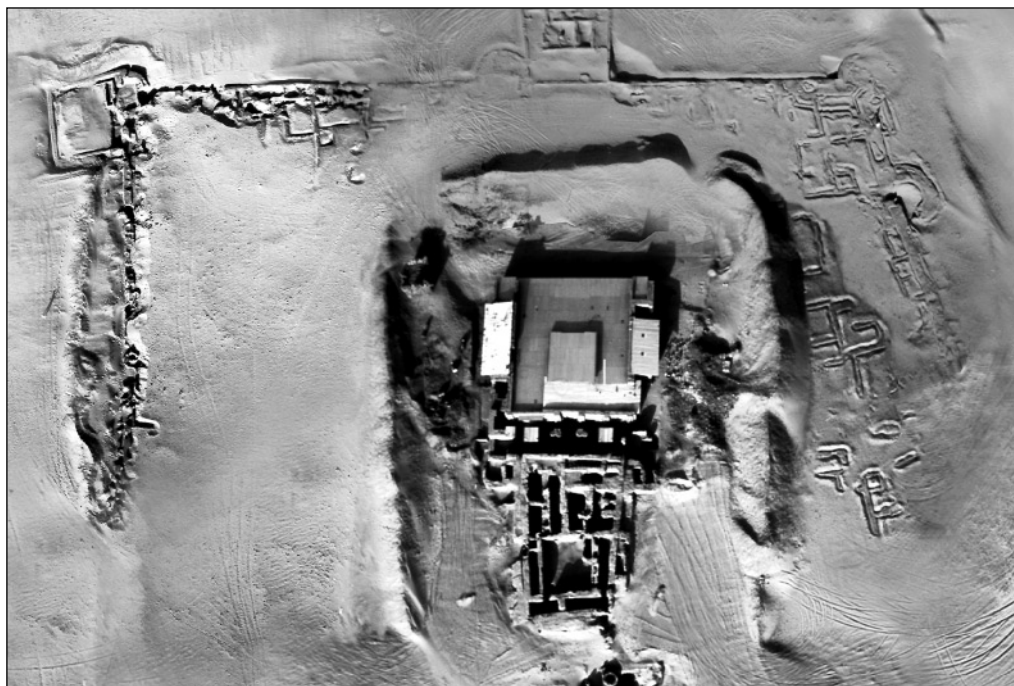
Fig. 2. *Aerial view of Banganarti site after the 2006 season*
(Orthophotomap B. Żurawski)

Low-altitude photographs of the church and the fortifications were taken as part of the aerial (kite) photography program successfully implemented in Banganarti since 1998. Some 500 aerial photographs were digitally assembled to create an orthophotomap of the site [cf. *Fig. 2*].

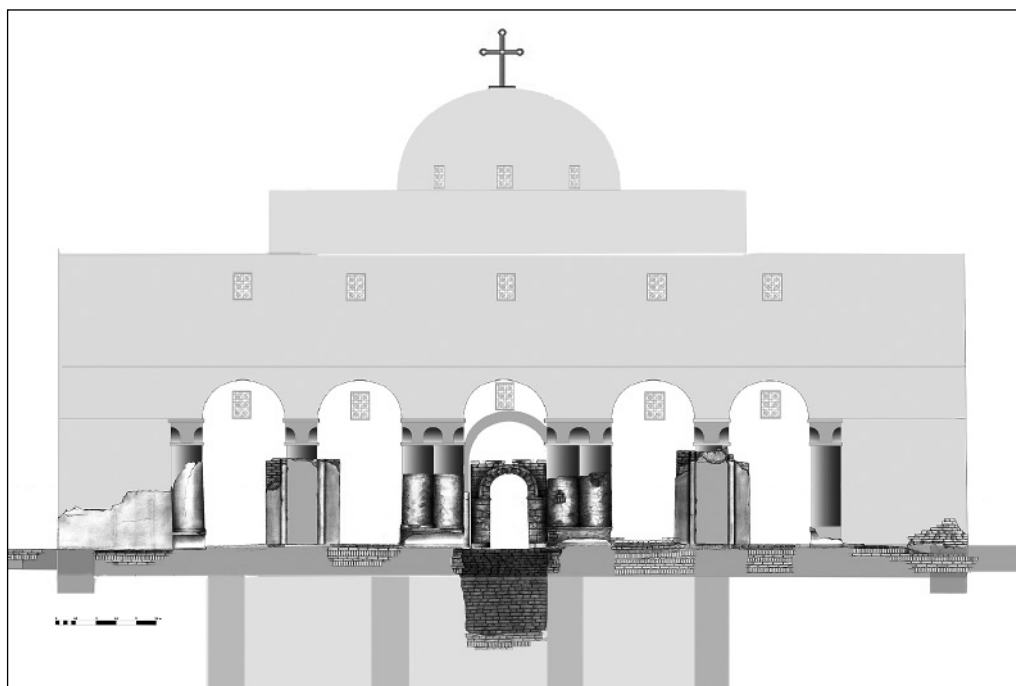
Fig. 3. Reconstruction drawing of the original appearance of the main western façade of the Rhabaelion (=Upper Church) (Interpretation B. Żurawski, drawing M. Momot)

The late blockages between the supports of the Western Portico were pulled down [Fig. 3], exposing two longer Greek inscriptions of a dedicatory nature and an abundance of graffiti, as well as scratched – some not without artistic mastery – representations of animal and human figures. Exceptional among these drawings is a portrait scratched on the southern face of the western portico pillar, executed presumably at some time in the 12th century. It depicts a man in profile, feeling his way with a short, pastoral staff (see Fig. 1 on p. 399 and A. Łajtar's report in this volume). A graffito in Arabic, but written in Greek letters, identifies this figure as Ali, a *def* or guest, meaning visitor to the church.

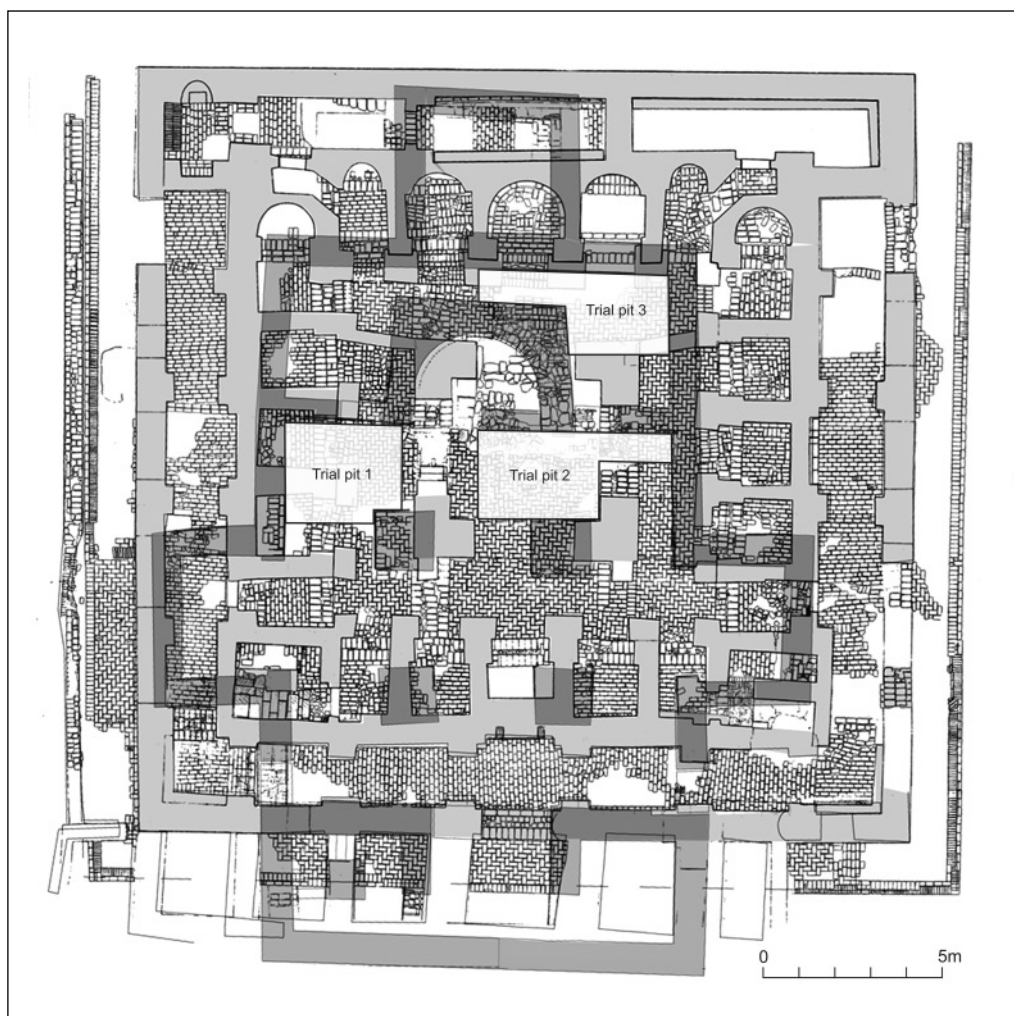
Fig. 4. Outline of the Lower Church marked on a plan of the Upper Church, indicating position of trial pits dug in 2006 (Drawing R. Łopaciuk)

Three trial pits were dug from the ground level of the Upper Church, cutting through the Lower Church deposits down to culturally sterile sand (which has been tested for at least 0.50 m for the sake of

certainty) [Fig. 4] The first was a northward extension of a trial pit dug already in 2004 (Żurawski 2005: 300) in front of the blocked door to the prothesis of the Lower Church. It now exposed the east wall of the northern aisle and part of the north wall to where the northern extension begins. Faint traces of painted decoration (unidentifiable, possibly standing figures?) in yellow ocher,

applied generously on a weak lime/mud plaster ground were detected on the latter wall. The plastering was treated and the test pit walls reinforced with corrugated-iron sheets and piping in order to display a fragment of Nubian history in a natural stratigraphical setting.

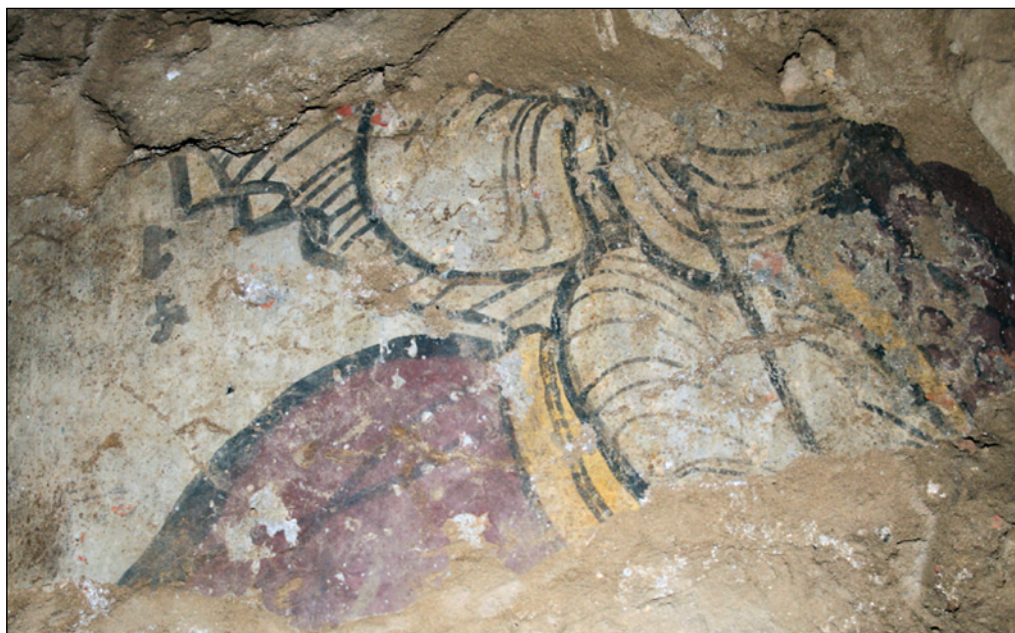
Fig. 5. Holy rider (?) painted on lime plaster on a stone voussoir from a column belonging to the first Lower Church (Photo B. Żurawski)

from the original columns of the LC 1 building. A similar technique (apparently of Meroitic origin as the Ammon temple in Begrawiya might suggest, was encountered also in an early church on Kom E in Dongola, near el-Ghaddar (Żurawski 1995; 1997: 182). The stones turned out to bear murals, some of the earliest ever recorded in Upper Nubia (painted probably shortly after the first of the Banganarti churches was built). The wall paintings were executed on a hard lime mortar background with extensive use of purple, white and yellow [Fig. 5]. An examination of a dozen or so painted voussoirs identified equestrian saints and archangels among the subjects.

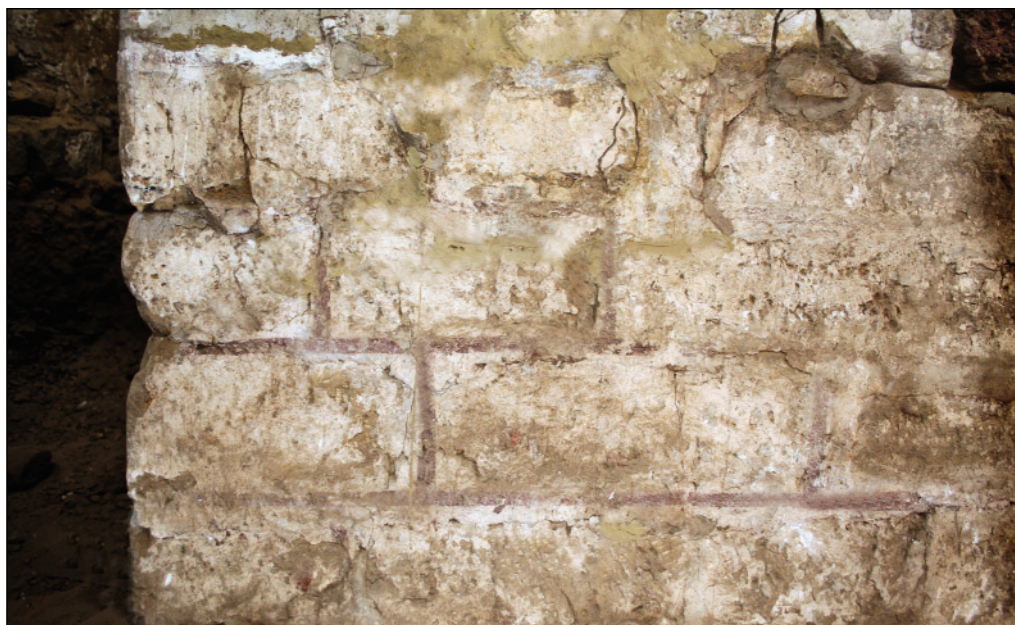
Fig. 6. Imitation ashlar masonry painted on the east wall of the south aisle of the Lower Church (Photo B. Żurawski)

Traces of a mural were also discovered on the east wall of the southern aisle, to the right of the apse and left of a door leading to the southern sacristy (*diakonikon*) in the Lower Church. It was an illusionary rendering of ashlar masonry in purple paint, applied on a lime-plastered stone wall [Fig. 6].

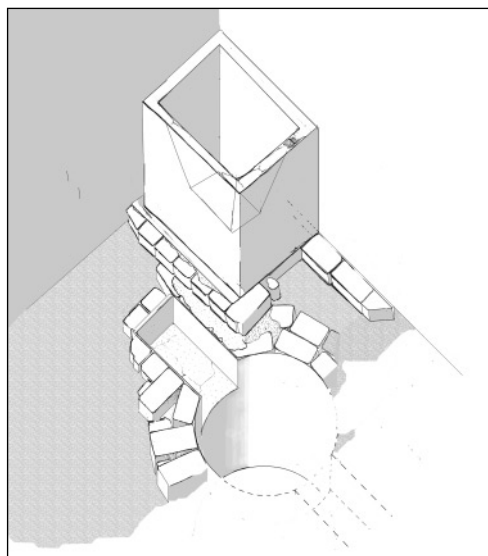
Fig. 7. Axonometric view of the two baptismal fonts (Drawing B. Żurawski)

The last trial pit dug inside the southern sacristy and in the passage behind the apse of the Lower Church exposed a baptistery [Fig. 7]. The lower one of the two masonry basins, a typical Nubian “keyhole” font provided with two approaches stepping down into the basin from east and west, was found with no base at all. Baptism must have been accomplished by aspersion rather than immersion and the baptismal water poured over neophytes standing on a layer of pure sand was inevitably soaked into it. This tank was in use when the Lower Church was still covered with a flat wooden roof supported on the four stone columns described above. A baptismal basin of red brick bonded and plastered with a hydraulic lime mortar was built on the original floor in the corner of the earlier baptistery [Fig. 8]. The lower tank may have still been used at this time.

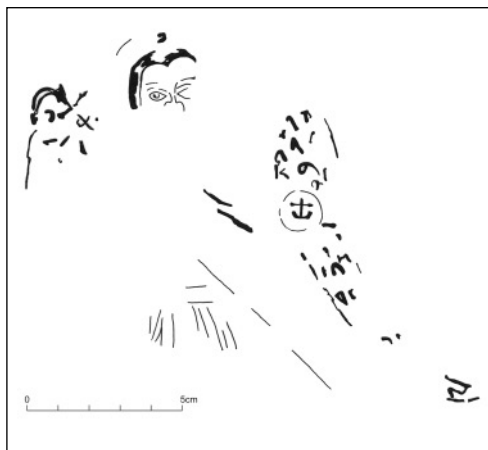
Fig. 9. *Miniature painting of an archangel* (Drawing B. Żurawski, W. Chmiel & A. Rak)

The baptistery was lavishly decorated with murals representing elongated, static saintly figures wearing slender pointed boots similar to the earliest portraits from the Faras cathedral and the Bawit chapels. As a point of interest, the smallest representation – a figure of an archangel [cf. Fig. 9] – was found on the southern wall of the baptistery. Simultaneously, the figures (of apostles?) on the east wall, reconstructed as at least 2.50 m high, belong among the biggest discovered so far in the church.

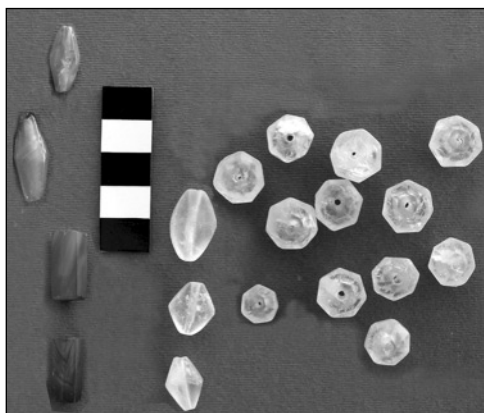
Fig. 10. *Carnelian and rock crystal beads from a necklace, 11th/12th century context* (Photo B. Żurawski)

A necklace of carnelian and rock crystal beads [Fig. 10, see also Fig. 3 on p. 406] was discovered west of the tower, already outside the enclosure wall.² It was found next to a cooking pot with damaged bottom, a stone basin and a fragmented ceramic toilet seat, in context with broken kitchen pottery dated to the 11th/12th century.

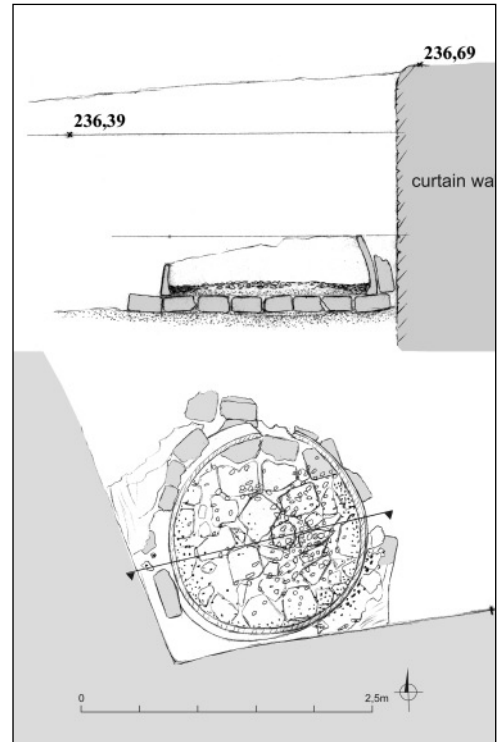
Fig. 11. Plan and section looking south through a bread oven found in Area V (Drawing M. Momot and B. Żurawski)

Digging in the 'pocket' outside the enclosure wall, just west of the southeastern corner tower, was expected to provide a pottery sequence covering a period from the 8th to the 11th century. The medieval practice of dumping kitchen waste, ceramics included, outside the fortifications had already been tested as an informative source on ceramic stratigraphy and site chronology in earlier trenches of the kind dug in 2003 and 2005 (Żurawski 2007: 307-309). The discovery of a bread oven [*Fig. 11*] with contents intact, including grains, charcoal and kitchen wastes interrupted the work until flotation could be done.

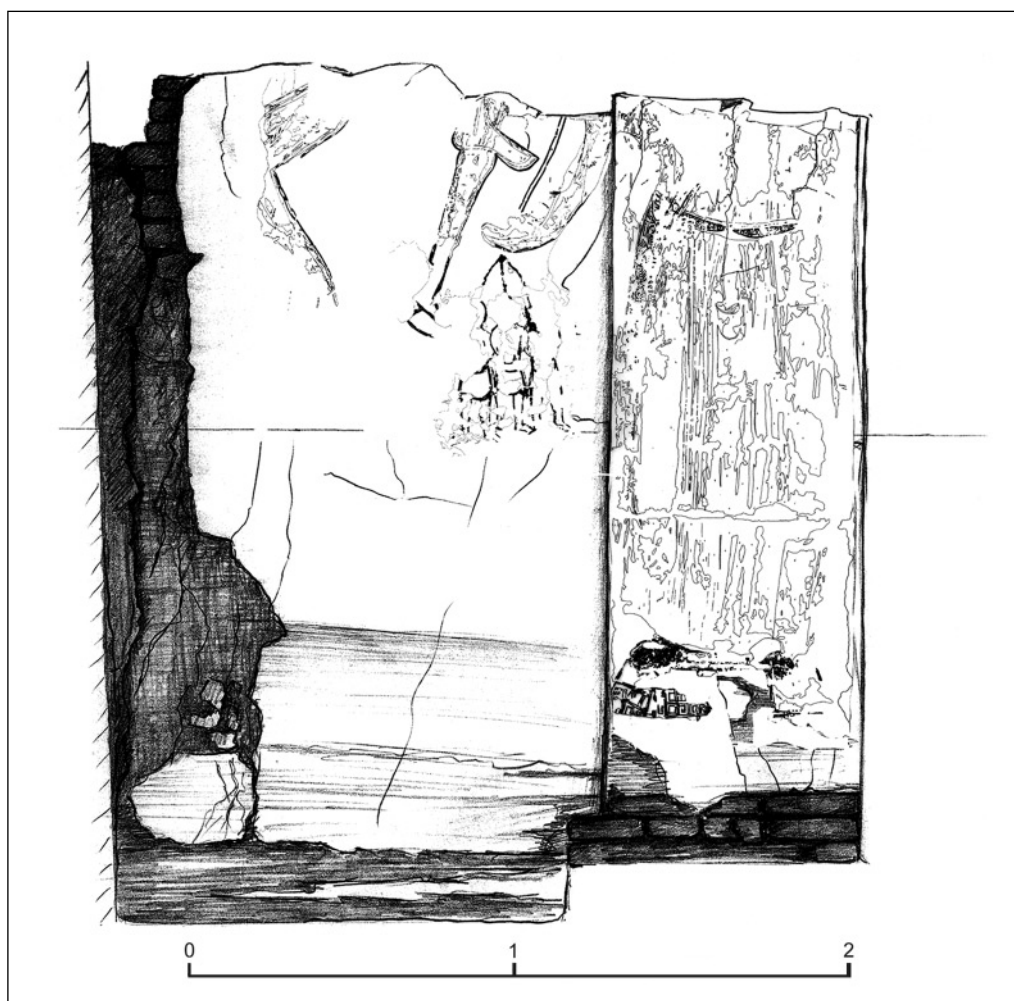
Fig. 12. Three captives led on a rope by a horseman, next to a standing figure of a saint (?) on the west wall of Room 20 of the Upper Church (Drawing M. Momot & B. Żurawski)

Iconologists continued their study of the murals, including documentation of newly uncovered examples, e.g. the mural in Room 20 [*Fig. 12*]. The same was done for the inscriptions, the epigraphic 'revisiting' resulting in the uncovering of
