THE TEMPLE OF TUTHMOSIS III

SEASON 2000

Joanna Aksamit, Rafał Czermer

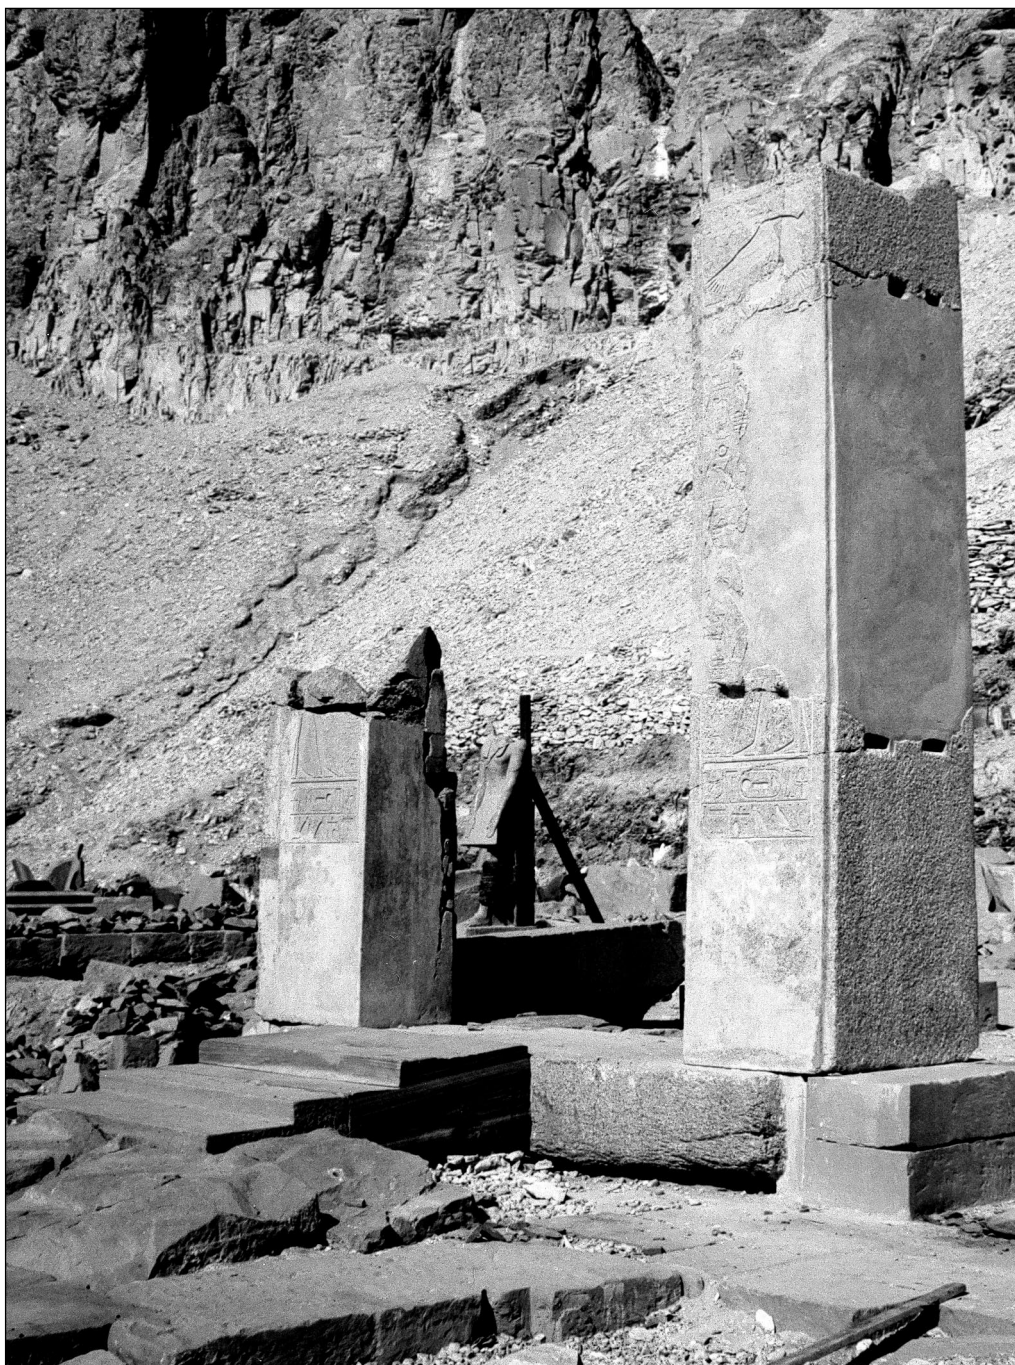
The most important task of the season was completing the restoration of the northern jamb of the granite doorway leading once from the Hypostyle Hall to the Bark Shrine (*Fig. 2*).²⁾ The reconstruction (comprising all loose pieces coming from the excavations in the 1960s) and re-erection of the jamb were carried out in 1996.³⁾ The jamb is 3.9 m high, 0.80 m wide and 0.95 m deep. Originally, it leaned 0°13'26" southwards and 2°6' westwards. The westward inclination has increased slightly since antiquity and now is 2°58'48"; it was decided nevertheless to leave the jamb in the present position, as the inclination does not affect its stability. Due to a shortage of time in 1996, the jamb had to be left unfinished and its bare

reinforced-concrete core remained visible where no original granite surface had been preserved. In 2000 the gaps between the original surface and the core were filled in with limestone chips bound together with white cement mortar. The filler was then covered with plaster tinted with crushed sandstone. The color thus obtained resembles that of the ancient plaster restoration visible in the lower part of the jamb's northeastern edge.⁴⁾ The reconstructed jamb illustrates very well the original dimensions of the whole doorway. The upper part of the southern jamb (unfortunately, almost devoid of decoration, which was hacked away already in antiquity, during the demolition of the temple), preserved as a two-ton block of

*Fig. 2. The Granite Doorway. State in April 2000
(Photo J. Aksamit)*

granite (1.96 m high, 1.0 m wide and 0.82 m deep), awaits re-erection; the complete documentation necessary to carry out this project has already been prepared.

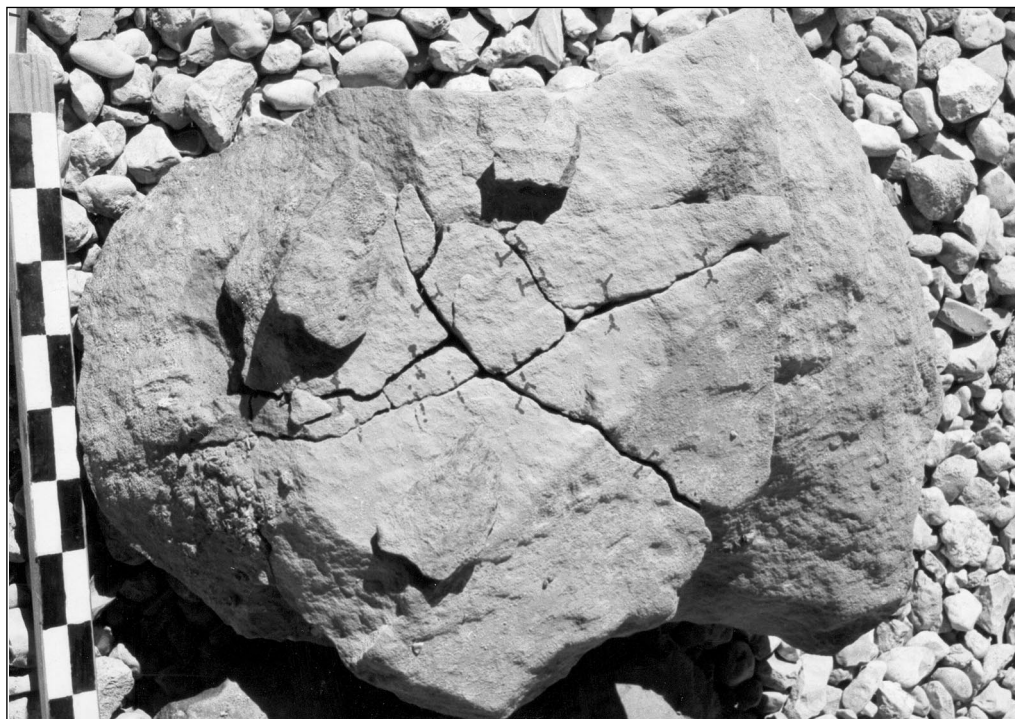
Two large pieces (each of them measuring c. 0.55 x 0.9 x 1.25 m) and several smaller fragments of sandstone remained of base D-2. Base E-2 originally consisted of two sandstone blocks, but only one of them –

the southern, bigger one (0.4 x 1.2 x 1.5 m) – had remained in place. After a detailed survey of the state of preservation of the bases the broken or leaning pieces were cleaned and the ones that were the most

*Fig. 3. Fragment of base D-2, before conservation
(Photo J. Aksamit)*

damaged were temporarily dismantled and consolidated with ethyl silicate (*Fig. 3*). Underneath both bases new foundations were made in the form of c. 10-cm thick reinforced-concrete slabs. Each slab was placed on a layer of gravel. In the next step the loose elements of the bases were put back in their original position. Where necessary they were glued together with epoxy resin (Araldite) or simply built up with mortar based on white cement. The gaps were then filled with small pieces of stone bound together with mortar of lime

and white cement, and the surface of the fillings was covered with colored mortar. The missing parts of base D-2 were reconstructed out of new sandstone blocks (0.55 x 0.35 x 0.7 m and 0.55 x 0.6 x 0.55 m). A place was left on the new foundation slab of base E-2 for the future reconstruction of its missing part. The inscribed sandstone drum of a column, which was put on top of column B-2 and temporarily supported with wooden pegs in 1993, was now fixed in place with stone and mortar.
