OLD DONGOLA

KOM A (ACROPOLIS), 2003

Włodzimierz Godlewski

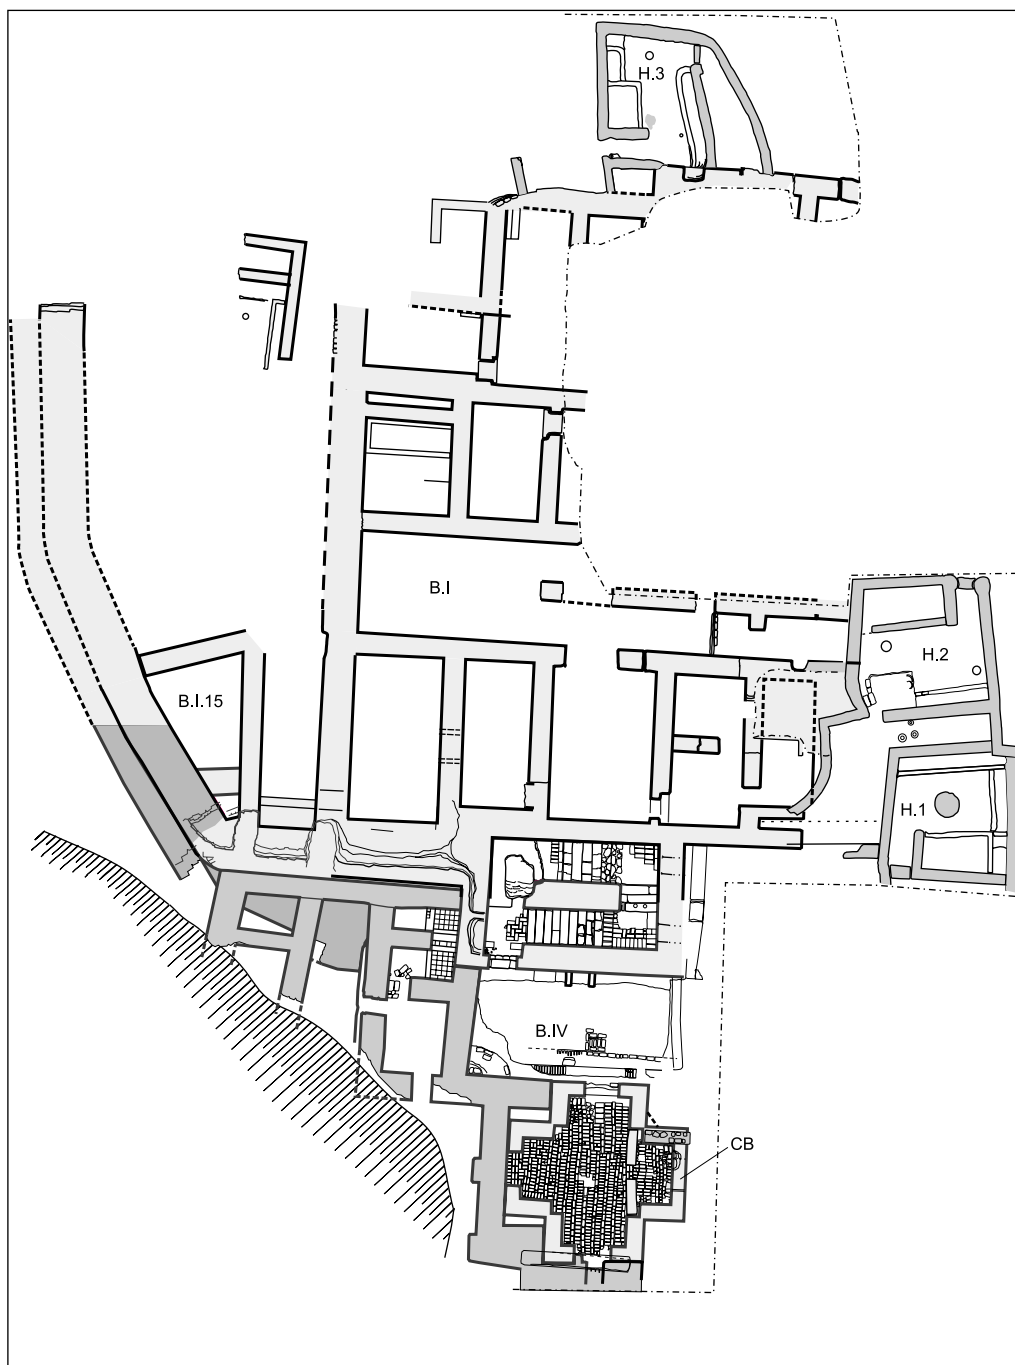
Fig. 1. Citadel. Site SWN, plan after the 2003 field season
(Drawing W. Godlewski, M. Puzkarski, D. Zielińska)

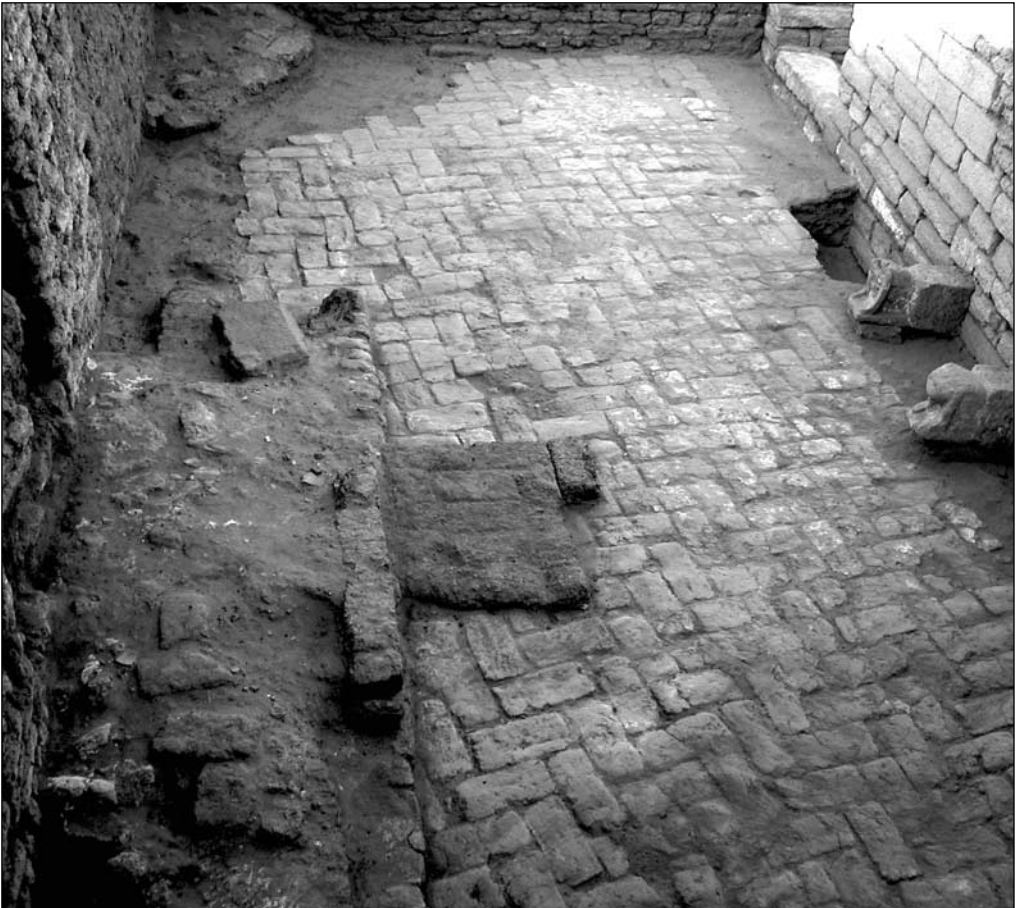
Fig. 2. Citadel. Site SWN, Building IV, surviving brick pavement (Photo W. Godlewski)

The remains of the southwestern corner of this structure, dismantled down to the floors, were found between the Palace (B.I) and Cruciform Building (B.III.1). Both the later structures were founded on bedrock, disturbing in the process the pavement and south wall of Building IV (*Fig. 2*). A section of the pavement of this earlier

more than 4.50 m. The southern face of this wall, which had an overall thickness of c. 70 cm, was damaged presumably during the building of B.III. The paving of B.IV consisted of baked bricks, 32.5 x 15.5 x 7.5 cm, set headers on edge on a regular bedding that looked as if it were a woven mat. The floor was cleared over a distance of over 7 m, the wall obviously taking its course to the east, under an artificial embankment; at the western end it was destroyed by the riverside defenses of the

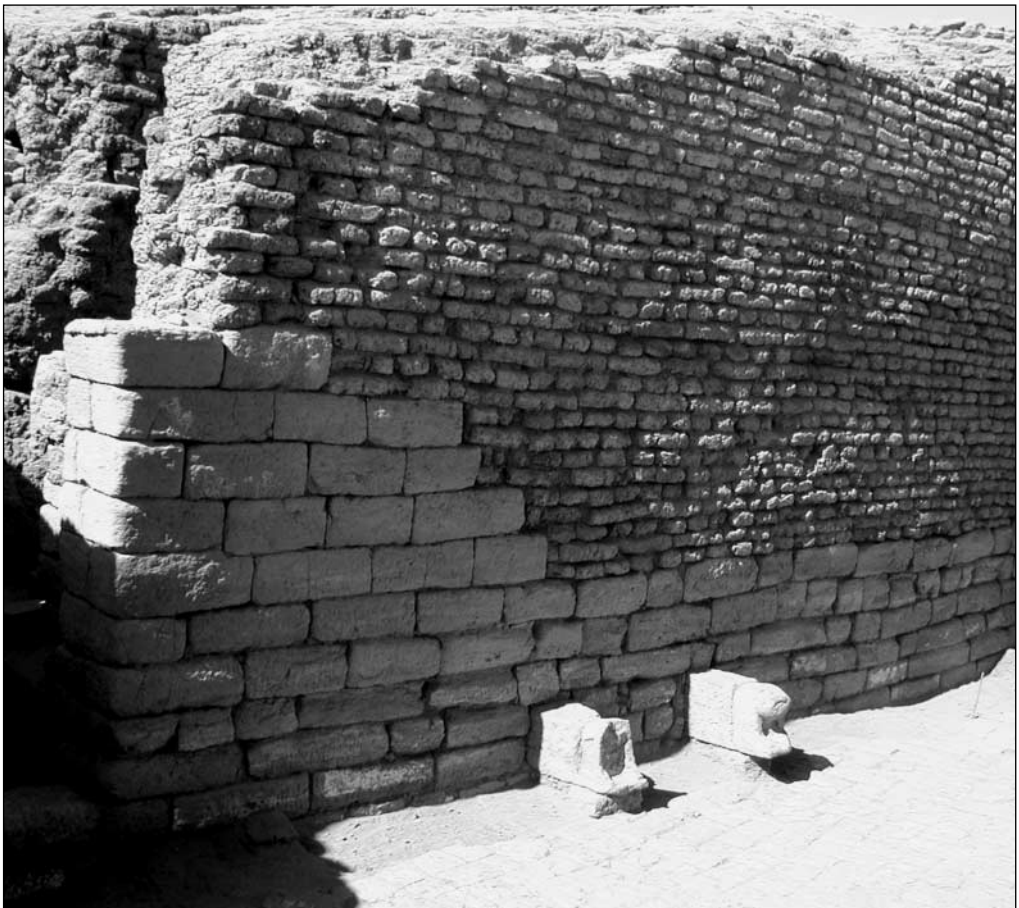
Fig. 3. Site SWN. Building B.I, south wall (staircase façade)
(Photo W. Godlewski)

facilitating communication between the floors. The southern staircase facade has now been cleared in its entirety (section 8.75 m long) down to the foundations. The bottom parts of the walls were constructed of gray sandstone (*Fig. 3*). The stone wall is 1.15 m high overall, except for the section by the southern entrance in the southwestern corner, where it is even with the door jambs supporting a stone arch of voussoirs above the doorway.⁵⁾ To the east of the entrance two stone blocks decorated with lion protomas projected from the stone base of the wall. The top back part of these stone blocks was squared and presumably served to support a horizontal

stone ledge. The structure appears to have been some kind of bench. The upper sections of the south facade were erected of baked brick on the outside and mud brick on the inside, forming a uniform construction. Windows lighting up the staircase were pierced only through the east wall.

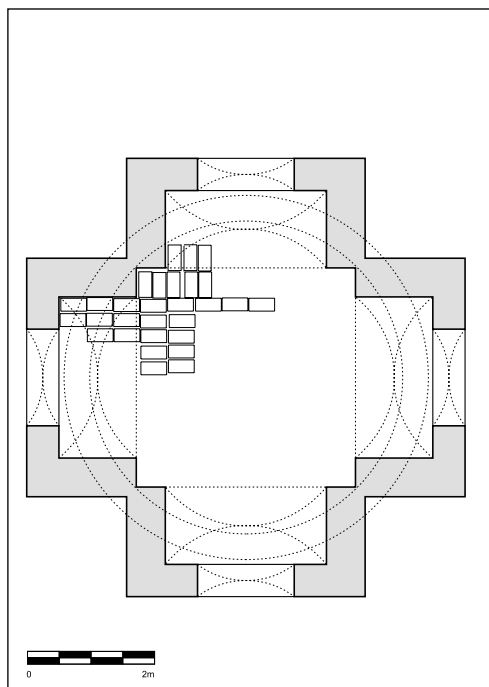
Fig. 7. *Cruciform Building (B.III.1), plan (north is at the top)*
(Drawing W. Godlewski, D. Zielińska)

The outer dimensions of the building were 6.80 x 6.80 m (*Fig. 7*). Inside, the square central space measured 3.30 x 3.30 m. The four arcades opening of this center-square were each 1.20 m deep and 3.35 m wide. The entrances in the end walls of each of the four arms also had an

The original paving, obscured by a later cement floor, was cleared in the western and northern arms of the structure and partly in the center (cf. *Fig. 7*). It consisted of bricks (33.0 x 16.0 and 36.0 x 17.0 cm, thickness as yet unknown) laid flat in a regular arrangement. From what can be said after fieldwork in 2003, the bricks in the northern arm were arranged longitudinally, that is, parallel to the lateral walls. The southern arm presumably mirrored this arrangement. In the center and in the western arm, the bricks ran parallel to the side walls in this arm, that is, following an E-W orientation. This was presumably

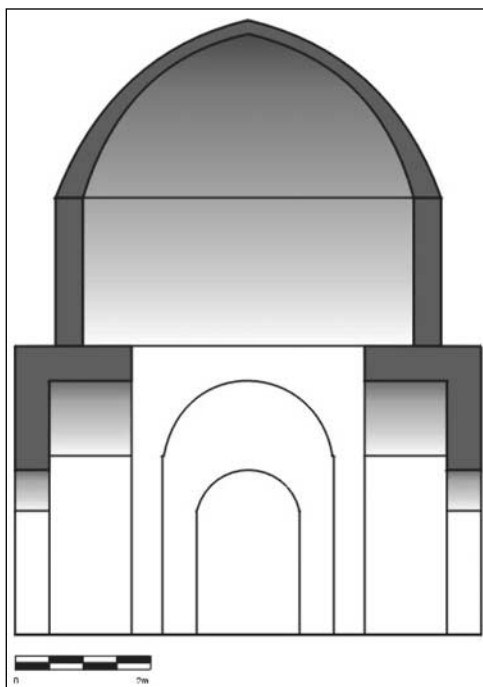
Fig. 8. *Reconstruction of the Cruciform Building (B.III.1)*
(Rendering D. Zielińska)

the vaults and the stone pendentive described above, a reconstruction of the building has been attempted (*Fig. 8*). This small cruciform structure obviously had projecting vaulted arms and a central dome supported on a drum. The assumed total height of the structure was c. 9.20 m.

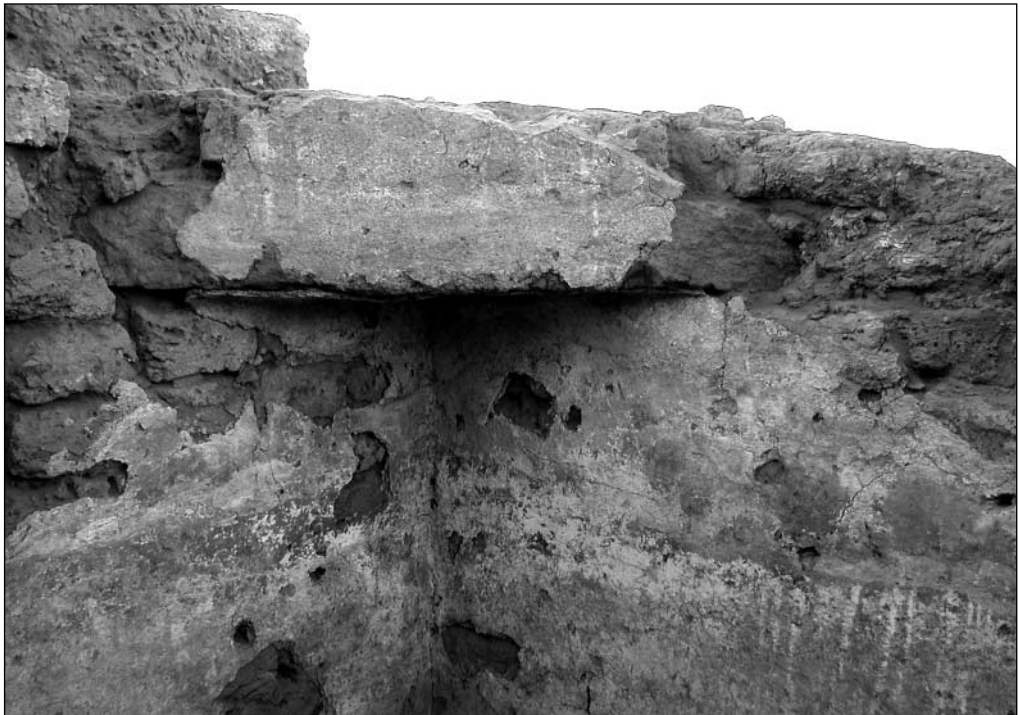
Fig. 9. Cruciform Building (B.III.1). Pendentive of the dome in the outer northeastern corner of the structure (Photo W. Godlewski)

In the outer northeastern corner, where the northern and eastern arms meet, a block of sandstone was preserved, 14 cm thick and c. 30 cm wide, squared and laid along the diagonal of the two joining walls, 3.34 m above the foundation level. It was structurally one with both walls and plastered on the outside like the entire structure. It must have been a kind of external pendentive under the circular drum of the dome (*Fig. 9*).

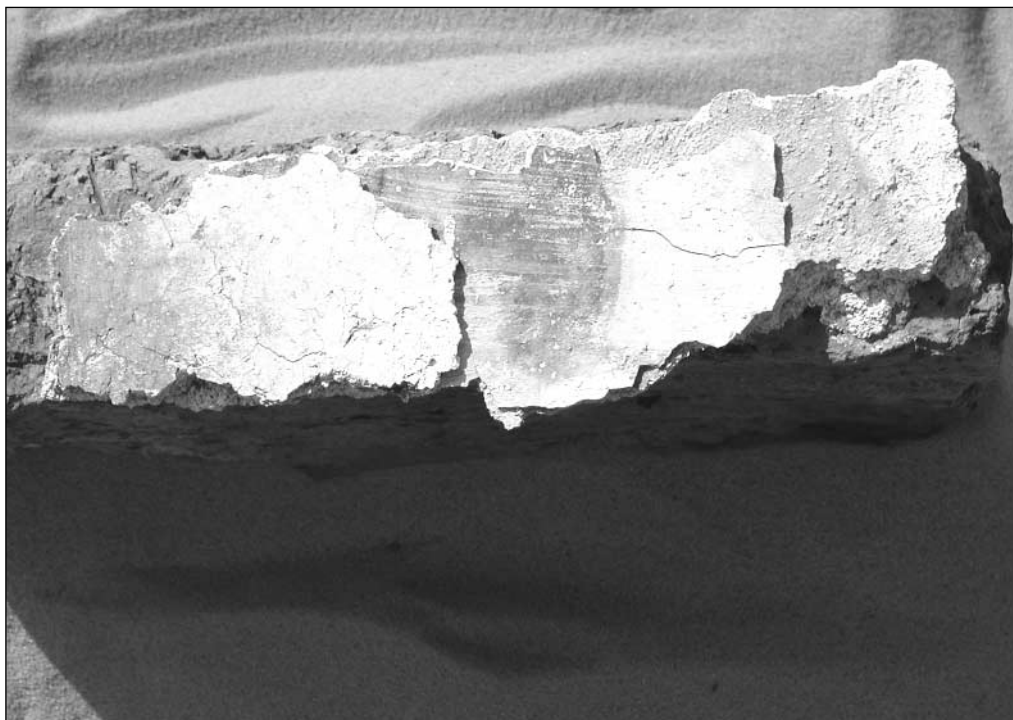
Fig. 10. Three layers of limestone plaster with painted decoration, from the interior of the Cruciform Building (B.III.1) (Photo W. Godlewski)

On the inside walls, three successive coats of lime plaster were noted, corresponding to successive renovations of the interior (*Fig. 10*). Evidence of renovations has been preserved in the bottom parts of the walls, just above the original pavement and below the level of the late floor. It is not clear whether successive coats of plaster covered the entire interior or only the bottom parts of walls that were most exposed to damages in an open interior. The second coat of plaster was especially fine and very smooth. The entire interior was decorated with wall paintings, executed obviously by master painters in the tempera technique. On the vault of the eastern arm of the building, the first coat of plaster preserved a representation of Nubian warriors standing in a heavenly meadow.⁹⁾ The bottom parts of the walls presumably had decoration imitating marble revetment and stuccowork emphasizing the tectonics of the interior.

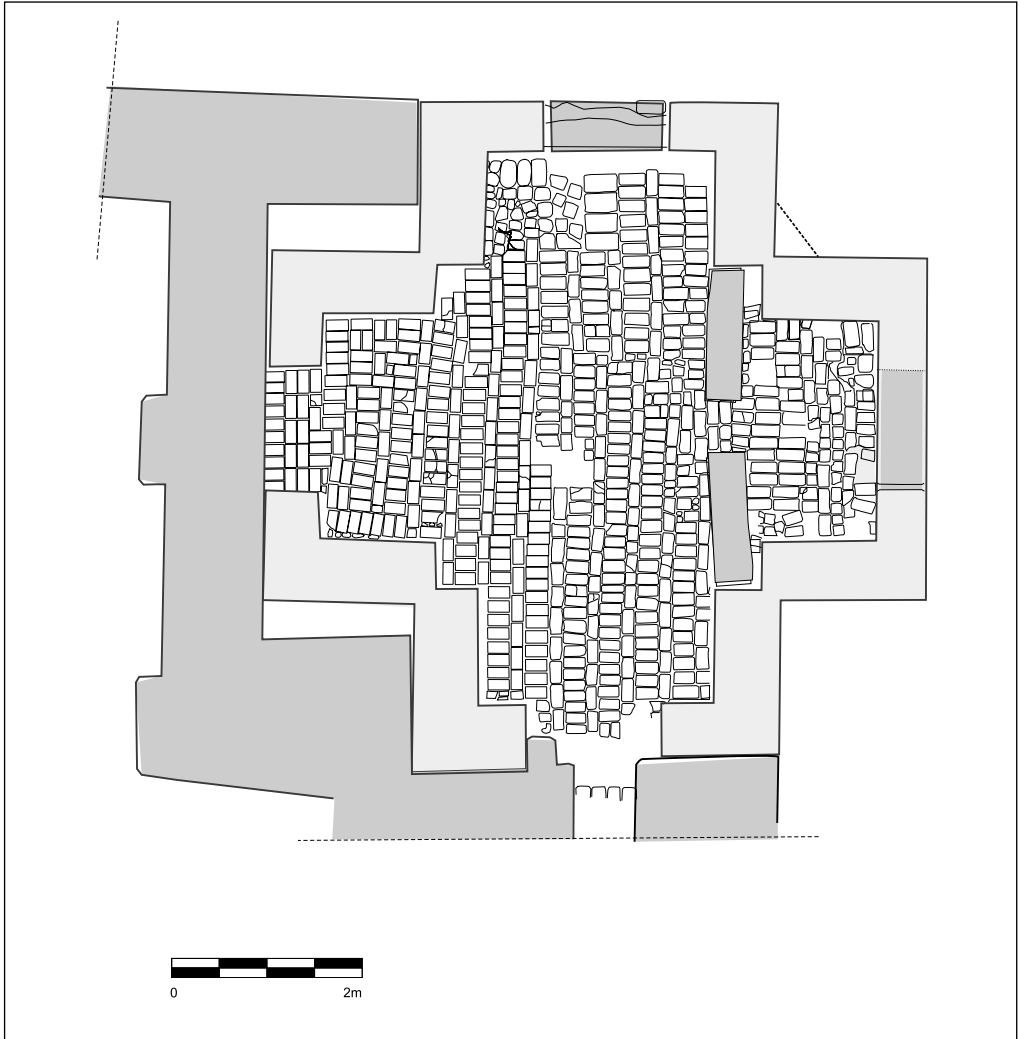
Fig. 11. Plan of the Cruciform Building after its restoration as a small church (B.III.2) (north is at the top) (Drawing W. Godlewski, D. Zielińska)

After the situation had stabilized, presumably in the first half of the 14th century, the Cruciform Building was transformed into a small church (*Fig. 11*). The entrances in the eastern, northern and western arms were blocked, leaving only one door from the south. The floor level was raised by 40 cm and a new brick paving was introduced. Just in front of the passage from the central space to the eastern arcade a high altar screen was constructed, providing only a narrow entrance to the sanctuary. The interior was coated with a new mud plaster and

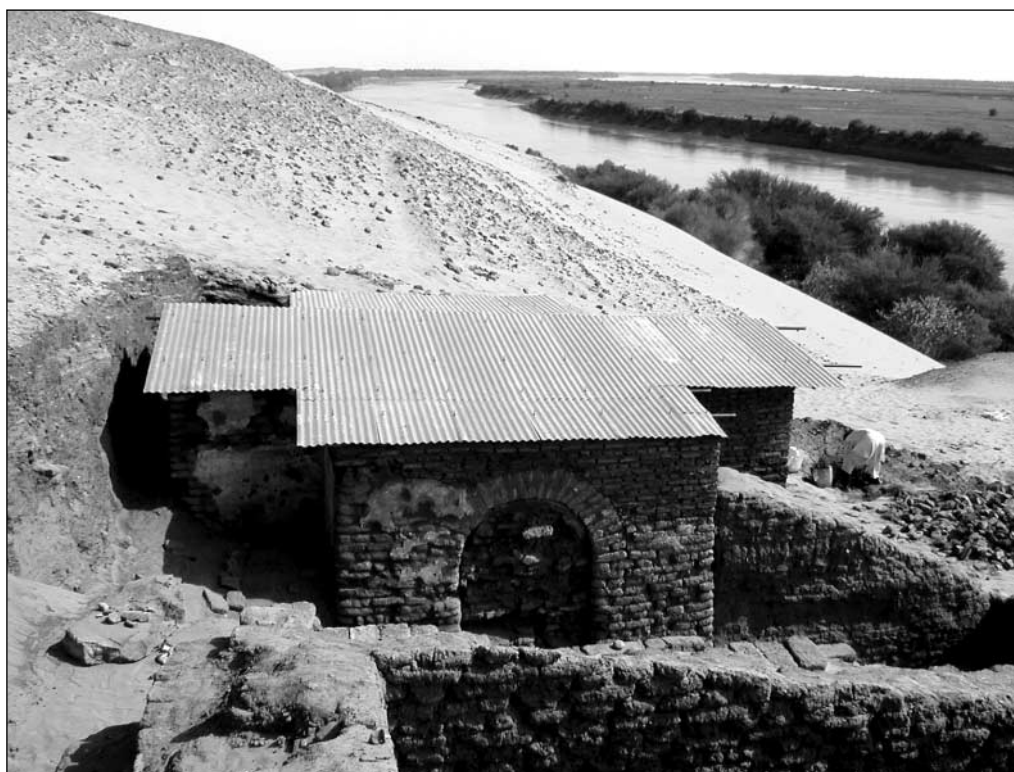
Fig. 12. Shelter built over the Cruciform Building (B.III) for protection of the murals inside it (Photo W. Godlewski)
