Journal: *Polish Archaeology in the Mediterranean* 23/1 (Research 2011)

MARINA EL-ALAMEIN: CONSERVATION OF ARCHITECTURAL DECORATION AND GEOLOGICAL STUDY IN AID OF CONSERVATION

Keywords: Marina el-Alamein, Tomb T17, Southern Baths, stone conservation, architectural decoration, geology

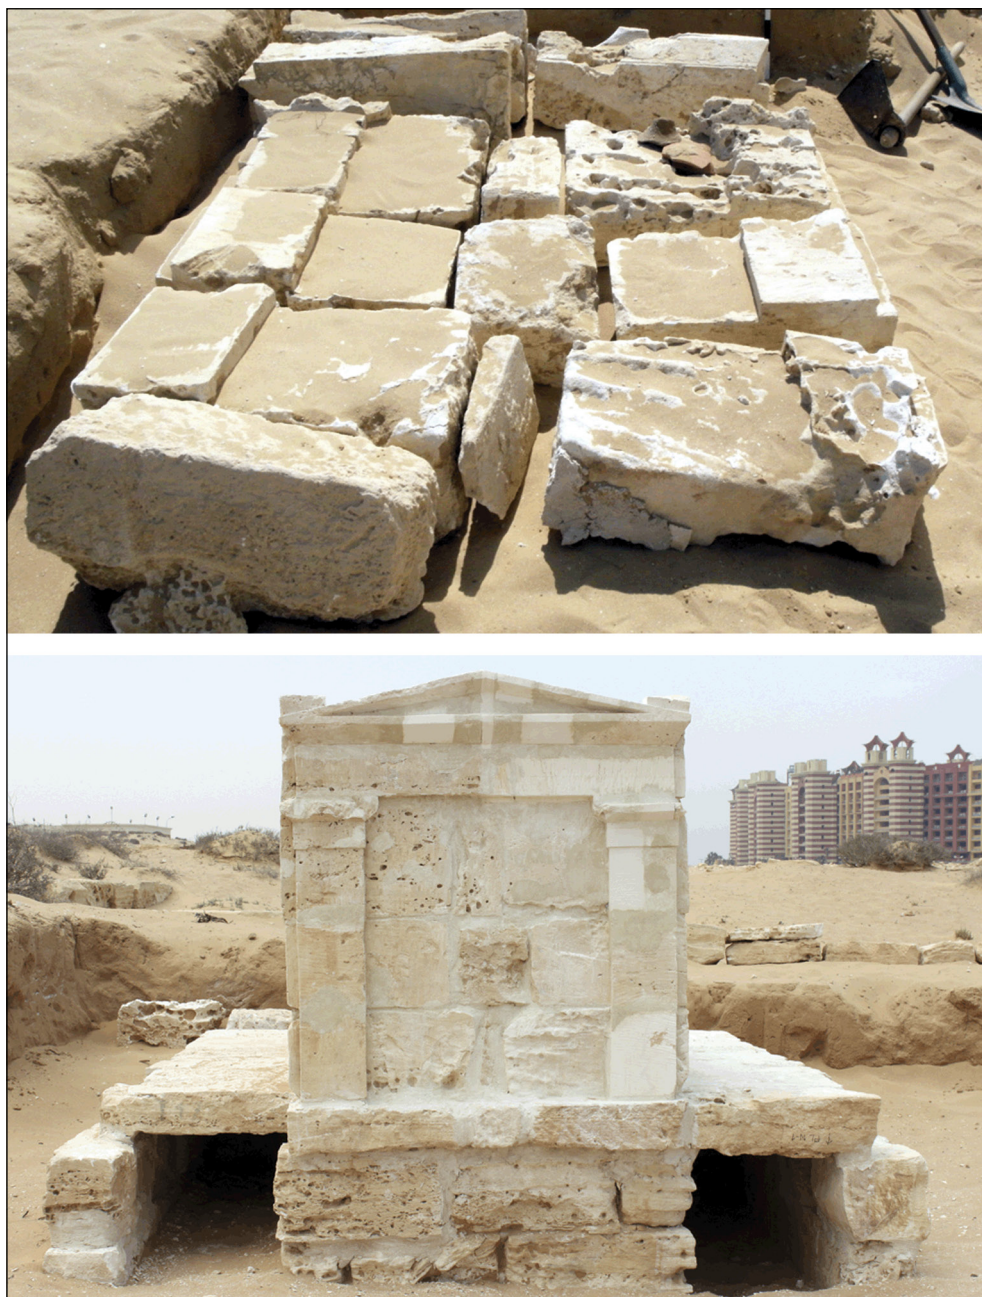
The planned work was part of the anastylosis project for this tomb [Fig. 2]. Elements of the tomb facade (discovered in 1997, see Daszewski 1998: 69–70) were in an extremely poor condition, the stone having eroded to the point that holes appeared in the masonry burial box structure. Elements like pilasters and cornices had become difficult to distinguish. The original elements had to be reconstructed in their original form (without losing their historical expression) in order to be reattached.

Fig. 2. Elements of the facade of tomb T17, before (top) and after conservation in 2011 (Photo G. Bąkowska-Czerner)

Description of work: Documentation was completed of the condition before conservation of particular elements. Sockets were prepared to be fitted with stone patches. Big losses were filled in with stone patches of a material with properties matching the original. An epoxy resin-based binder (KEMAPOXY 150 produced by CMB) with lime filler was used to fit the patches. Small losses were filled in with lime–cement mortar with sand filler (6 parts sand to 3 parts lime to 1 part white cement). Post-conservation documentation was prepared.

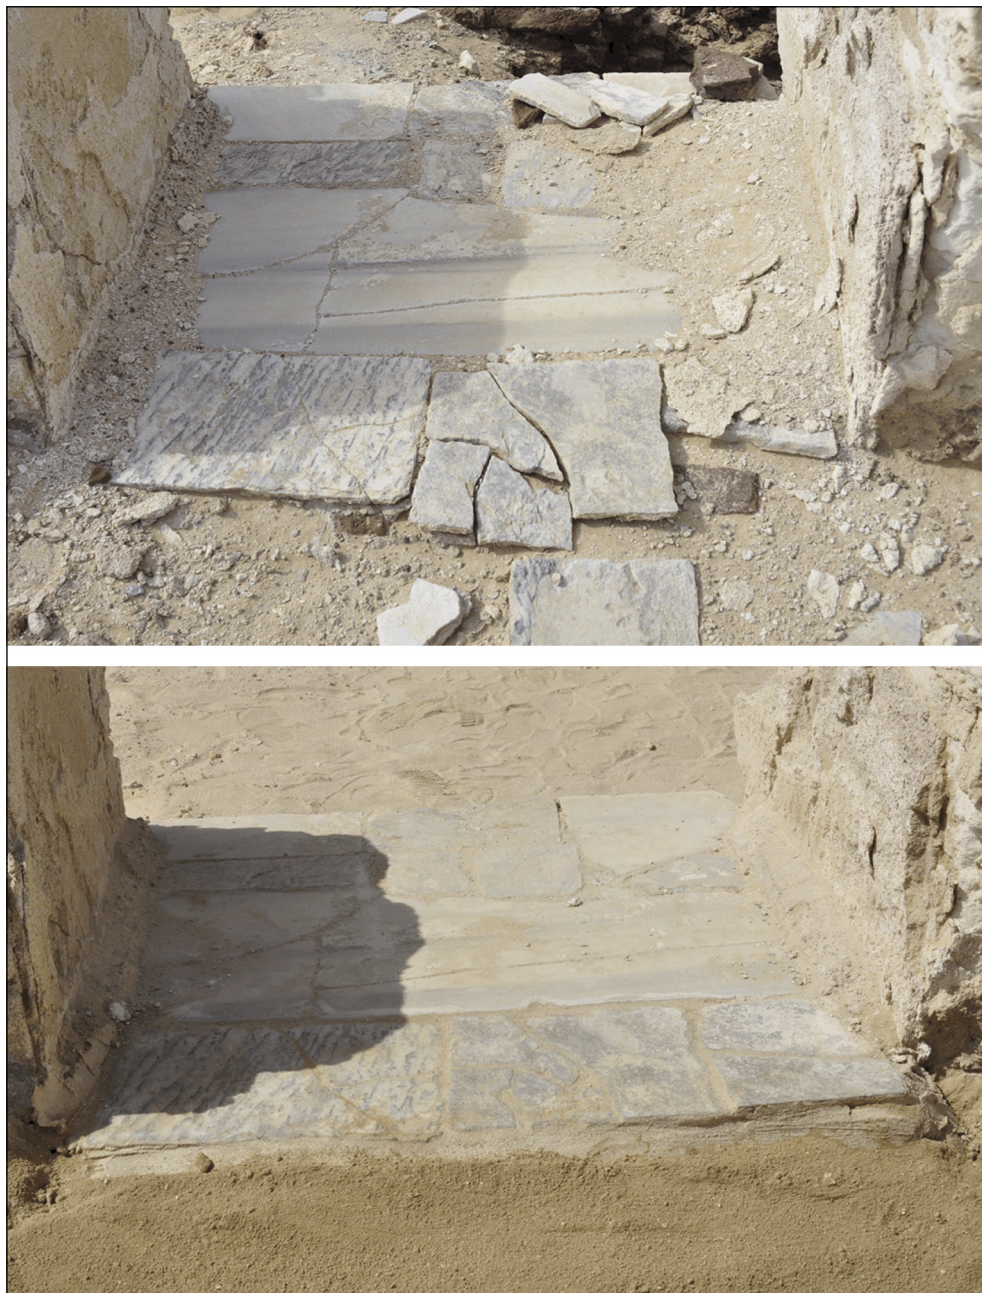
Conservation was essential in this case of the preserved relics of marble floors in the passage between rooms 6 and 7, to avoid the expected damage resulting from the use of the passage, as exemplified by already detached edge slabs [*Fig. 3*]. The weakened bedding had to be reinforced and the stone slabs returned to their original position.

*Fig. 3. Floor in the passage between rooms 6 and 7, before (top) and after conservation
(Photo P. Zambrzycki)*

Description of work: The current state of preservation of the marble tile flooring was documented (G. Bąkowska-Czerner, P. Zambrzycki) and programs were prepared for protecting the hypocaust cellar remains and preserving the marble floor (R. Czerner, G. Bąkowska-Czerner, P. Zambrzycki). Geotextiles were used to cover the relics before backfilling the area with sand up to the level of the reconstructed part of the floor. The membranous fabric also served as a marker between the ancient substance and backfill. Cracked and detached fragments of the floor in the passages were removed in order to prepare a new

substructure. The bedding consisted of limestone bonded with lime-cement mortar with sand filler (6 parts sand to 3 parts lime to 1 part white cement). Dismantled floor slabs were cleaned and replaced using mortar as above (P. Zambrzycki). Final documentation was prepared.

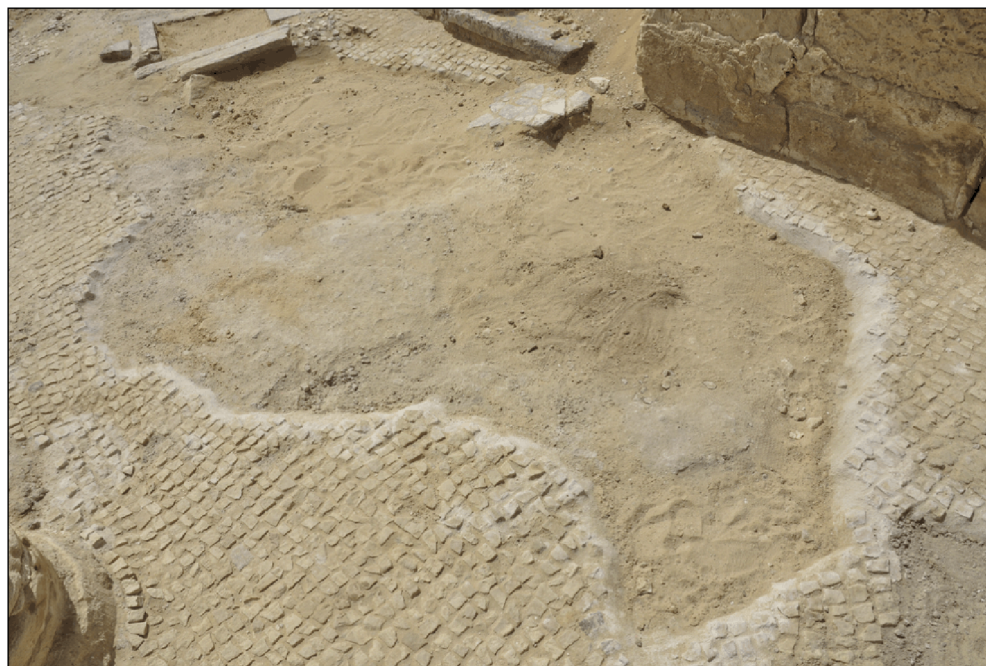
The planned two-year program of emergency preservation work includes on-site exposition of the decoration. Taken together, building structure, technique and preservation condition determined the extensive nature of future conservation works, which will include a transfer of the mosaic decoration to a new setting. A reconstruction of the whole floor will not only enable effective rainwater draining of the surface, but also ensure renewed use of the passage in its original function. At present, activities were limited to reinforcing the weakened parts with bands stabilizing the edges of the decoration and to fixing detached tesserae in place [*Fig. 4*].

Fig. 4. Southern Baths, southern portico of courtyard 4 after conservation of the floor mosaic (Photo P. Zambrzycki)

Description of work: The state of preservation was assessed (P. Zambrzycki). The mosaic was cleared of loose dirt lying on it and fragments that should undergo conservation work were selected. Cement mortar with lime filler (1:3) with added plasticiser (5% solution of PRIMAL AC33 in water) and natural pigment (vine black) was used. Wherever the original mortar was lost, a lime–cement mortar (3:1) with filler (coarse gravel) was used as a stabilizing base put under a band. Post-conservation documentation was completed.
