HOUSES

HOUSE A.106

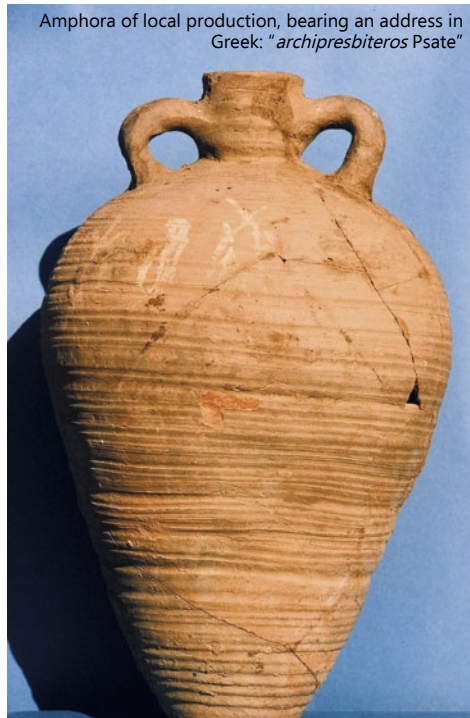
Amphora of local production, bearing an address in Greek: "*archipresbiteros Psate*"

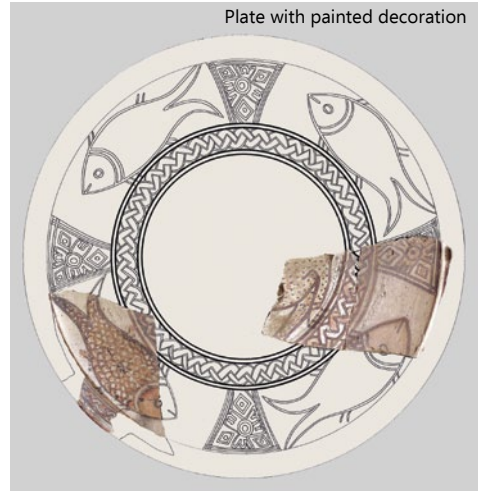
Plate with painted decoration

House A.106 was erected on the ruins of earlier architecture from the 6th century. It is dated on the grounds of the tableware fragments discovered in the toilet depository. Red-ware plates and flat bowls, sometimes with simple white painted decoration on the bottom inside, dated the first period of use to the mid 7th century. Window grilles, similar in execution, form and decoration to the grilles from the Church of the Granite Columns (RC.I), also speak in favor of dating the foundation of this house to the first half of the 7th century.

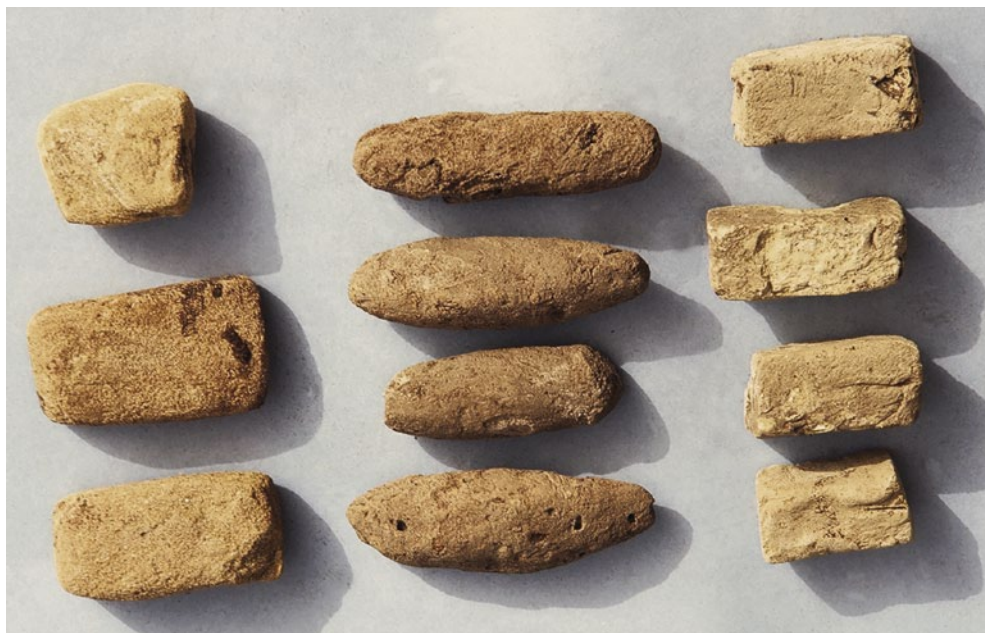
Toilet accessories from House PCH.1: toilet "paper" (top) and toilet seats

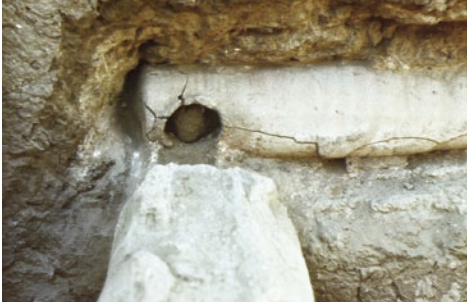
Bathroom of House A with preserved water installation in the north wall; close-up of the tap in the pipe

Room 3 adjacent to the staircase on the north was thoroughly rebuilt soon after the original construction. A narrow wall with a shallow arched niche on the east side divided it into two. Two arched doors by the side walls gave passage from one part to the other. Both of these units were furnished with pools set against the east and north

walls. The pools were faced with stone and coated with waterproof plaster. Each had a step facilitating access. The floor of the room was paved with irregularly cut stone slabs. A terracotta pipe ran along the north wall, supplying the pools with water from a tank set up above a furnace built against the outer wall in the eastern courtyard. Three vertical terracotta pipes in the east wall acted as flues bringing warm air to the rooms with pools and the upper-floor hall above it.

The furnace in the eastern courtyard was a rectangular structure with two round pillars inside it, presumably supporting the water tank. The bottom part of the furnace, with an opening that could be opened and closed, presumably served as a hearth. The vertical pipes in the east wall of the room with pools was connected with it. Thus, room 3 may

be said to have been a bathroom with two pools for bathing, filled with hot water from the outside tank set atop the furnace.

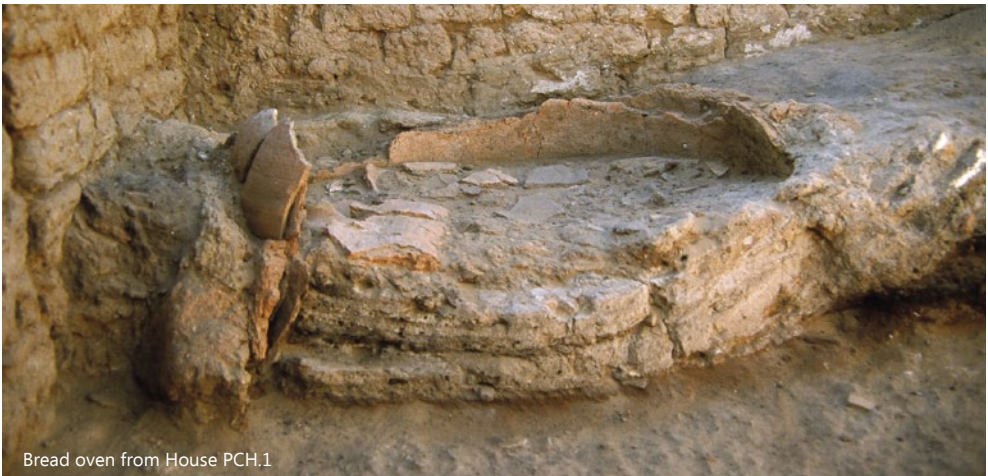
Bread oven from House PCH.1

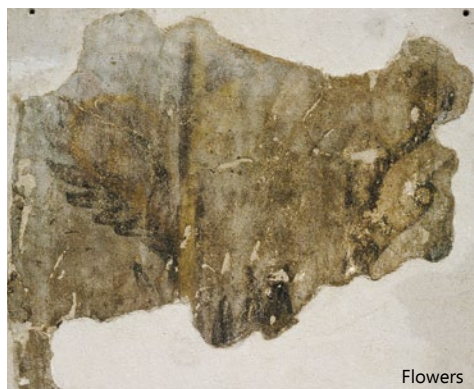
Murals from the bathroom in House A

Flowers

All paintings were taken off the walls of the house and were transferred, after conservation, to the collection of the National Museum in Khartoum.

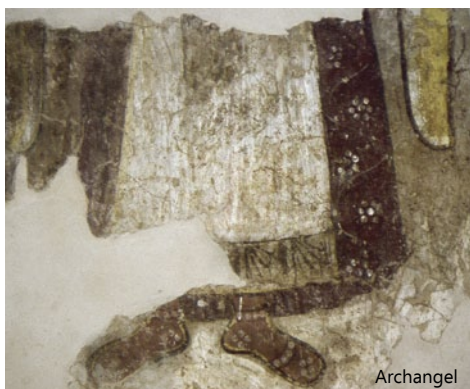
Archangel

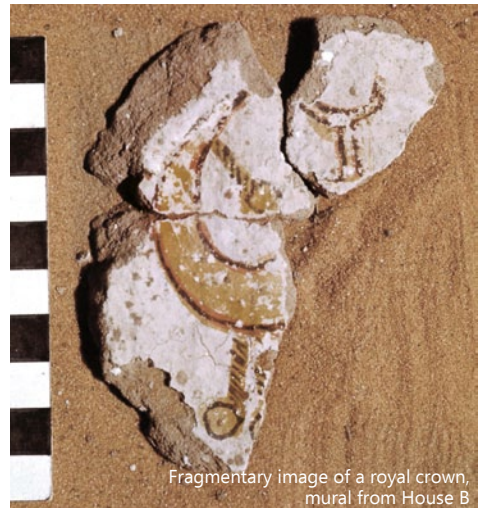
Fragmentary image of a royal crown, mural from House B

The interior was given a plaster coating and it is very likely that it was painted. The evidence is modest to the utmost: a few pieces of plaster with color polychromy found in the fill of the rooms. They could have come from the upper floor. The best preserved piece is a fragment of a small composition depicting a figure dressed in a royal crown with horns.
