Maad

The Church of St Charbel in Maad belongs to a Maronite community and was raised during the medieval period on the ruins of a Roman temple incorporating parts of this earlier structure, such as the columns dividing the interior into three aisles. Two layers of wall paintings dating from different periods survive in the room adjacent to the apse. The first layer dates from the 12th century, the second, painted directly on top of it, is of 13th-century date. At present losses in the outer layer have partially revealed the underlying murals (best visible on the north wall). Depictions of saints and a kneeling figure of a donor can be seen on the north wall, with an archangel in the upper portion of the composition. The south wall features an elaborate scene of the Dormition of the Virgin with a standing figure of Christ accompanied by apostles and angels. Inscriptions in Old Syriac survive in fragmentary form on the halos of these figures.

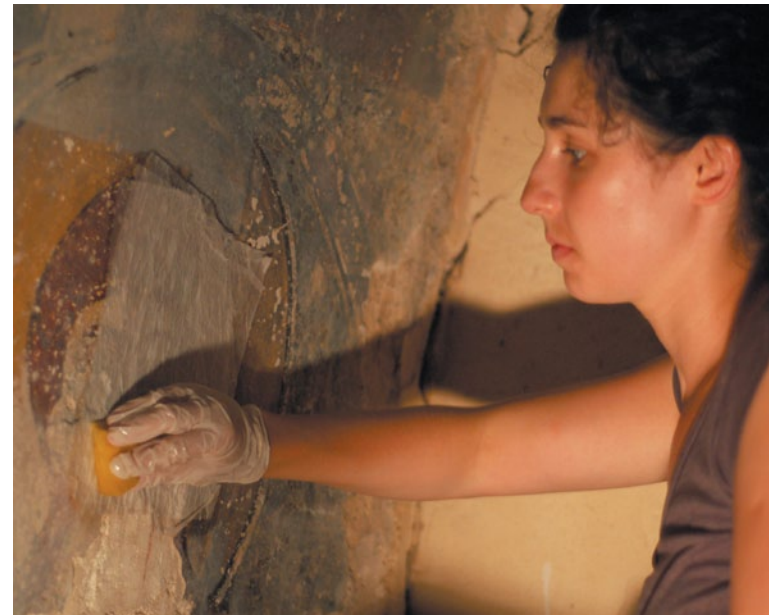
Attempted cleaning and removal of efflorescence from the surface of a painting reveals the degree of its soiling.

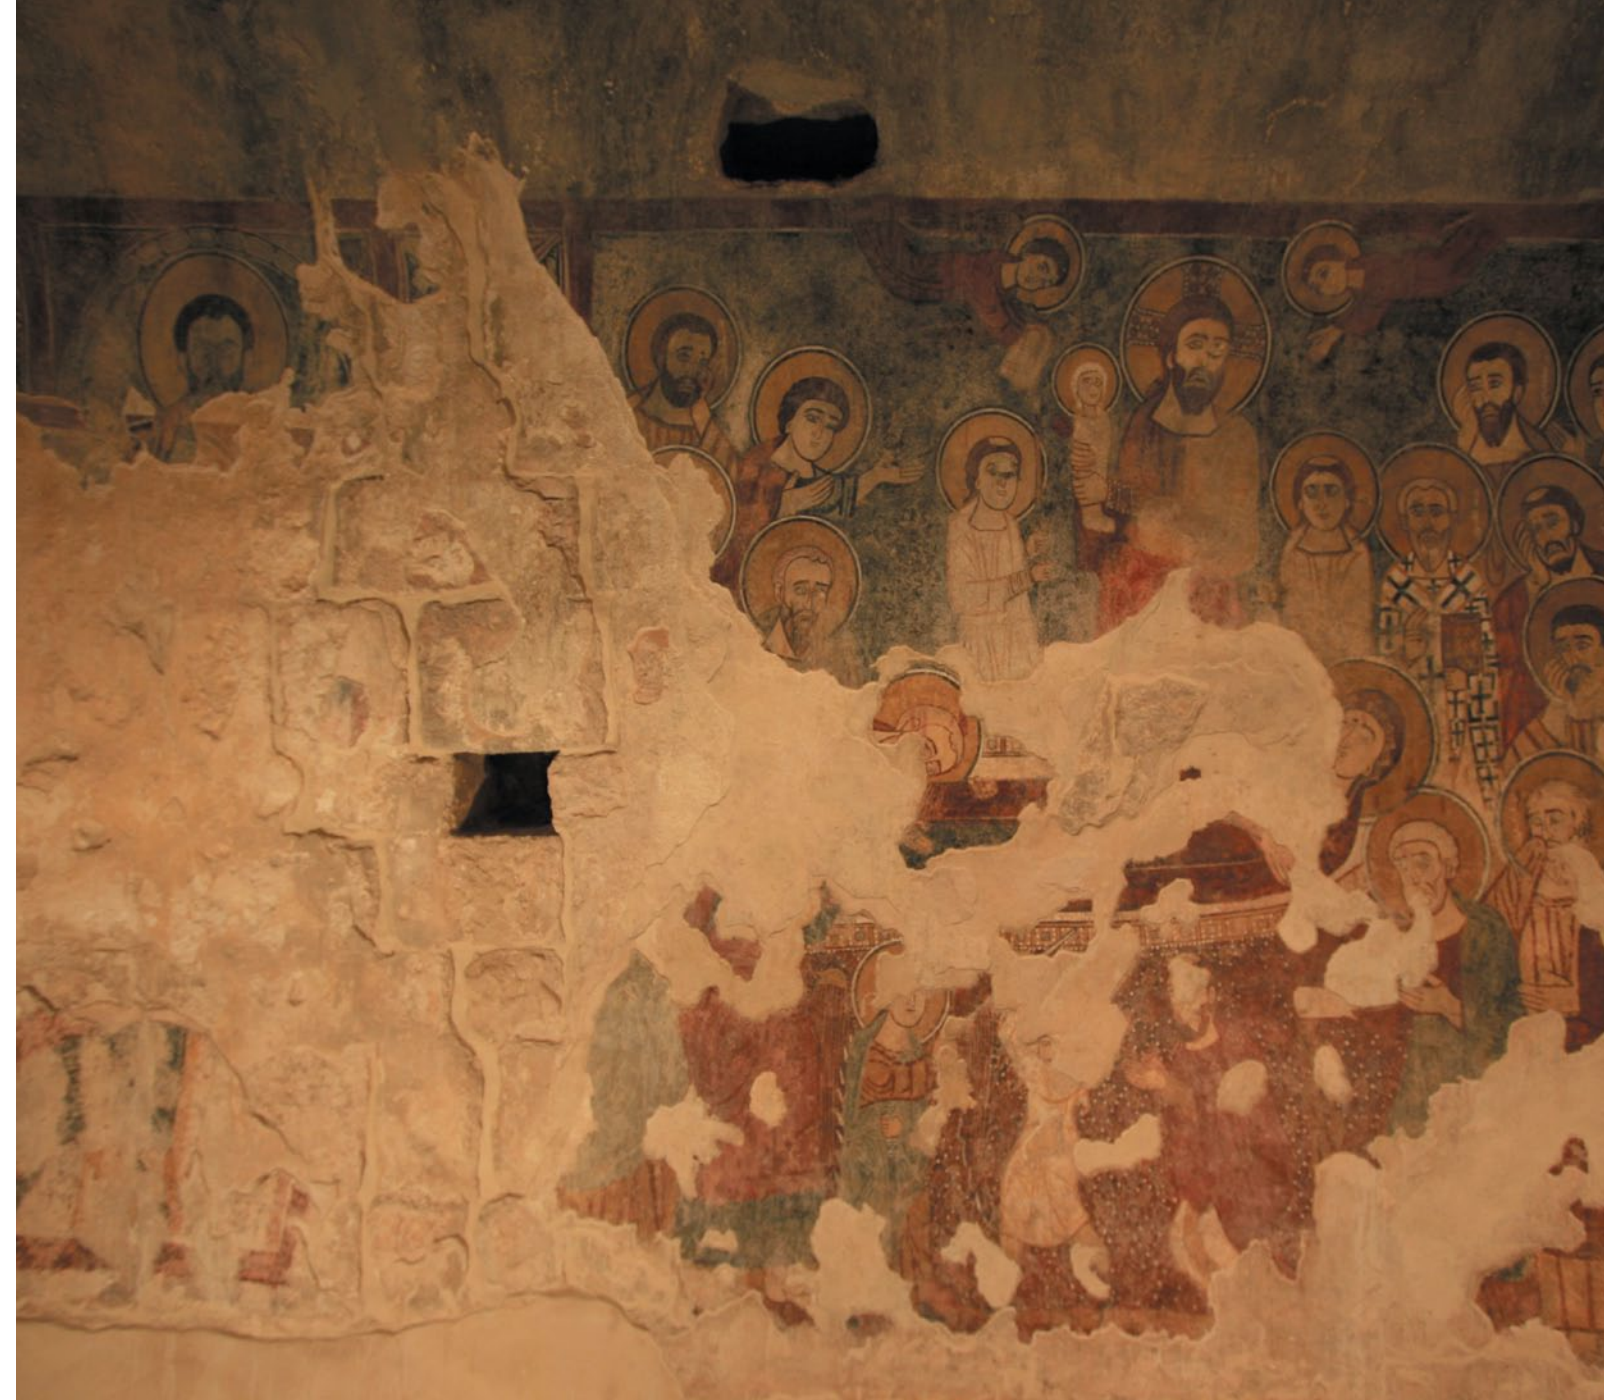
The Dormition of the Virgin after conservation.

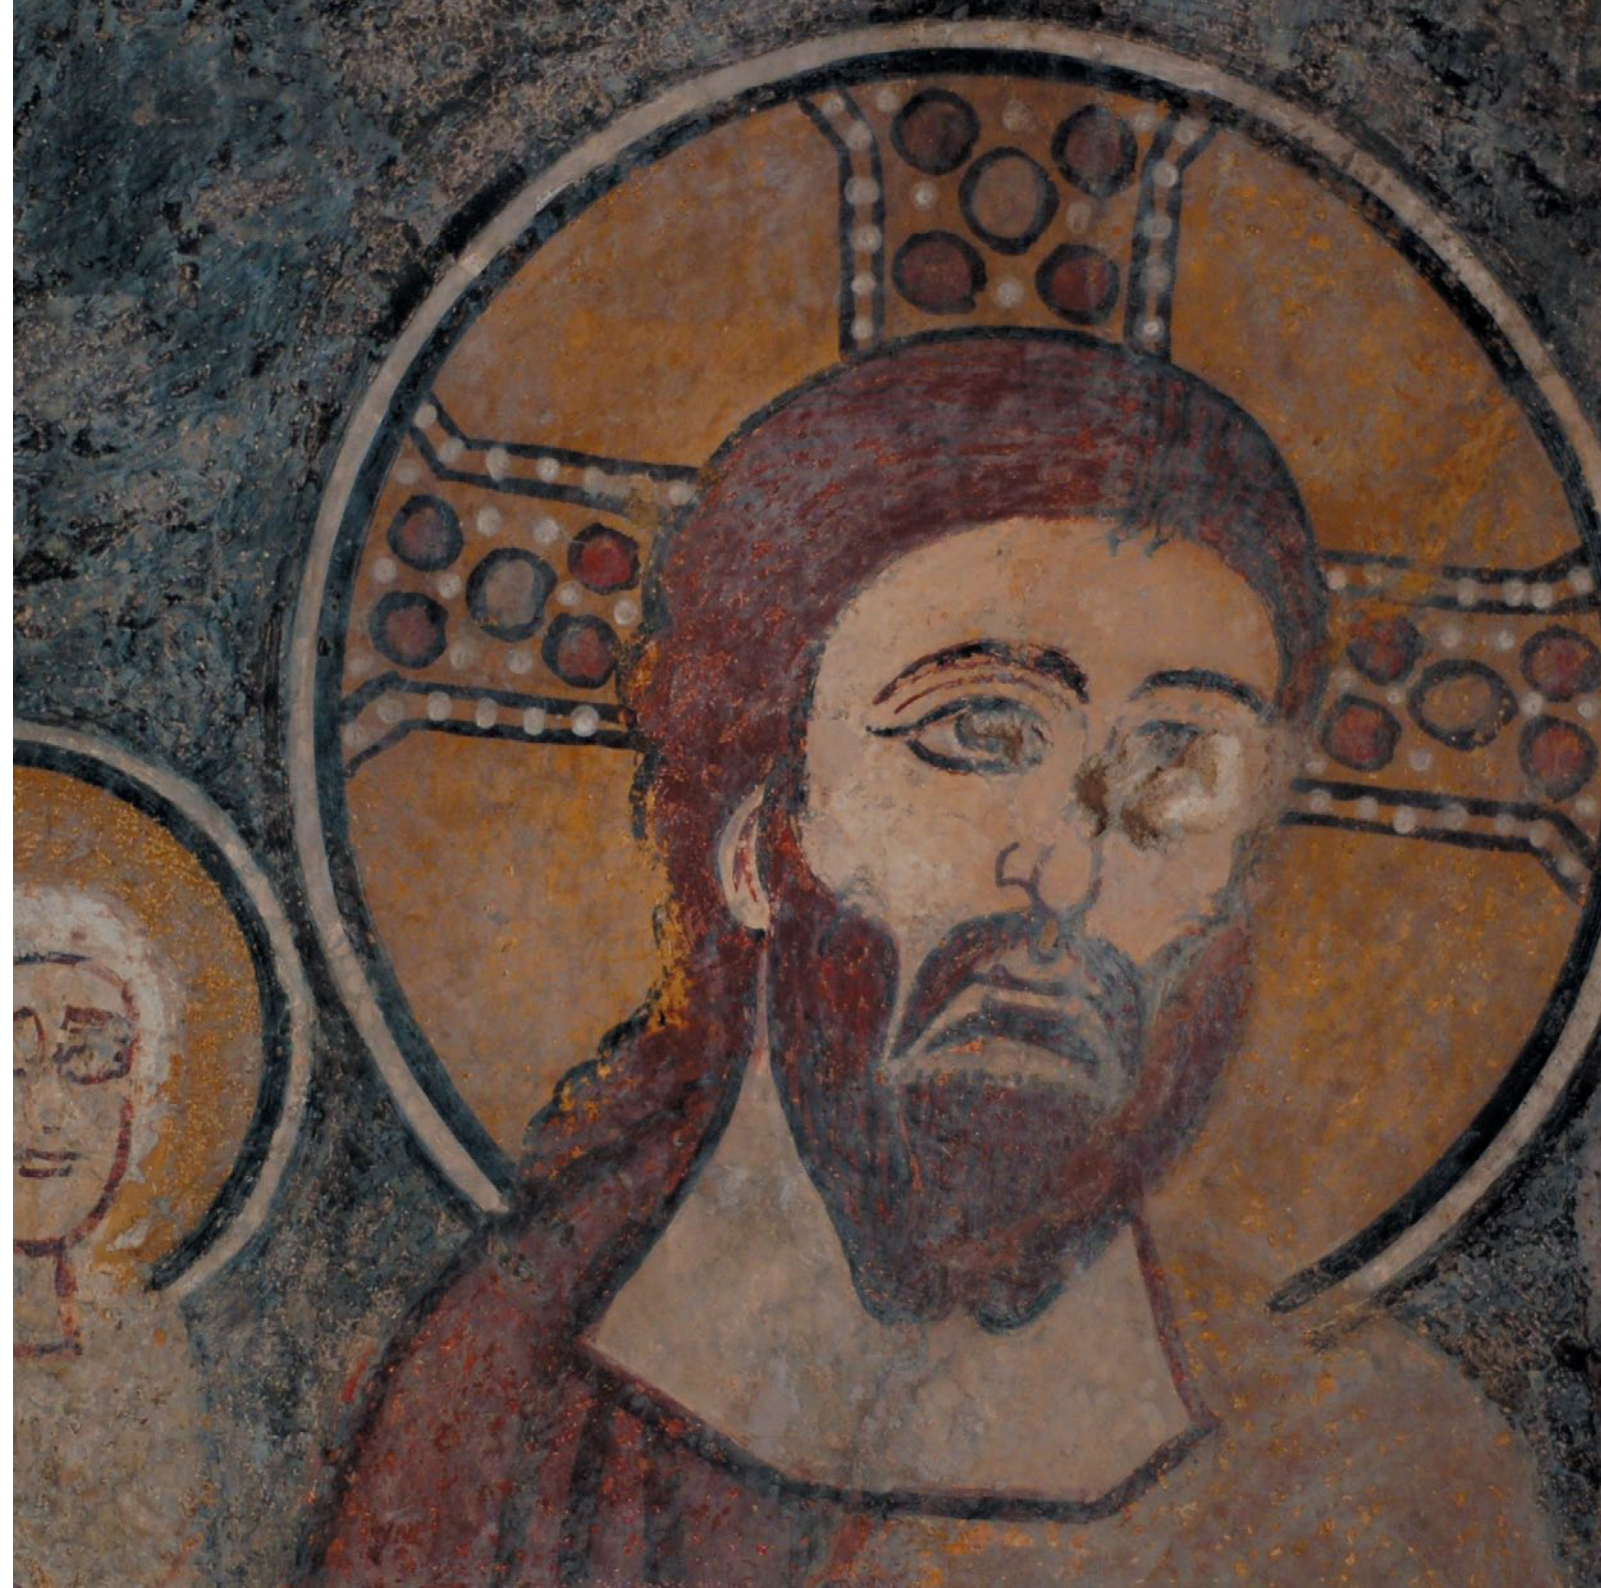
◀ Detail of painting before and after removal of dirt and salts.

This work focused on fixing delaminated layers of painted plaster in danger of becoming detached, cleaning their surfaces of hard salt accretions, replacing losses with fresh plaster and limited previous retouch of the painted layer.

As well as being secured, the wall paintings also substantially regained their clarity and colour intensity.
