Beirut

The Greek Orthodox Church of Mar Elias Btina in Beirut

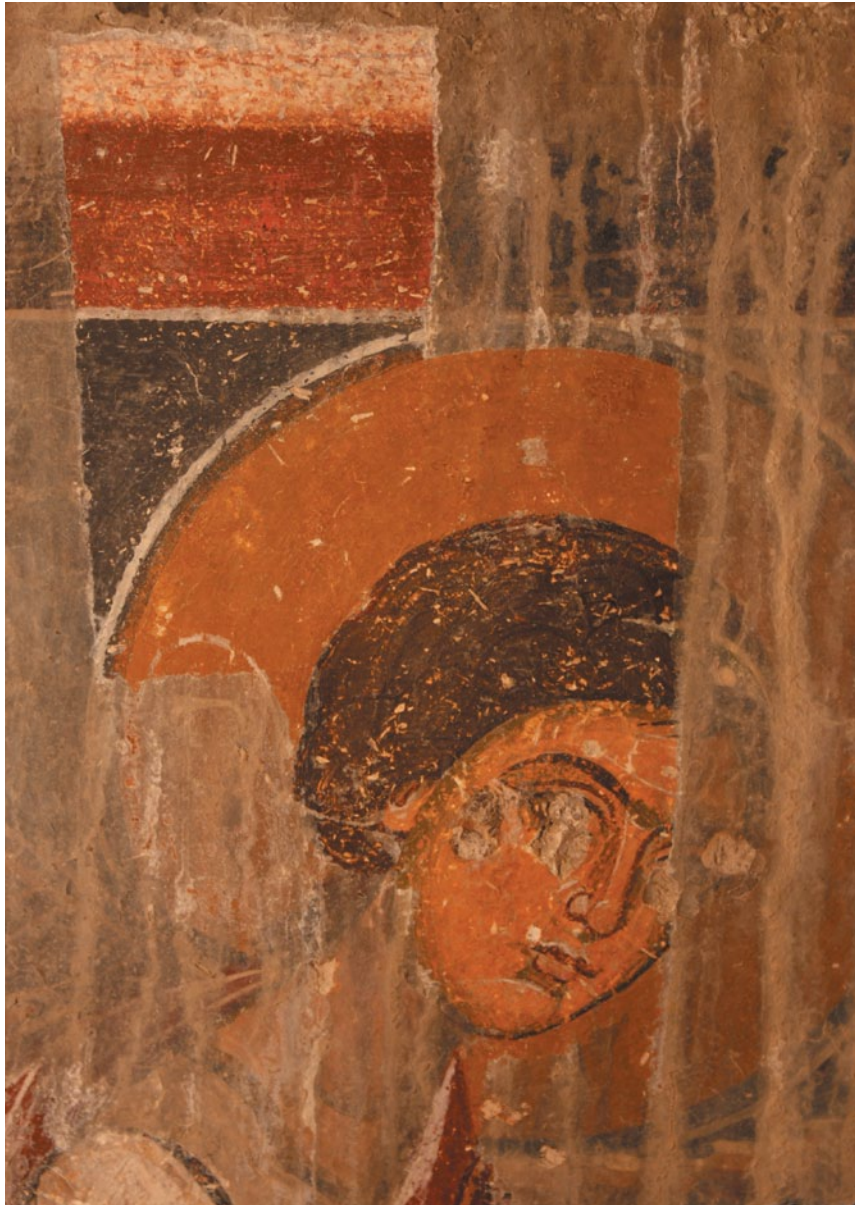
▲ Conservation treatment – one of the stages of calcite accretion removal.

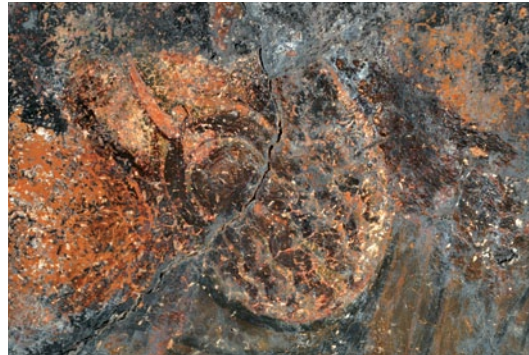
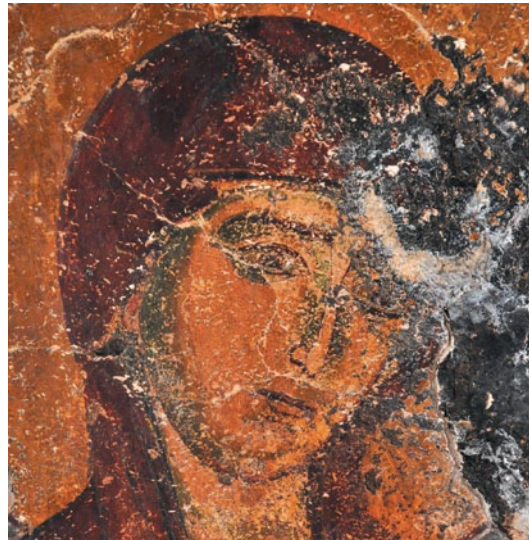
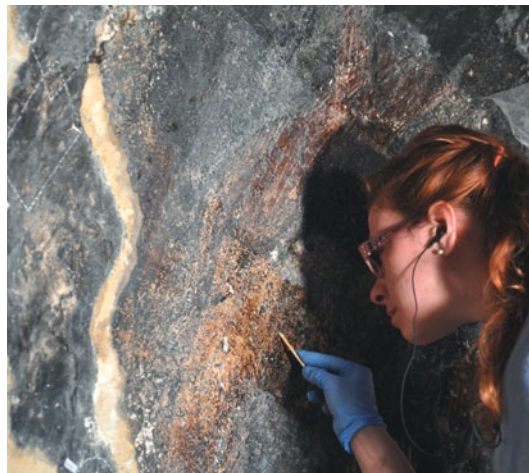
Various stages of conservation: cleaning, after treatment and during removal of salts. ►

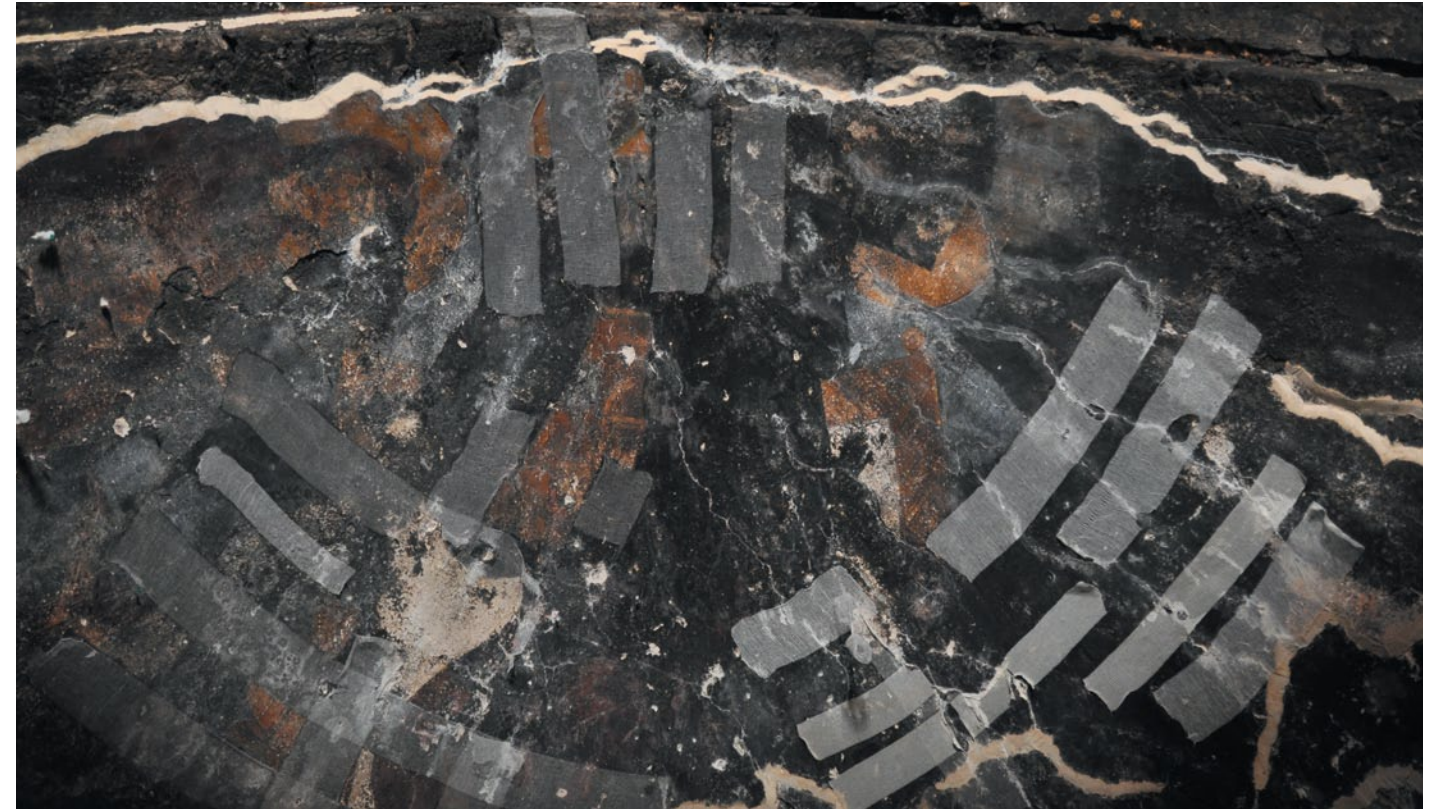
Conservations measures were taken to remove soiling in the form of a thick layer of soot resulting from a fire. Strips of cotton gauze were also applied in order to prevent the compromised plaster and paint layer from becoming detached.

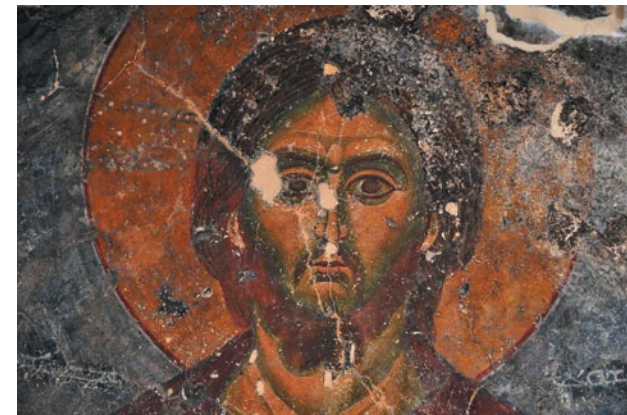
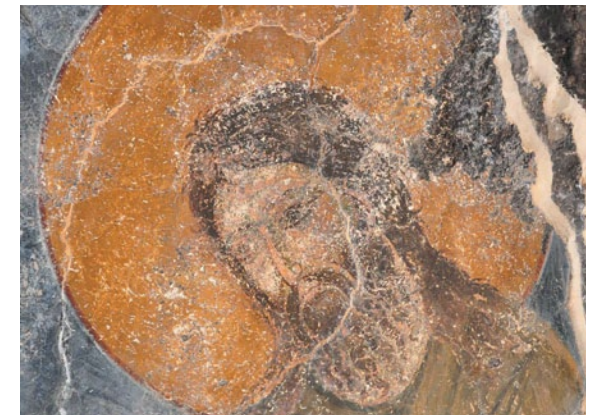
The face of Christ and of St John the Baptist after cleaning.

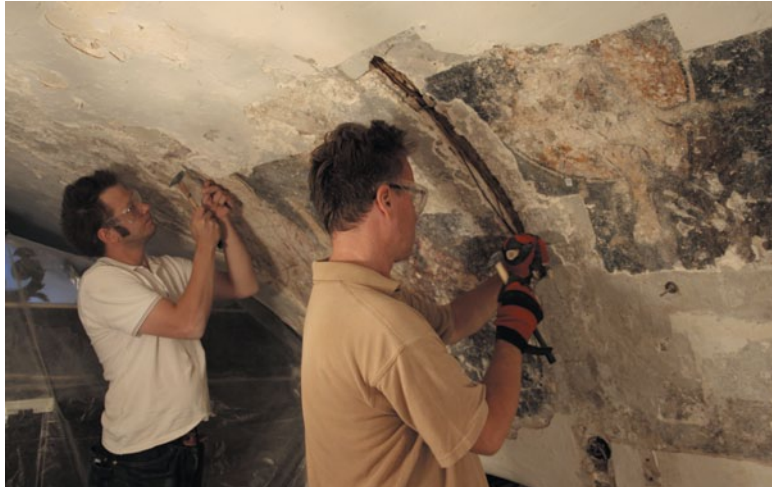
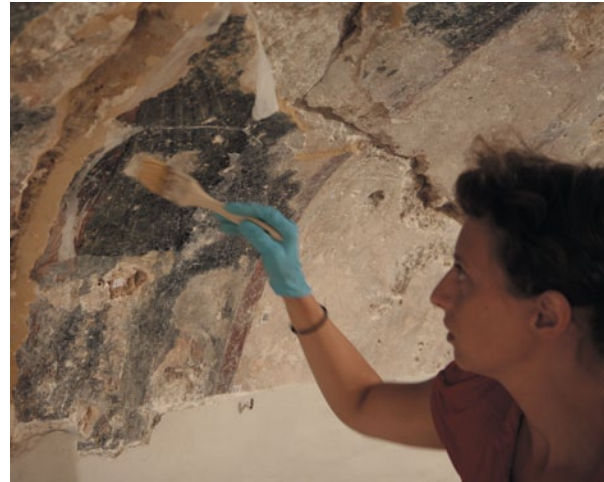
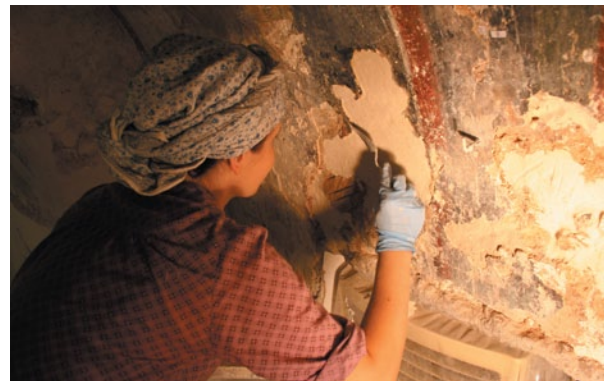
Conservators carrying out various procedures: hacking away secondary cement accretions, securing the paint layer and working on areas of putty filling.

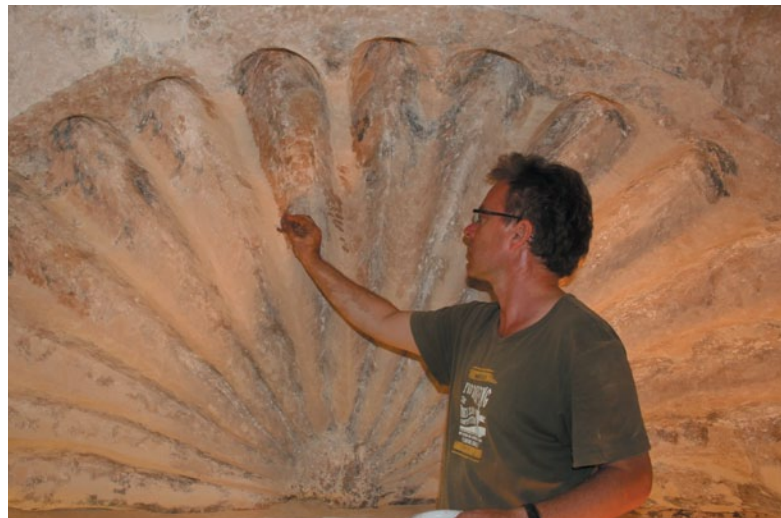
Conch-shaped apse. Condition after removal of multiple secondary layers, filling of losses with putty and colour reintegration.
