# MARINA EL-ALAMEIN CONSERVATION WORK, 1999

Stanisław Medeksza

The site of the ancient town of Marina el-Alamein – Houses H 9 and H 9a, as well as H 10, H 10a and H 19 – was for the fifth time the object of conservation activities conducted by a Polish-Egyptian expedition between March 16 and May 30, 1999.<sup>1)</sup>

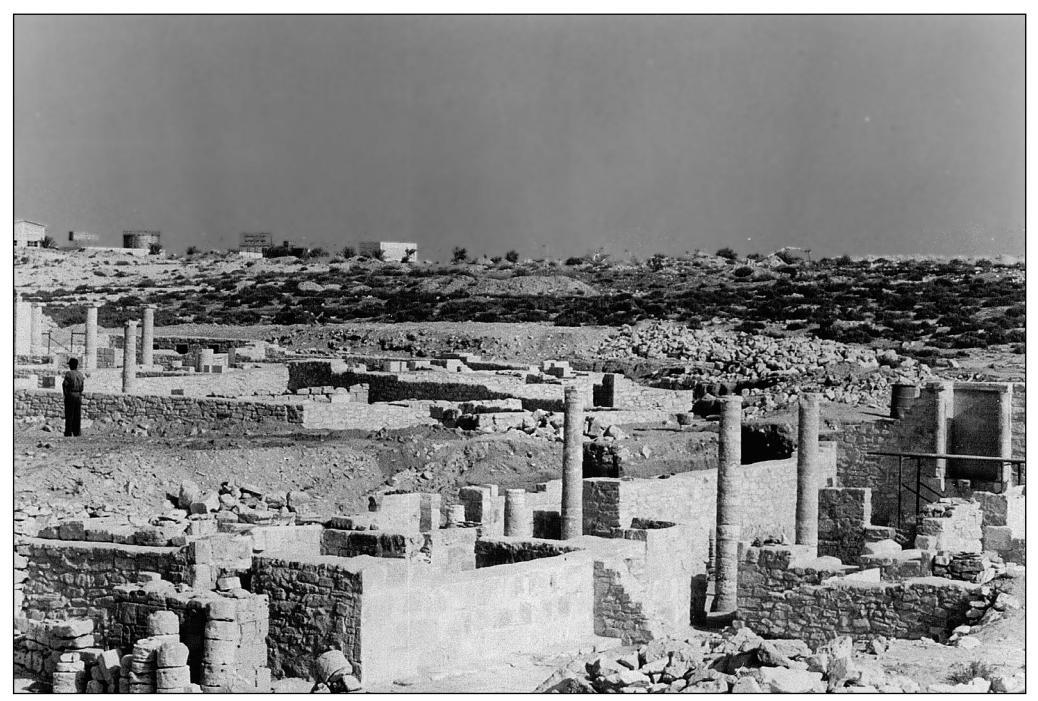
Fig. 2. General view from the northwest of houses H 10 (foreground) and H 9 and H 9a, at the close of the 1999 season (Photo S. Medeksza)

The brunt of the conservation and cleaning work this season was concentrated in this complex, which is now seen as including not only the recognized peristyle houses H 10, H 10a and H 10b, but also a smaller, as yet not fully excavated residence H 19 (*Figs. 1, 2*).

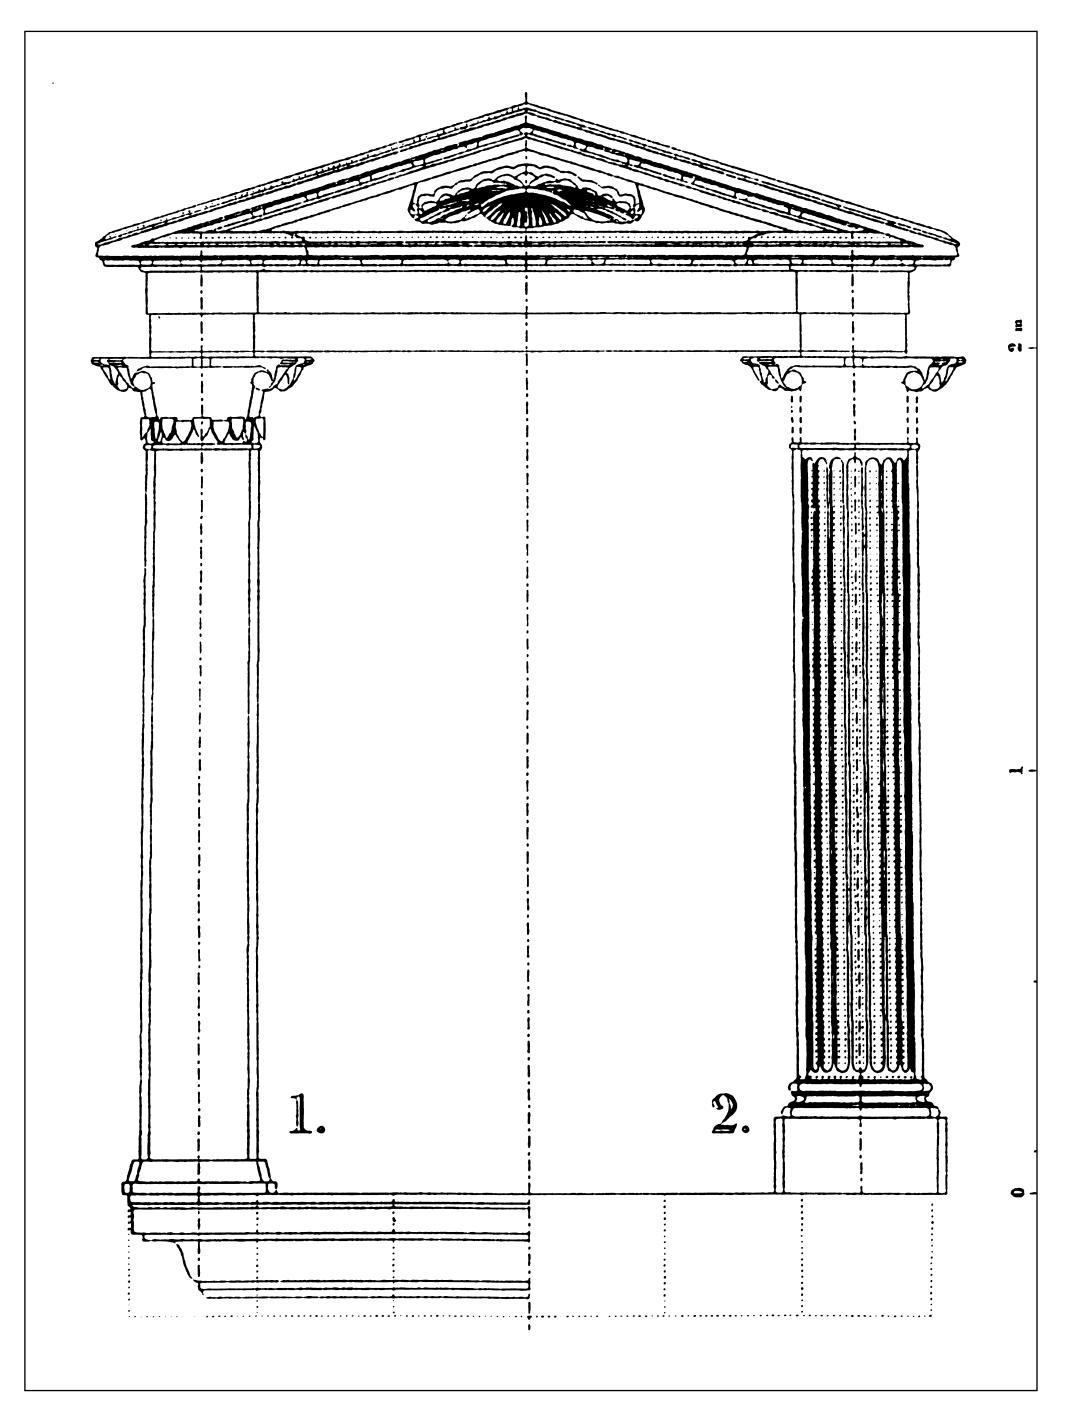
The cornices and conch, preserved in 70%, will be restored in the coming season, when it will be possible to recreate most of the missing stucco elements (*Fig.*  $\theta$ ).

Fig. 5. House H 10, room 2. Reconstruction of two stages of the architectural decoration of the niche (Reconstruction R. Czerner)

The niche discovered last year in room 2 (Fig. 3) was now restored (Fig. 4), the mural removed to be displayed in the future onsite museum. The only step taken was to insert the two blocks directly supporting the columns of the niche. No effort was made to recreate in detail the ornamental profile of the parapet, eroded beyond recognition, but about 90% of the original decoration of the niche has been preserved (Fig. 5). Nevertheless, the structure was found unsound, the blocks of the engaged columns being only shallowly inserted into the original wall structure. Every second element of the columns was reinforced, using steel rods and epoxy resins, to bond the niche to the wall behind it. The inside of the niche, once decorated with paintings, has been finished in plaster.

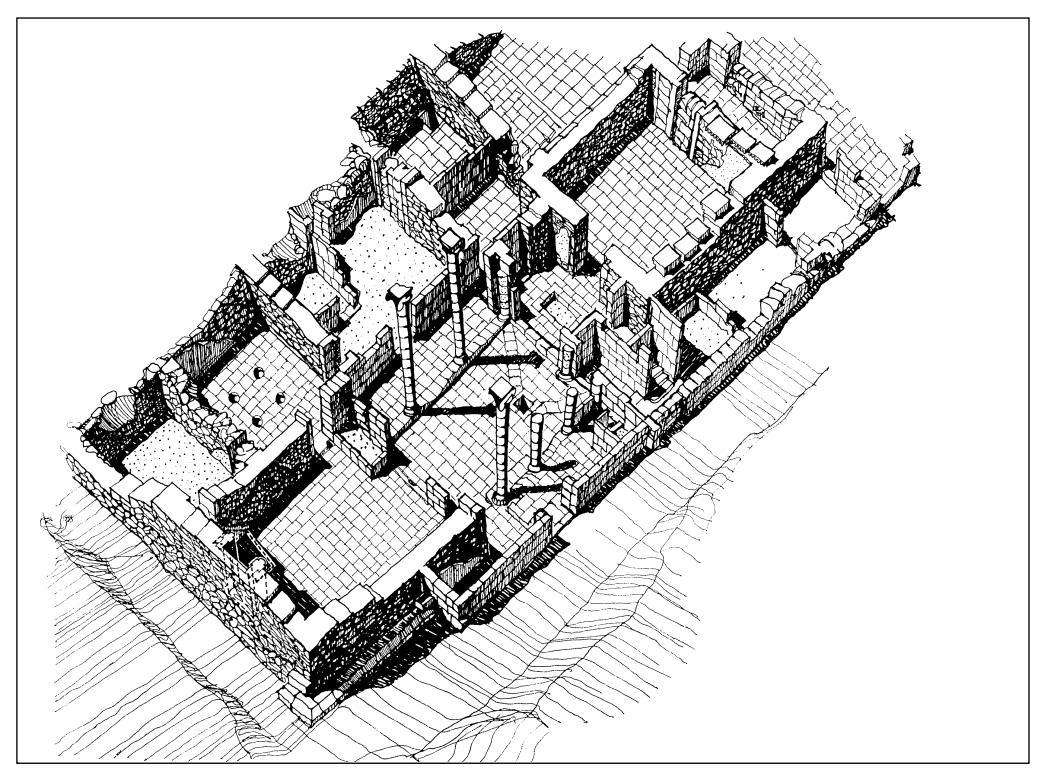
*Fig.* 7. House H 10. Axonometric view after restoration. View from the southeast (Drawing R. Czerner)

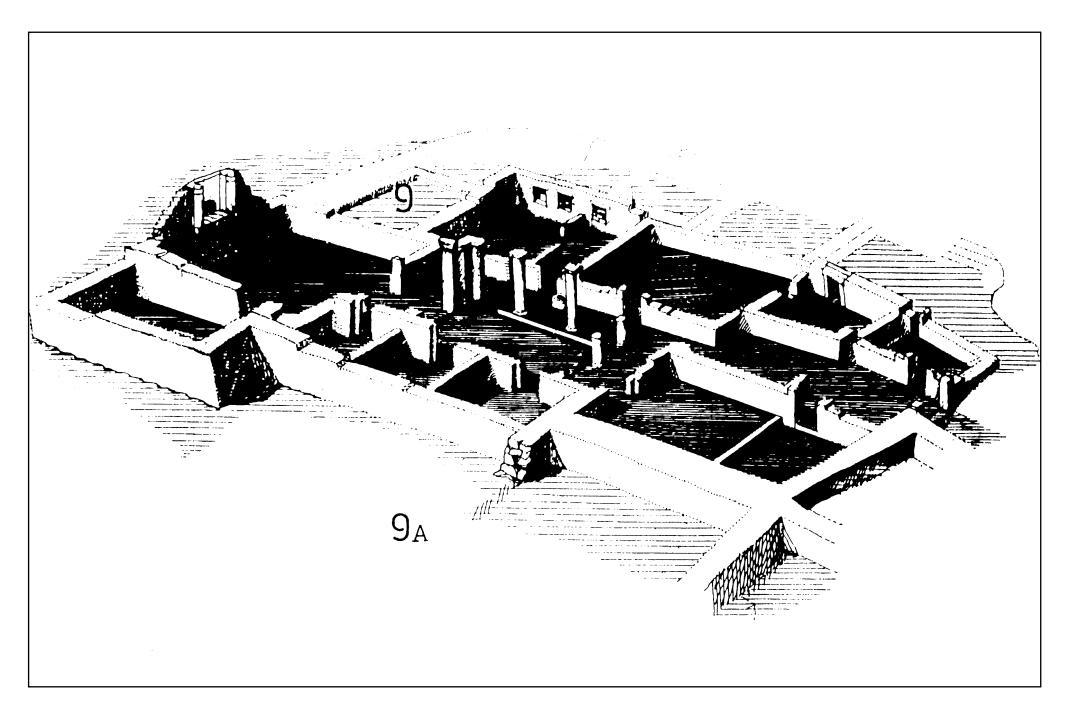
HOUSES H 9 AND H 9A The major work in House H 9 (*Fig. 9*; cf. also *Figs. 1, 2*) was the restoration of a niche in room 14, made possible by last year's fortuitous discovery of the niche in House H 10. The niche, which had been excavated several years ago (*Fig.* 10),<sup>3)</sup> had suffered considerably from lying out in the open. It now proved impossible to use all the original elements; the northern column had to be reconstructed entirely, and there is little chance for saving the conch (*Fig.* 11).

Fig. 8. House H 9. Axonometric view after restoration (Drawing E. Łużyniecka, R. Czerner)
