MARINA EL-ALAMEIN PRESERVATION AND CONSERVATION IN 2005

The Polish-Egyptian Preservation Mission carried out the eleventh season of work at the site of Marina el-Alamein from April 13 to May 30, 2005.¹

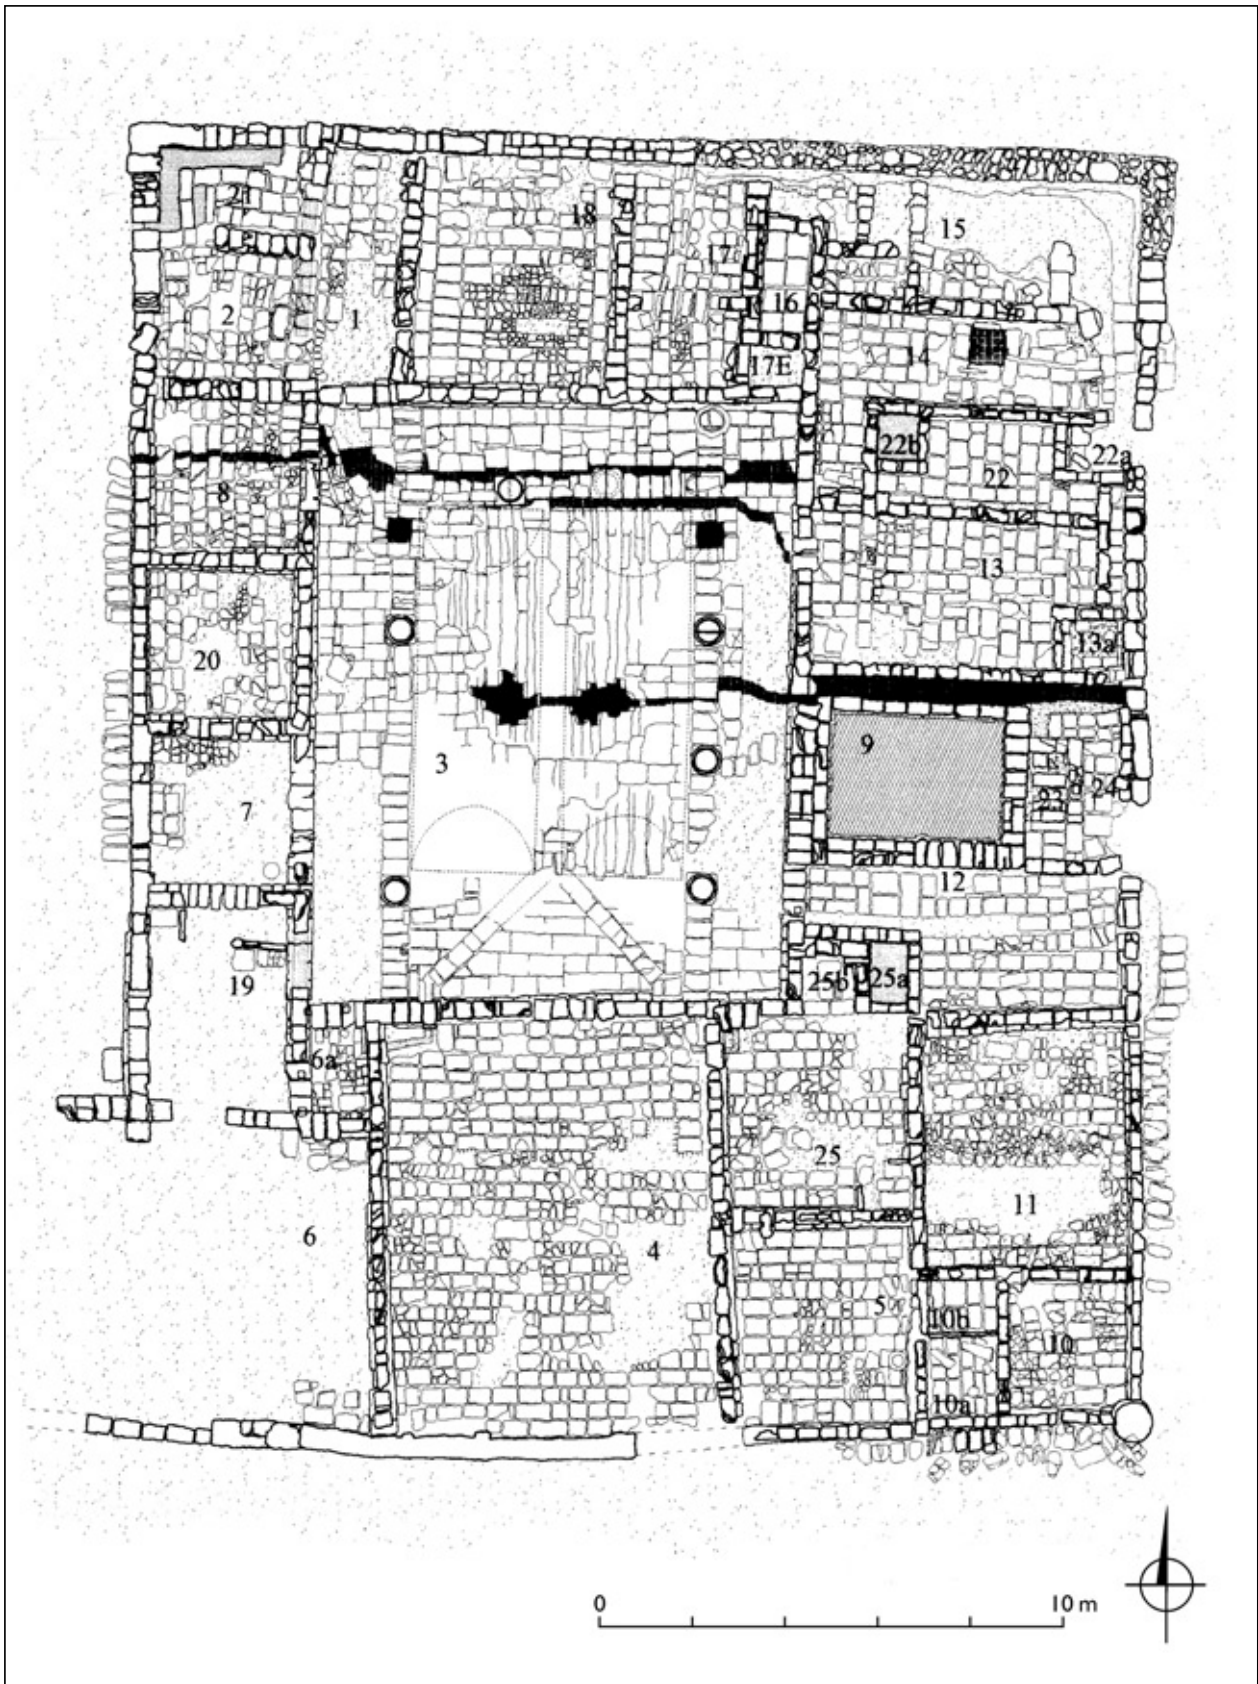
Fig. 2. Plan of house H1
(Inventory drawing R. Czerner and M. Krawczyk)

The building has suffered evidently from earthquakes and ground movement caused by other geological factors, resulting in a considerable distortion of the architectural appearance. Much subsidence of the original stone pavements is in evidence, especially in the courtyard (north portico of the peristyle) and in the area of rooms 4, 5, and 10 [*Fig. 3*]. Only the vaulting of the cistern under the floor in room 3 seems to be at the original level, but it has a deep E-W fissure that is pushing apart room 13 and basin 9. The perimeter wall also proved to be very poorly preserved, even missing entirely in places (especially in the eastern part of the house, in the vicinity of rooms 15, 14, 22, 13, 24). Room 6 appears to have been a projection, extending west, beyond the rectangular body of the house.

for the past two seasons. Rubble and secondary deposits, including vegetation, have been removed, and the vaulting of the cisterns under the courtyard protected. Architectural documentation work, in preparation for the building works to start next year, was completed this season, including fundamental revisions of the earlier documentation [*Fig. 2*]³ (indeed, more research needs to be done in order to understand the internal chronological stratification of the building).

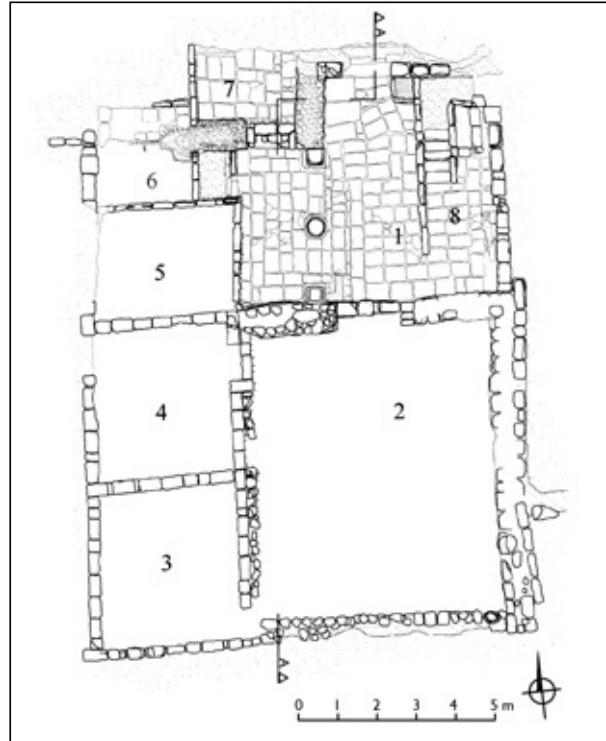
Fig. 4. Plan of house H2
(Drawing M. Krawczyk)

The hall has not been cleared completely as yet, but the architectural evidence points to a history of rebuilding. The original walls appear to have been made of a single row of blocks 0.26 m wide (corresponding to an ancient royal cubit). At some point, perhaps following a quake, the walls were strengthened on the inside with a second set of walls made in the broken-stone technique. The varied bondwork, as well as vagaries of layout are proof of an agglutinative form of development, which is generally characteristic of the house architecture in Marina. In the case of H2, rooms 3, 4, 5, and 6 clearly

In 2005, all the walls surrounding the courtyard were consolidated [Fig. 5]. New jointing was carried out and the missing plaster completed. The broken-stone walls had the tops protected with the regular lime-cement mortar used by the mission.
