MARINA EL-ALAMEIN

CONSERVATION WORK IN THE 2003 SEASON

Stanisław Medeksza et al.

From March 27 to May 30, 2003, an Egyptian-Polish conservation mission completed its ninth season of conservation work at the site of the Early Graeco-Roman town of Marina el-Alamein.¹⁾

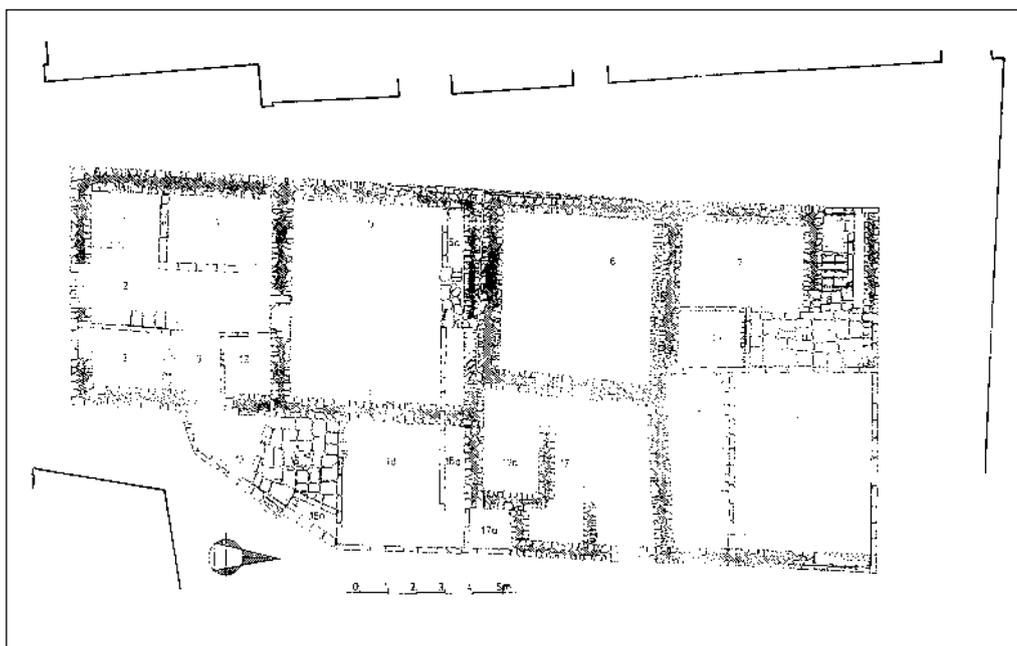
Fig. 2. House H 10 "E". Complete plan following the 2003 season
(Drawing S. Medeksza)

a height of c. 1.00-1.20 m, occasionally 1.40 m, in an effort to clarify the layout of particular houses and trace the surrounding streets. The houses are studied architecturally in the process. For example, this season the investigations of House H 10"E" were completed; the structure now appears to have had eighteen main rooms and five subsidiary ones (Fig. 2). It also seems clear now that rather than the four houses previously hypothesized in this insula, there were only two.

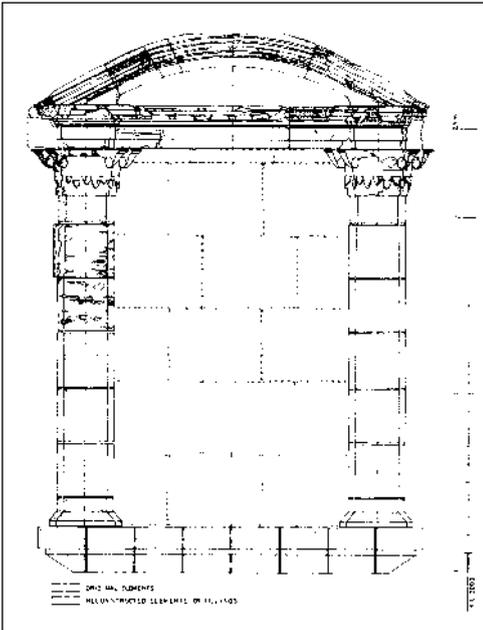
*Fig. 4a. Wall niche from hall H 21N.
Theoretical reconstruction
(Drawing R. Czerner)*

As reported previously,⁶⁾ the niche in the south wall of Hall 21“N” had been reconstructed to the height of the impost. In 2003, the work was completed based on reconstruction drawings prepared by R. Czerner (*Fig. 4a*).⁷⁾ New fillings were inserted, glued and fixed with stainless steel dowels. Areas around the joints were strengthened with ethyl silicate stone strengthener FUNCOSIL STEINFESTIGER OH (Remmers). The adhesive used for both stone and steel was an epoxy resin ARALDITE AW 1360 (CIBA-GEIGY) with powdered limestone added. The missing sections of the ornamental cornice were carved using traditional tools. Small

fillings were made on the base of a silicon resin ADHESIL K1 with powdered limestone. The reconstructed impost blocks were then reinserted in place and fixed with mortar. The missing part of the niche tympanum was reconstructed in the same way as the impost blocks. The original elements, which had been impregnated in 2002 with FUNCOSIL STEINFESTIGER 300 (Remmers), were reassembled and the recreated piece fitted into place, thus completing the reconstruction (*Fig. 4b*).

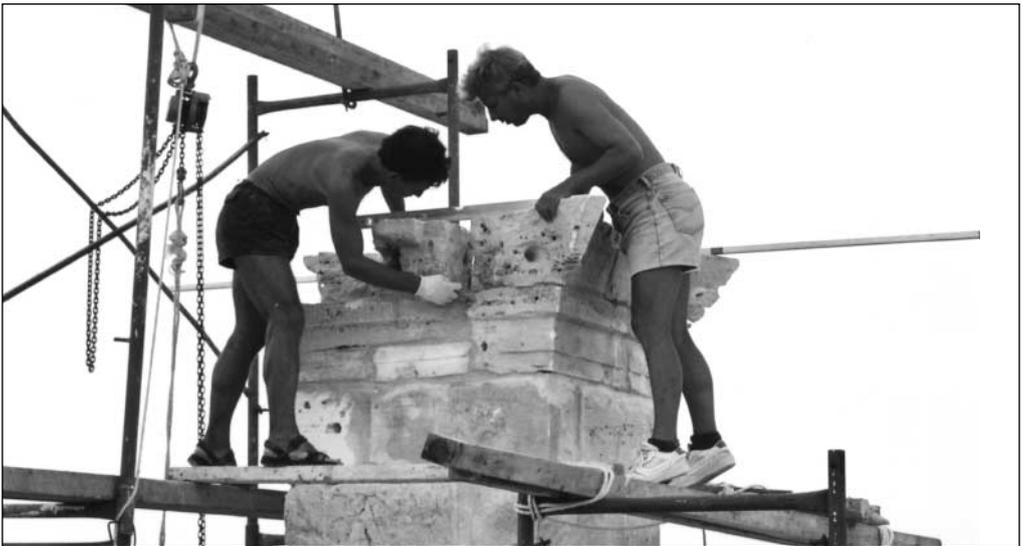
Fig. 7. Anastylis of the capital on top of pillar tomb T 1K (Photo S. Medeksza)

surviving elements of this pillar-shaped monument were put back in the position in which they were found and carefully protected for future restoration.¹⁰⁾ Several blocks of similar dimensions were lying in the vicinity and it turned out in consequence that few new blocks had to be prepared for the reconstruction. Sadly enough, one of the missing pieces was the southern jamb of a small niche located in the middle height of the pillar. With some modifications resulting from the need to include the results of recent research, it was possible to raise the pillar to a height of 5.30 m, (Figs. 5, 6), leaving the remaining
