THE ACTIVITIES OF THE POLISH-EGYPTIAN PRESERVATION MISSION AT MARINA EL-ALAMEIN IN 1988

Włodzimierz Bentkowski

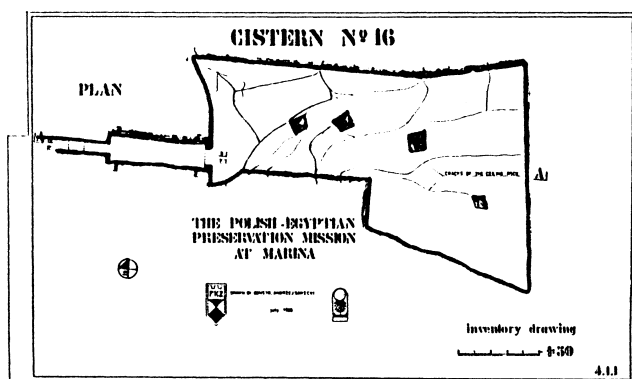
Fig. 1. Plan of the cistern.

UNDERGROUND CISTERN (Fig. 1)

The cistern, situated in the southeastern part of the ancient site, consists of a reservoir excavated in the rock and a partly vaulted entrance. It is filled with a deep layer of silt sand and the rocky roof is supported by four extant stone pillars has been damaged by seismic activity.

The main problem for conservation in this case was to find a way to consolidate the rock in order to create conditions for completing research and making the site accessible to visitors. A special system of reinforced concrete binding joists was designed to strengthen the cistern roof; damaged sections of the roof should be underslung

to this grid. The whole construction can be hidden under sandy soil such as covers the roof of the cistern already. The conservation program includes reinstallation of several sections of the corridor vaulting, bracing of the pillars and filling gaps with concrete. These measures will stabilize the structure, making future research safe.

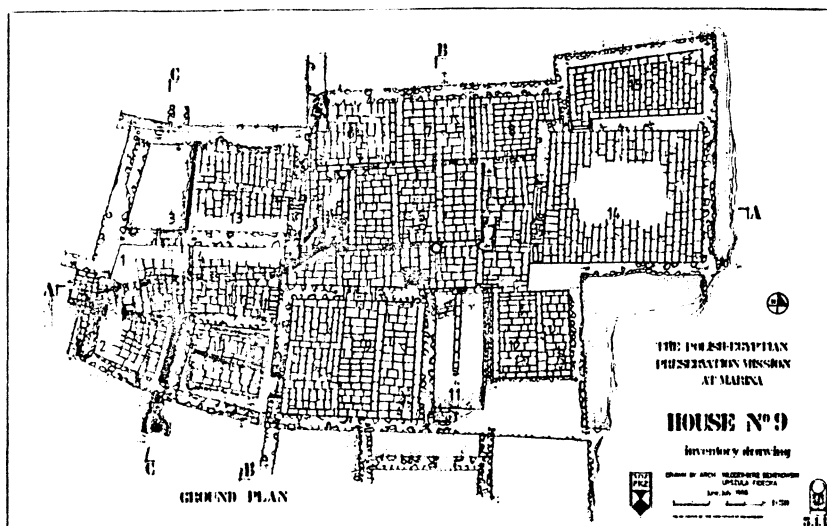
Fig. 2. House H 9, ground plan.

HOUSE H 9 (Fig. 2)

House no. 9 is located in the central part of the ancient site. It is rectangular in outline (40 by 24 m), its walls preserved to the height of c. 2 m. The house has been cleared by Egyptian archaeologists, providing a complex of 14 rooms grouped around a central courtyard.

The entrance to the building is on the western side. Four stone steps lead through a door to a vestibule (No. 1). South of it there is a latrine (No. 2) provided with a channel leading to a sedimentation tank located behind the outer wall of the house. On the northern side of the vestibule there is a storage (?) room (No. 3). Next is a kind of corridor (No. 4) leading to the courtyard (No. 5), the central part of which was probably left open.

This court was lined on two sides by a portico and on the third by a vaulted (?) passage flanked by two pilasters. On the northern side, three medium-sized rooms (Nos 6, 7, 8) opened onto the court. In one of them (No. 6) fragments of a ceramic vessel were found forming part of a 'chimney' system.

On the south the court is flanked by a large hall accessible through an opening with traces of a door (No. 9). In the next room (No. 10), which probably had a storage function, the floor was made of horizontally placed amphorae covered with sand. An opening closed by a stone slab gave access to two small storage cellars. Next to hall No. 9 there is a double-track stairway (No. 11) with its lowest two steps preserved. Next to it is a room (No. 12) situated in the

southeastern corner of the house. Facing west, one can enter room No. 13 from the courtyard, while turning east through two openings one can enter the largest room of the house (No. 14). In one of these openings traces of a wooden doorframe were preserved. In the other there were remnants of wooden partitioning. The last space is a longitudinal room accessible from the previous one.

The house was provided with a cistern under the court. Rain-water ran directly from the roof to the cistern. Water from the courtyard served to flush the latrine or was directed to a container disguised as a bench near the entrance.

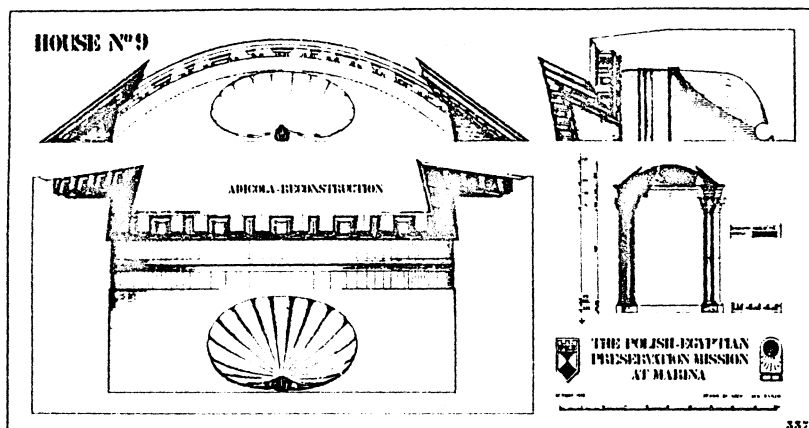
Fig. 3. Reconstruction of the aedicula found in House H 9.

In the course of exploration many architectural details were found, including column drums, capitals, fragments of a tympanon, cornices and a frieze with triglyphs and metopes. Of the greatest interest were remnants of an *aedicula* – a shallow niche crowned with a conch and a tympanum supported on either side by two small columns (Fig. 3).

Beside preparing a full architectural record of the monument, our aim was to specify the required reconstruction work. In the case of House H 9 we decided to limit such work as much as possible. The structure we were dealing with here was only partly uncovered and its plan could not be traced in its entirety. However, some of the discovered elements needed to be protected and enhanced. Thus, we suggested such conservation work as was necessary to enable a clear and proper exposition of the structure in the future. Beside reinforcing and building up the walls in several places and making the openings more visible, we proposed a full reconstruction of a column from the portico and of the aedicula which could be placed in the wall of room No. 14.
