# ALEXANDRIA

## EXCAVATIONS AND PRESERVATION WORK

### 2001/2002

Grzegorz Majcherek, Wojciech Kołataj

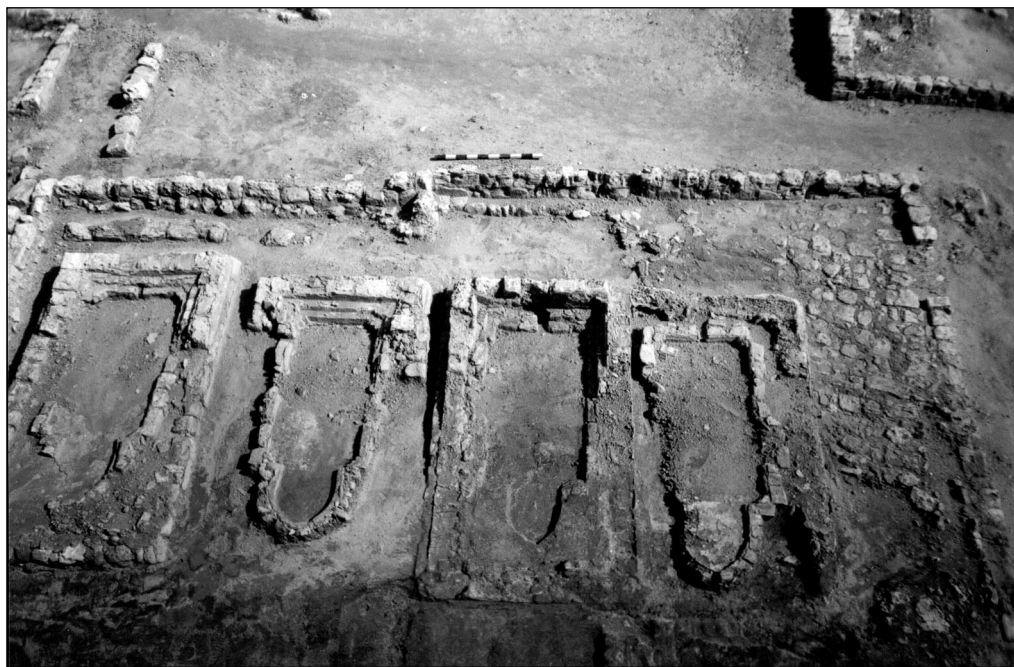
Fig. 1. Area E. Moslem necropolis. Graves E 49-E 52, viewed from the west (Photo G. Majcherek)

The trench was expanded westwards for another 5-6 m, clearing graves which were also grouped and enclosed by perimeter walls. Two such enclosures came to light. The larger one to the south grouped eight graves (E 41-E 48) and the smaller one to the north comprised four graves (E 49-E 52) (Fig. 1). This section of the cemetery

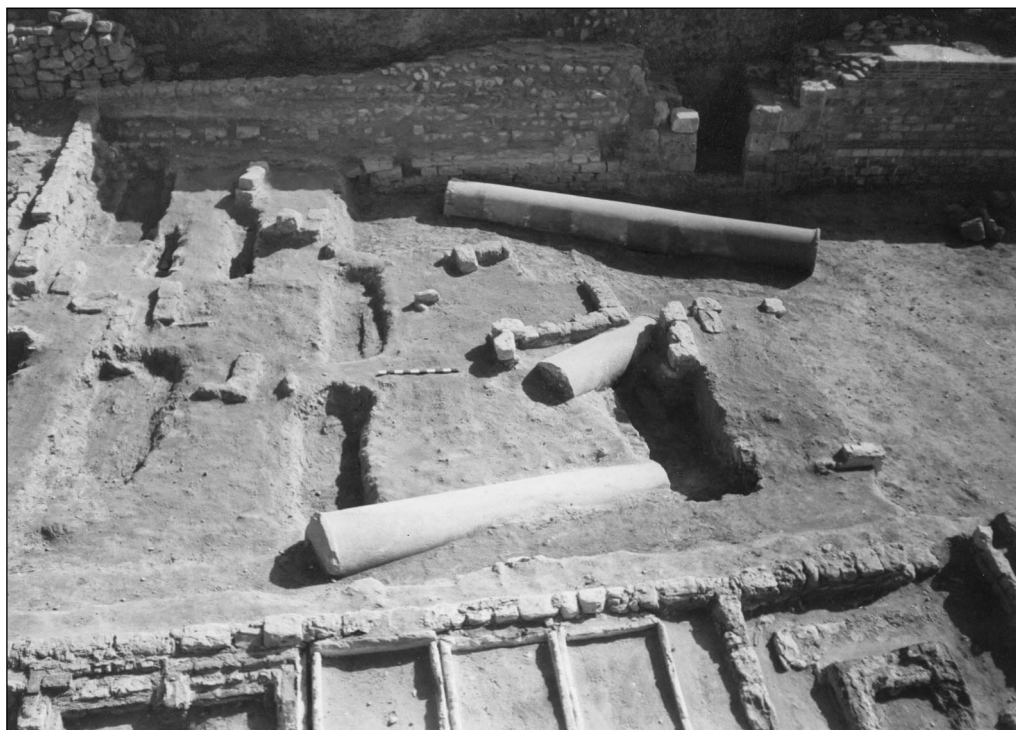
Immediately below the graves of the Middle Necropolis three toppled granite columns were cleared. All were found broken, but their position indicates that they had not been moved. Two of them (nos. 15 and 17) were found practically *sub situ*, their lower parts still on the stylobate, while the third (no. 14) had rolled over and now lies close to the Portico back wall (Fig. 4).

The destruction of the Portico may likely be connected with an earthquake that devastated Alexandria in AD 796.<sup>6)</sup> Apparently, the columns collapsed on some

Fig. 4. Area E. Theater Portico. Fallen columns found underlying the Moslem cemeteries layers, viewed from the west (Photo G. Majcherek)

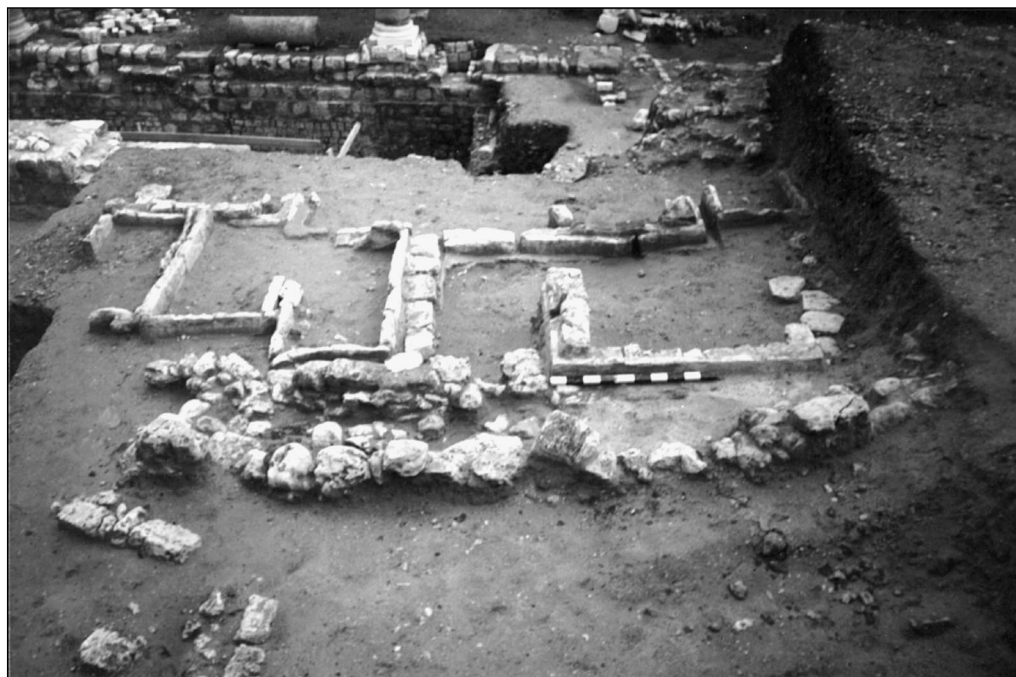
Several graves of the medieval cemetery were explored in this area (*Fig. 5*). Tombs of the Upper Necropolis (nos. M 350-M 357) were cleared at c. 12-12.50 m above sea level. They were largely disturbed and poorly preserved, most of the aboveground structures damaged, especially in the area adjoining the portico back wall (possibly due to later stone robbing).

*Fig. 5. Area M. Moslem necropolis, view from the east (Photo G. Majcherek)*

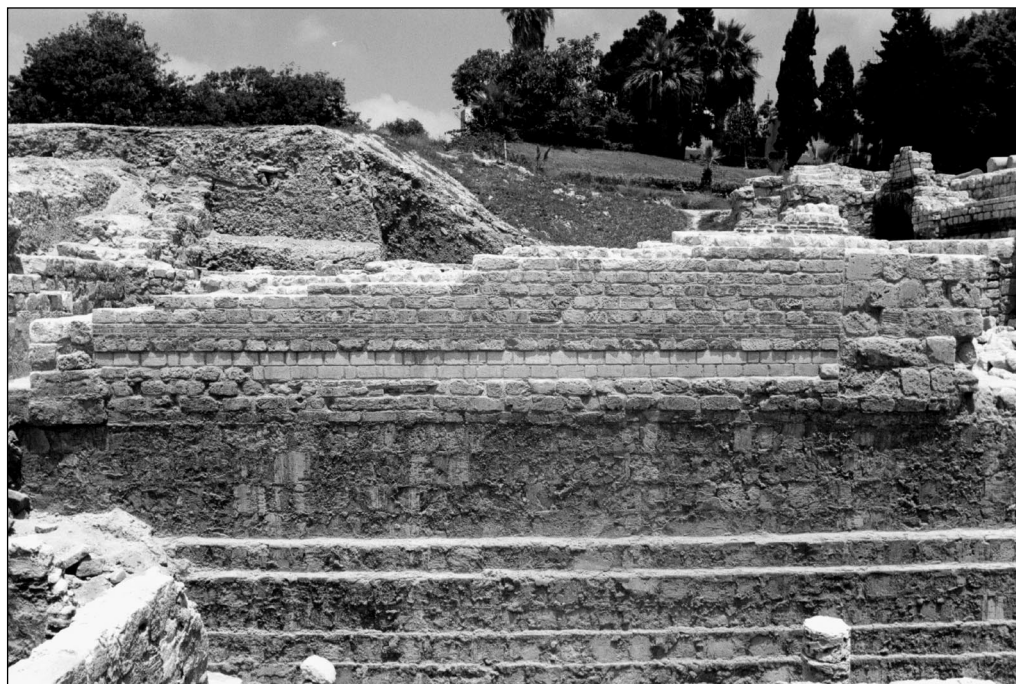
Fig. 7. Theater Portico. The back wall in sector M, view after restoration (Photo G. Majcherek)

The wall had a core of irregular stones thickly poured with ashy lime mortar and a facing made of regular courses of smaller dressed blocks, with conspicuous brick lacing laid every seventh course. The disintegrated core was consolidated and the missing facing duly rebuilt to a height of 3 m above the portico pavement, using original stones taken from the immediate vicinity. Brick lacing was restored with new bricks cut to the required dimensions (Figs. 7, 8-10). (The wall coping in the northern section will be completed following a thorough clearing and examination of the other (eastern) facing.) The newly restored wall facing, albeit done in original stones, was clearly separated from the extant original masonry with a layer of

bitumen tarpaper and additionally with two slightly recessed courses of new blocks. Moreover, the bitumen tarpaper introduced into the wall structure also works as an insulation layer, preventing damp and salt migration.

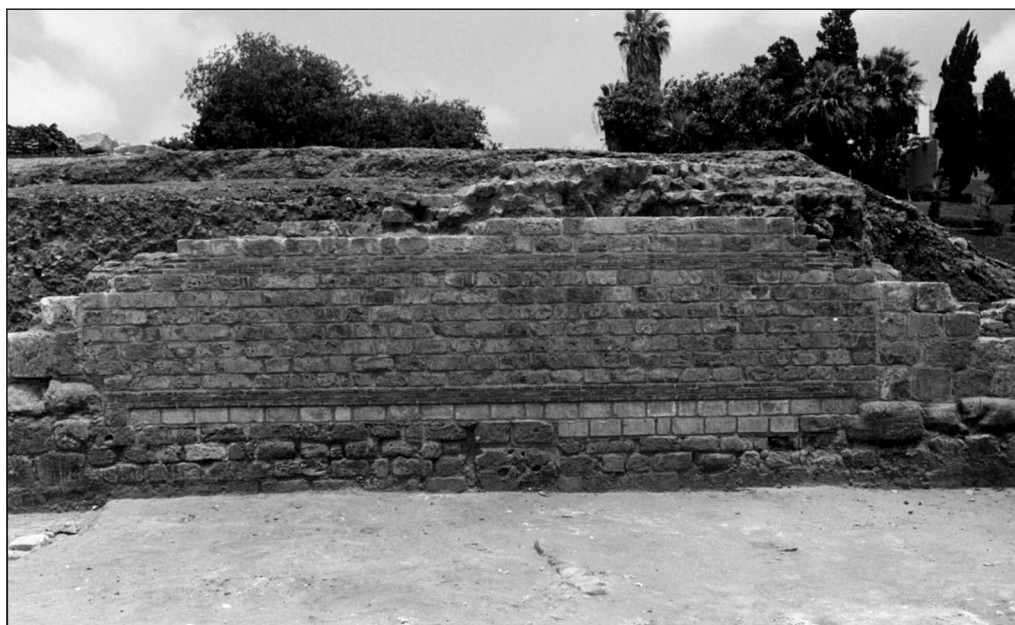
*Fig. 9. Theater Portico. The back wall in sector L, view after restoration  
(Photo G. Majcherek)*

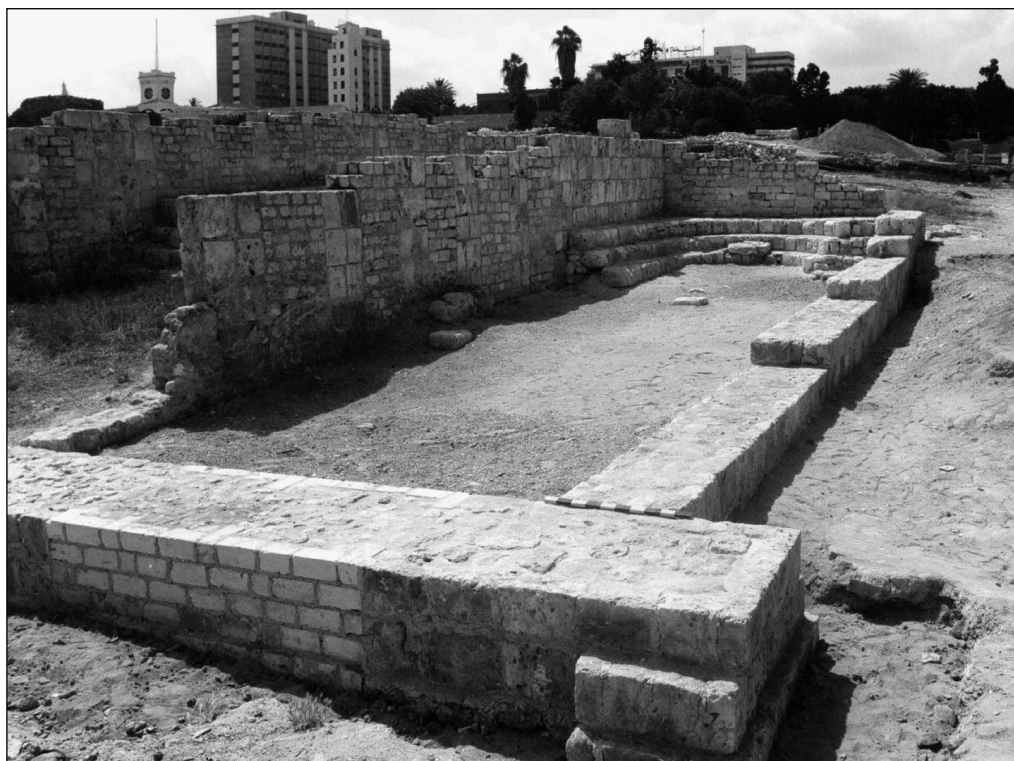
Fig. 11. Area AW. Northern auditorium (no. 2), view after restoration  
(Photo G. Majcherek)

Preservation work at the far end of the Theater Portico concentrated on restoring the walls of one of the auditoria (no. 2) uncovered there in the late 1970s.<sup>10)</sup> The auditorium built behind the Portico back wall had been dismantled completely in the medieval period. Restorers cleared the foundation trench to a depth of some 2.60 m below the floor level of the auditorium (i.e., to the level of the original footing). Since the missing section of the portico back wall was some 13.50 m long here, it proved necessary to restore also an adjacent section of the northern wall to provide for lateral stability.

Ancient building principles were followed strictly in the restoration of the foundation. The lower courses (up to c. 2.00 m above the footing) were made of coursed squared rubble topped with two layers of small dressed stones. An additional bonding course of small blocks was introduced at mid-height. For the upper courses larger blocks of a size similar to those used originally were used, there having been quite a number excavated in the vicinity. The wall was restored from one to three courses above the pavement of the portico. The section of the northern wall (c. 6 m long, 1.30 m wide) was rebuilt in the same manner and the missing facing

completed in new masonry (Fig. 11). During accompanying archaeological exploration preceding the restoration work, it was ascertained that the northern wall of the auditorium ended with a pilaster-like projection (ca. 0.70 m), flanking the entrance to the northern passage of the bath complex. The lower part of the pilaster was duly restored to its original shape.
