OLD DONGOLA THE MOSAIC CHURCH (KOME) 1993/94

Bogdan Żurawski

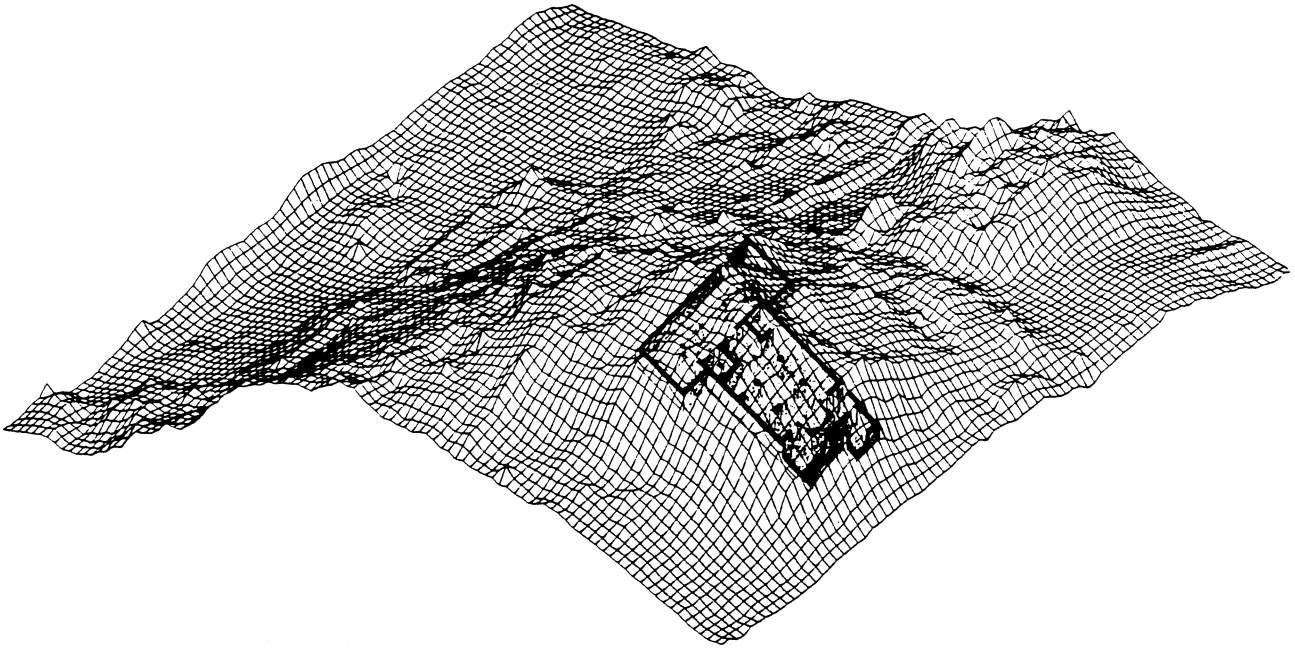
Fig. 1. Computerized model of Kom E with scanned-in church outline.

The Church on Kom E (known also as the Mosaic Church) is the only church in Nubia whose whole interior was once paved with mosaics. The regular geometrical pattern in the western part of the *haikal* is analogous to the mosaics found in the presbytery of the Church of the Stone Pavement in Dongola (Fig. 1). The computerized model of Kom E with the Church outline on it presents the ground relief in somewhat exaggerated form.

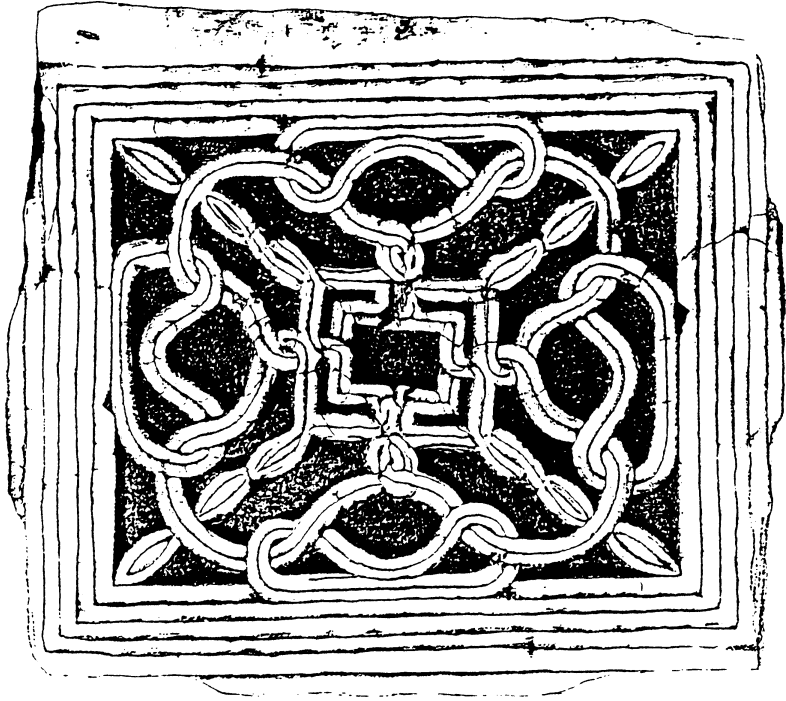
Fig. 2. Reconstruction of the cancelli slab. Drawing B. Żurawski.

The *higab*, which was a later addition, was made of ornamented *spolia* of ferruginous sandstone and slabs of yellowish sandstone decorated only with a single-lined moulding. The cancelli slabs which screen the *haikal* from the nave are bordered by the eastern pair of naos columns and stone jambs. Probably the jambs flanking the nave entrance to the presbytery were capped by spheroid caps made of sandstone. The original *higab* should not have been higher than 110 cm.

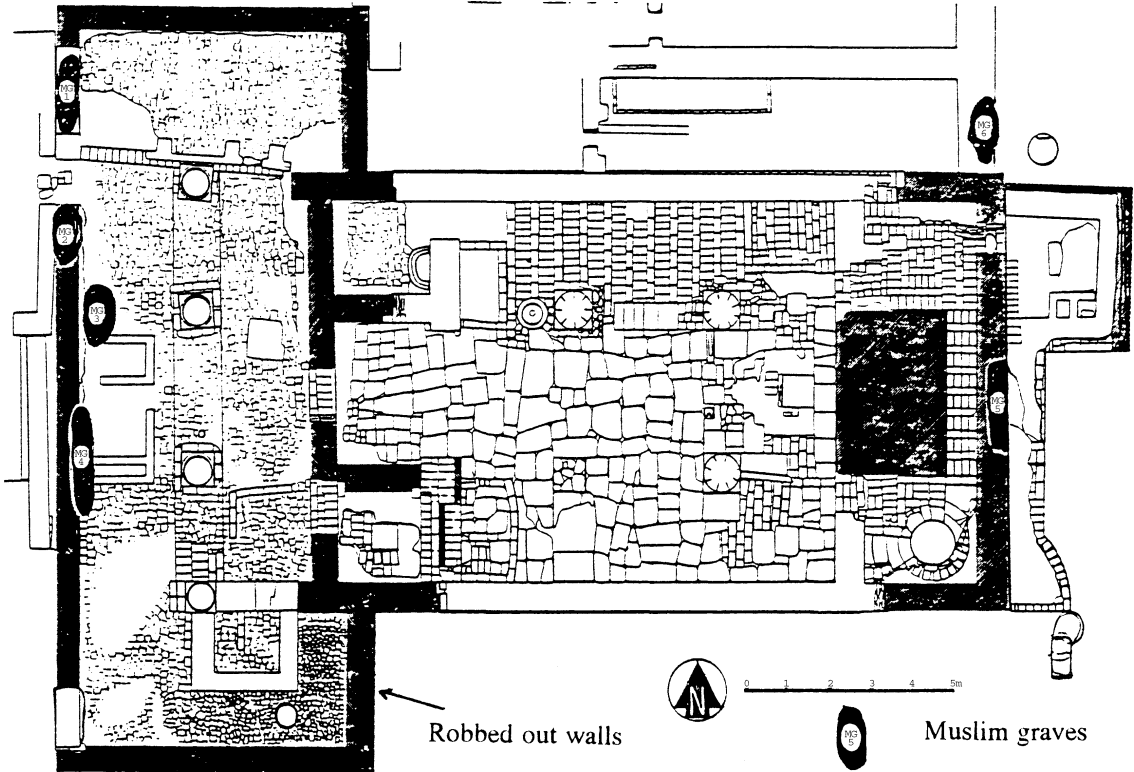
Fig. 3. The Mosaic Church on Kom E. Drawing B. Żurawski.

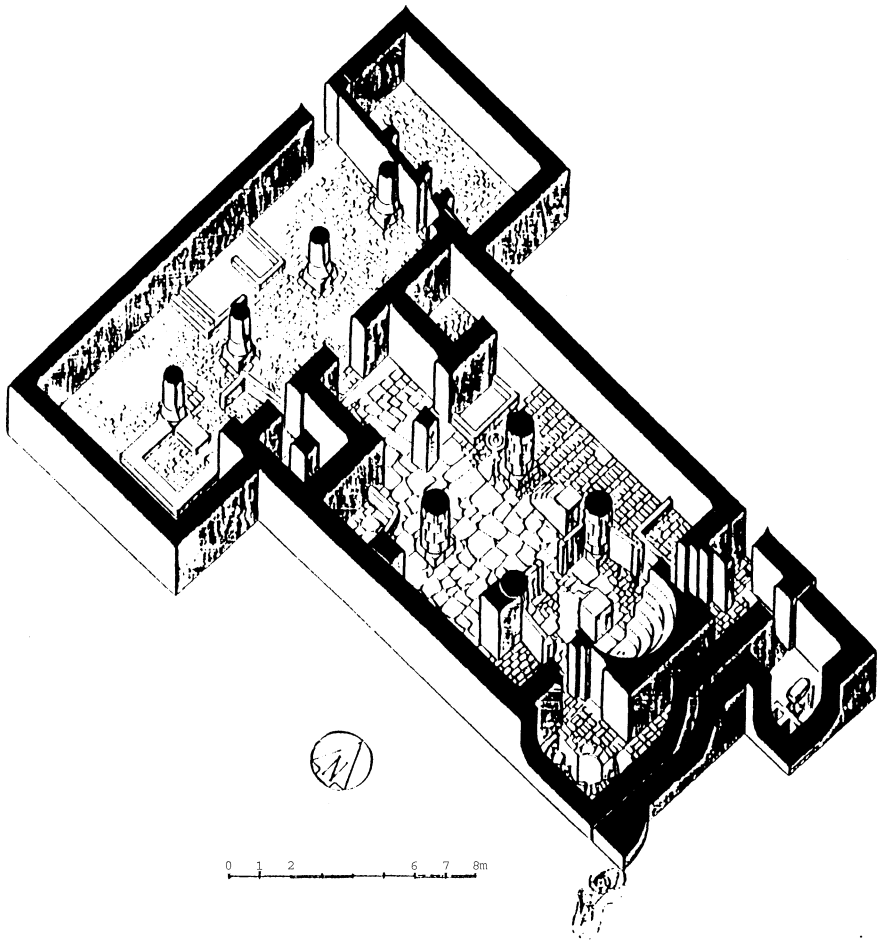
Fig. 4. The Church on Kom E. Isometric view. Drawing B. Żurawski.

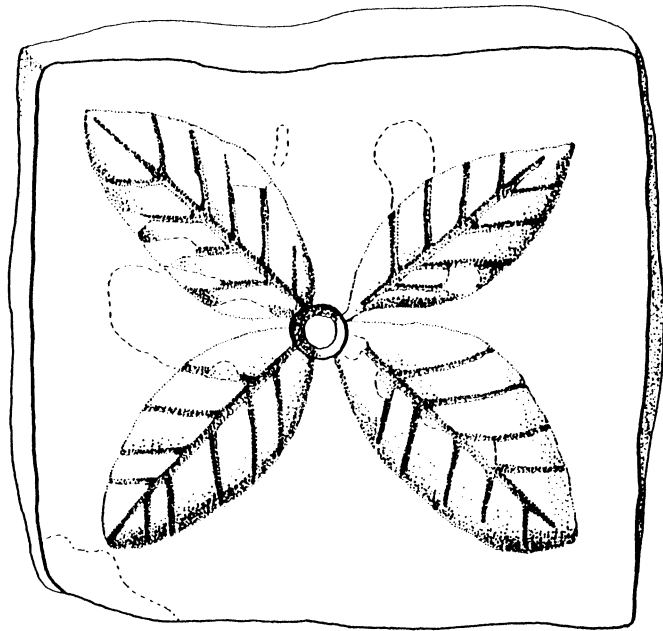
Fig. 5. Perforated ferruginous slab, possibly a "Stocklampe" base.
